THE PRACTICAL USE OF NDE METHODS FOR THE ASSESSMENT OF DAMAGED MARINE COMPOSITE STRUCTURES

P. J. Sheppard¹, H. J. Phillips¹ & I. Cooper²

SUMMARY

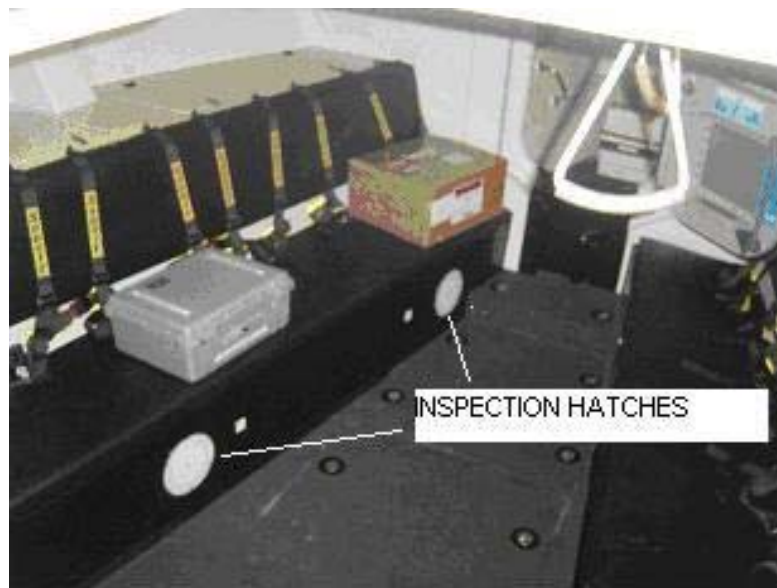
It was evident that one of the transverse frames had impacted with the underside of the survivors compartment sole moulding and there was a strong possibility of shear web failure in the transverse frame. Figure 1 shows the issues involved with traditional inspection methods in confined spaces, with damage only being accessible through a series of 150mm diameter inspection hatches. Accurately tapping to ascertain the extent of the damage was not possible as much of the area was out of reach and obscured from sight.

Figure 1 – View of survivors' space compartment

It was however possible through the limited access, to establish that there was a significant amount of delamination between the longitudinal stiffeners and the hull bottom although the full extent was unknown. It was evident that the secondary structure would require removal to carry out repairs. More advanced NDE methods would be needed to determine the extent of the delaminations whilst minimising the need to remove structure.

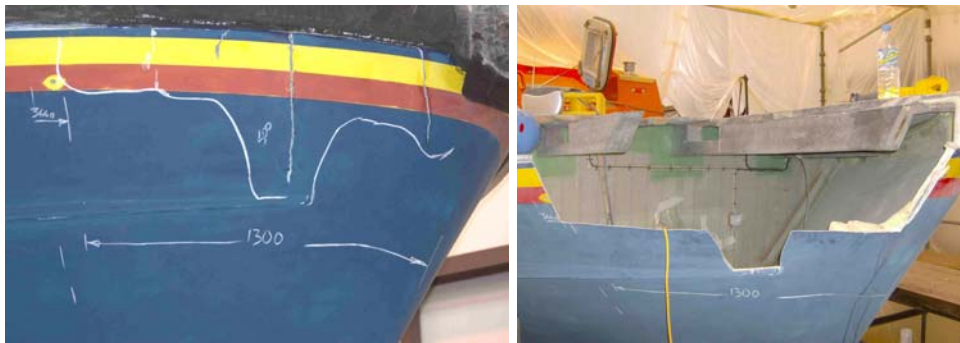
A second example of when shearography has been used to assist in damage assessment is shown in Figure 3. The hull has been marked up to show the extent of defects detected during the shearography inspection. This corresponded closely to the final extent of the damage that had to be removed. In these situations the NDE results are used to place the initial cuts when removing the damaged structure.

Figure 3 – Damage marked up after inspection and with damaged material removed

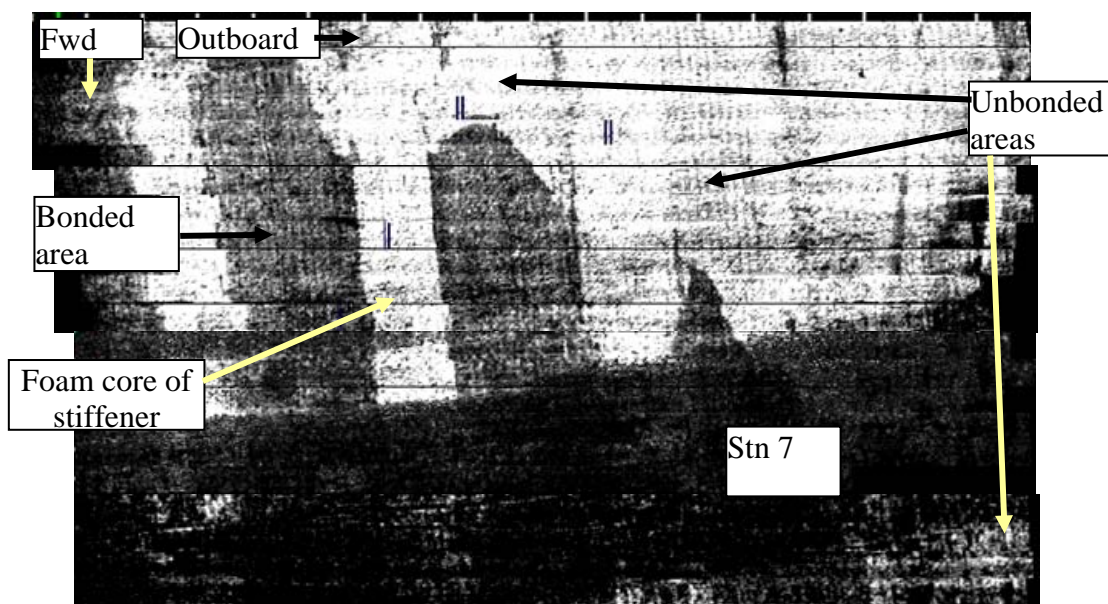
Figure 4 - Composite image of amplitude C-scans from the area around stn 7.

The area around stn 7 was tested and a composite image of around 30 amplitude C-scans is shown in figure 4. The foam cores of the longitudinal stiffeners and the disbanded areas are clearly seen as light areas. The dark areas correspond to the well bonded areas and the transverse frame at stn 7.

The stiffeners and secondary structure were cut away and the actual damaged areas corresponded well with the results obtained from the area scanning. When repairs had been effected the area was scanned again using the markings on the hull from the previous inspection. Figure 5 shows this same area following repair.

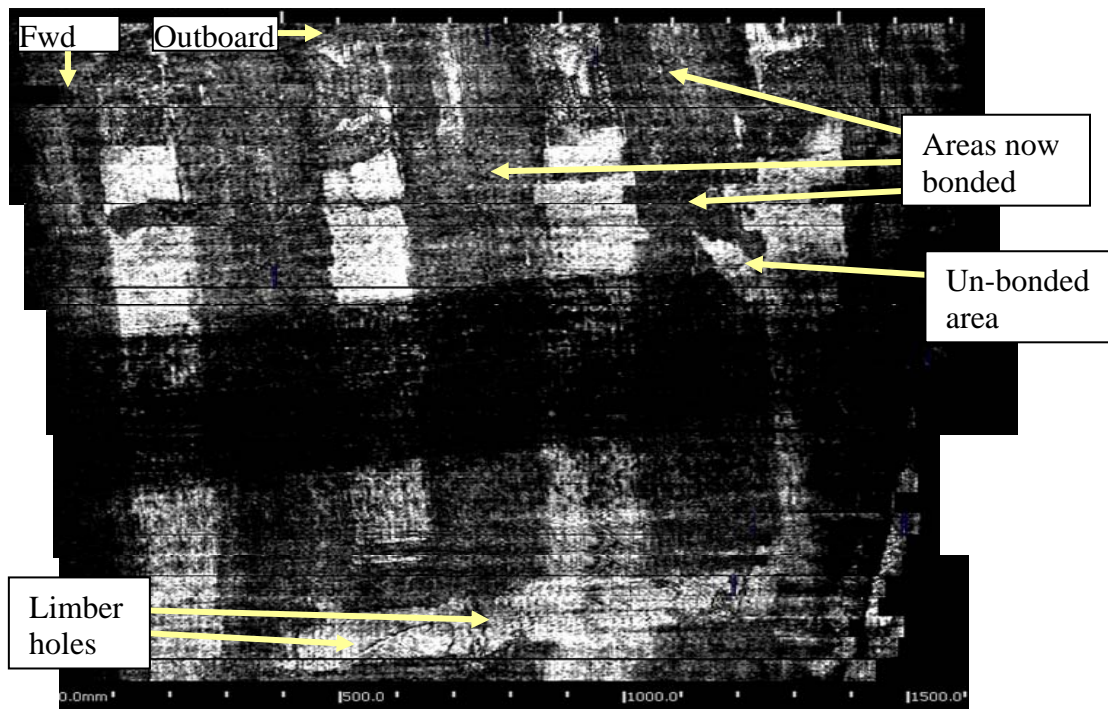
Figure 5 - Composite image from the area around stn 7 after repair.

The large un-bonded area is now not present, as expected. One small un-bonded area remains as indicated in the Figure that was later locally repaired. The limber holes forward of stn 7 can also be seen.

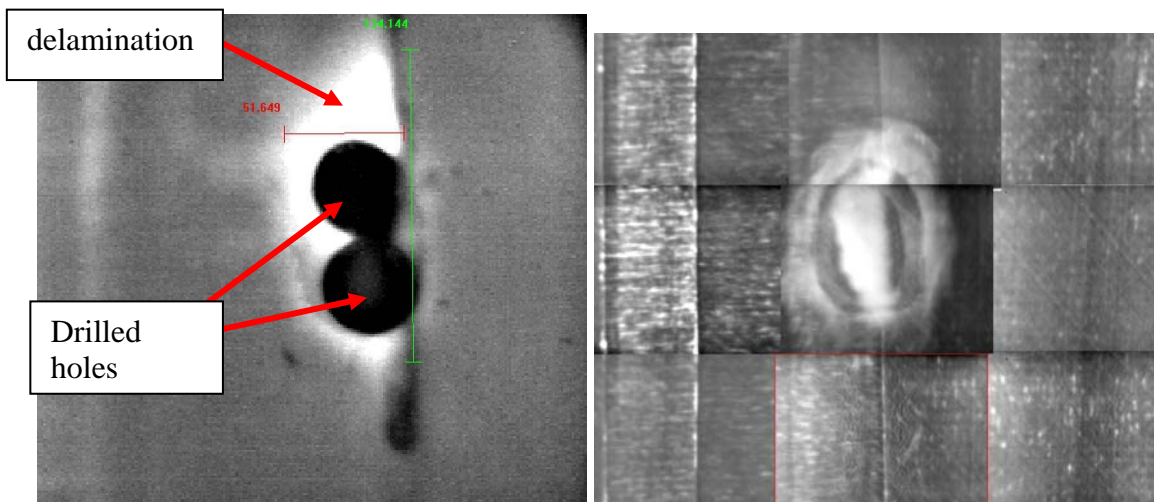
An area of visible damage could be seen at the forward edge of stiffener 5 at station 5. The damage appeared to consist of a vertical crack of approximately 200mm in length running along the line of station 5. In the upper part of the crack an area of approximately 134mm in vertical length appeared to have delaminated for a distance of approximately 50mm aft. Two 40mm diameter holes had been drilled into the delamination to determine the depth of the damage. Tap testing had been carried out and the extent of the suspect damage had been marked on the skin.

Several shots were taken of the area around the damage site and the technique was optimised. Figure 8 shows an image of the damage area and the subsequent repair. The delaminated area and the crack can be seen. The delaminated area shown as white was indicated to be approximately 25% larger than that detected by tap testing as marked on the hull. The vertical crack indication appeared to match the visible length.

Figure 8 - Thermogram of damage site

The right side of Figure 8 shows a composite image of a meter square area centred on the damage site. The scarf repair can be seen with detail, also visible are the glass prepreg cloth overlaps seen as vertical stripes.
