A STUDY ON NONDESTRUCTIVE INSPECTION FOR VARTM COMPOSITE WING STRUCTURE

Sunao Sugimoto*, Yuichiro Aoki*, Yoshiyasu Hirano*, Yosuke Nagao* Japan Aerospace Exploration Agency (JAXA)

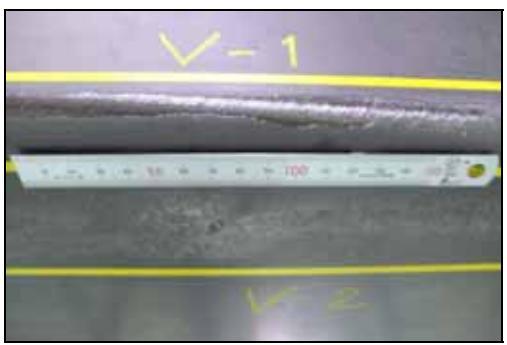
Several quality instabilities in the manufacturing were found by visual inspection, such as incomplete resin impregnation in the thick region of corner where is skin/spar intersection, deformation of stringer web, surface wrinkle in the ply drop region and springing at the spars. These quality instabilities are shown in Fig. 4. It is considered that the dry spots of the thick region in the corner surface are caused by not supposed resin

(a) Incomplete resin impregnation

impregnation because these dry spots are the tool side. Resin went around the region and then a dry spot was remained. This problem can be solved by changing of resin impregnation time and location of resin inlet and vacuum outlet points. The deformation of stringer web is caused by moving of inner mold in the process. The surface wrinkle is caused by complex thickness change at the intersectional region between ply drop and stringer. It is considered that this complex change make fiber alignment and/or vacuum pressure disturbance. In addition. spring-in angles of the spar are approximately 1 degree in the wing root and 1.5 degrees in the wing tip. It can be solved by modification of tool angle along spar in consideration of thermal deformation.

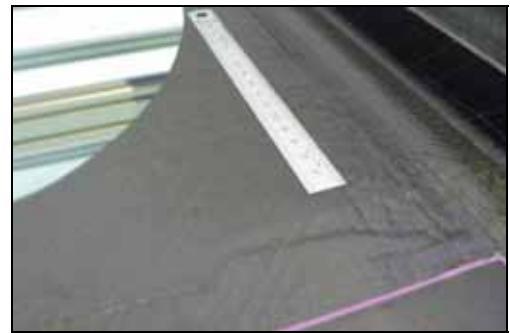
(c) Wrinkle of bag side surface

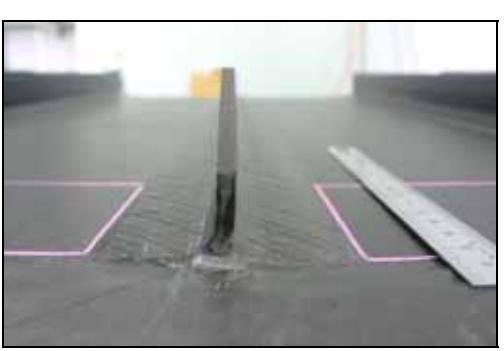
(b) Deformation of stringer web

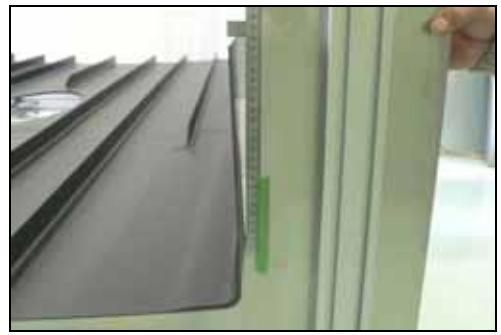
(d) Spring-in of spar

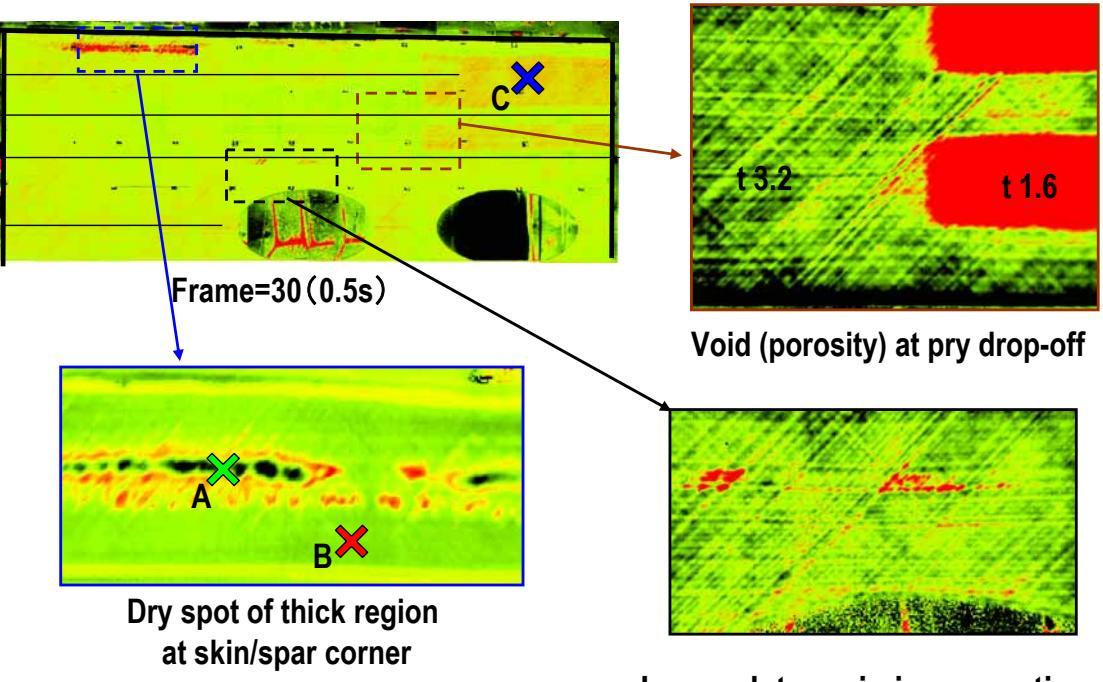
Fig. 5. NDI result of pulsed thermography.

Incomplete resin impregnation of skin-stringer jointed part

NDI result of pulsed thermography is shown in Fig. 5. This result indicates incomplete resin impregnation regions in the corner and under a stringer that were also obtained in the visual inspection. Fig. 6 shows Log-Log plot of surface temperature time history on the specimen at the marked points in Fig. 5. Evaluation of this time history of temperature change provides the incomplete resin impregnation is only several plies from surface. This NDI method is suitable for large area inspection because this method has very fast inspection feature.

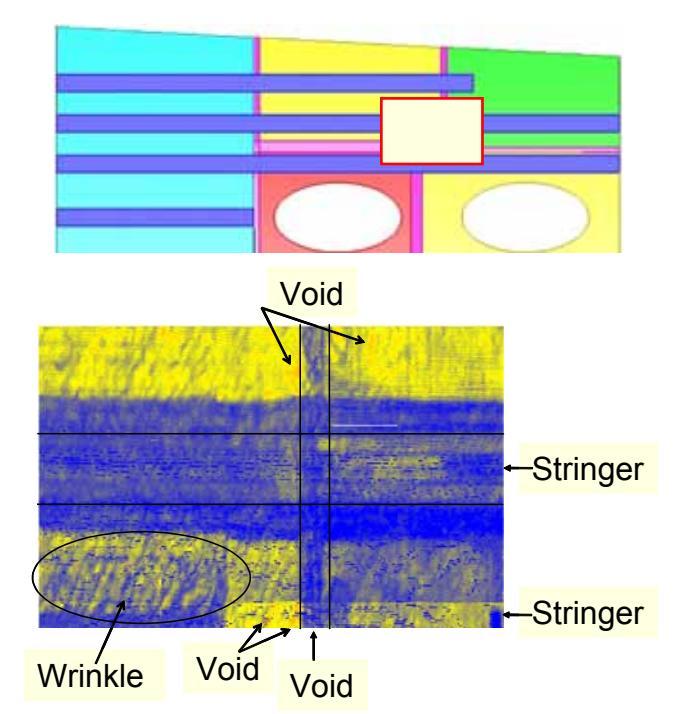
Fig. 7 Result of Ultrasonic C-Scan of thick part.

Fig. 7 shows NDI result of thickness change region using ultrasonic C-scan. Fig. 7 indicates there are some voids around the ply drop off region and wrinkle on the bag side.

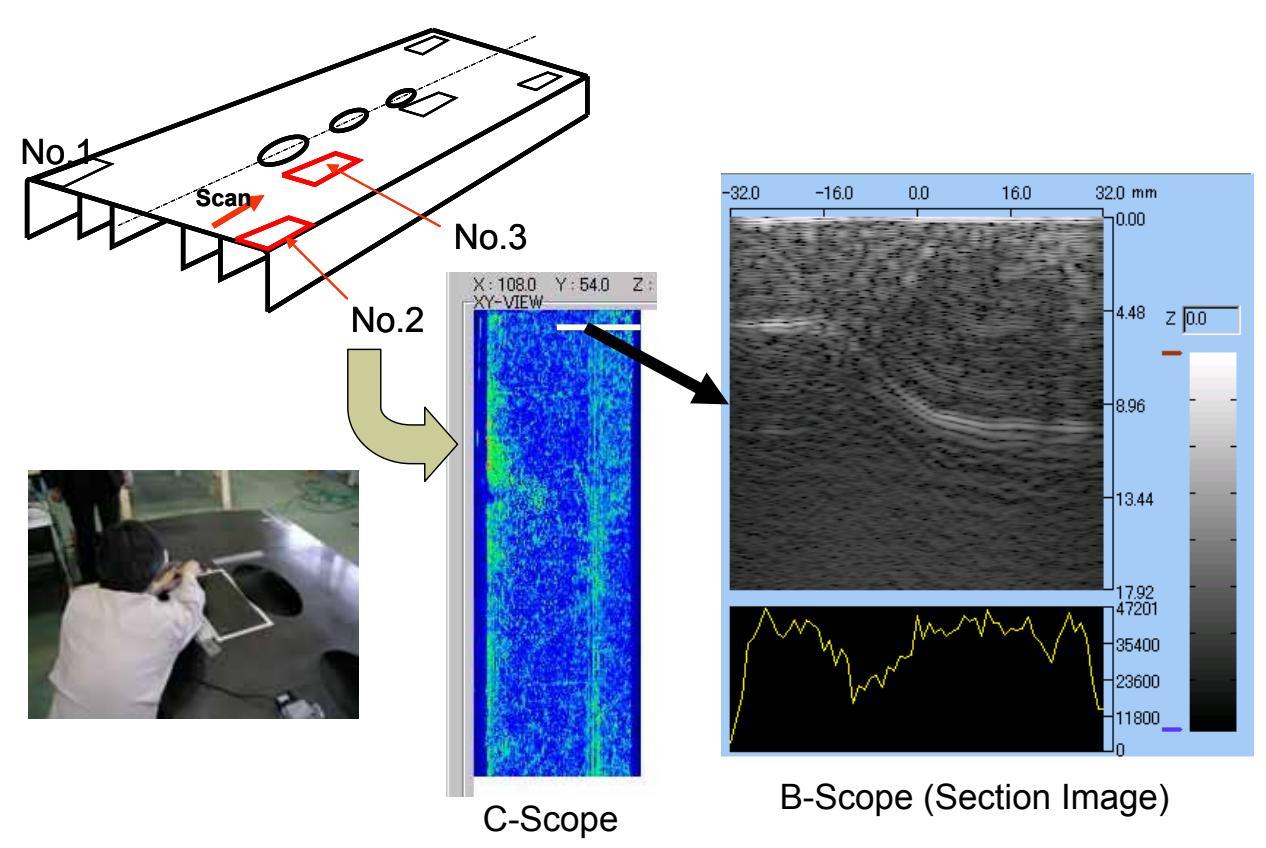
Fig. 8. Results of 3-D Ultrasonic Scan of part No. 2.

3-D Ultrasonic Scan was also applied to the specimen and a scan result is shown in Fig. 8. This method uses linier or matrix array type probe. Each segment of selected segments of array probe respectively transmits pulses and selected segments receive the echo, and then 3-D scan image is created with aperture synthesis. The scanned part in Fig. 8 (No.2) shows a scan result of thickness change part because of additional plies for corner of between skin and spar. NDI of this part could not be done by conventional ultrasonic inspection. This method is faster and provides better result for thickness change part than conventional ultrasonic inspection.
