CHARACTERIZATION OF FATIGUE DAMAGE IN LONG FIBER EPOXY COMPOSITE LAMINATES

Abstract

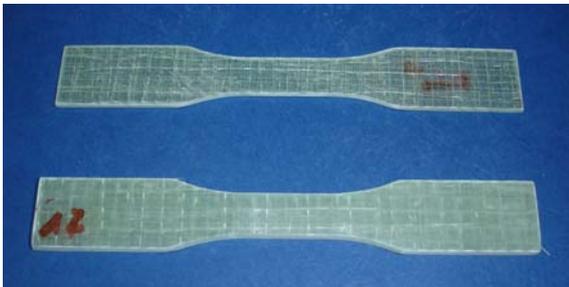
Fig. 1. Two specimens with different stacking sequence and identical geometry.

Taking as reference the longitudinal specimen axis, two different stacking sequences have been considered: $[0/90/0/90]_s$ and $[90/0/0/90]_s$.

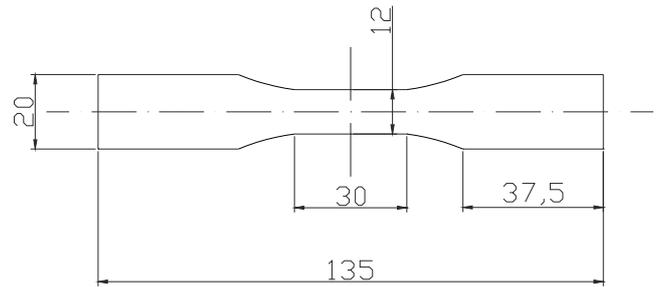
The specimen geometry in figure 2 has been adopted; using specimens with large fillet radius of 60 mm is possible to reduce stress concentrations and at the same time to use simple hydraulic grips without additional tabs.

Fig. 2: Geometry of the flat specimen.

From every 300 mm \times 300 mm plate, 20 specimens have been obtained, for a total of 60 specimens. The laminate thickness is 4.3 mm.

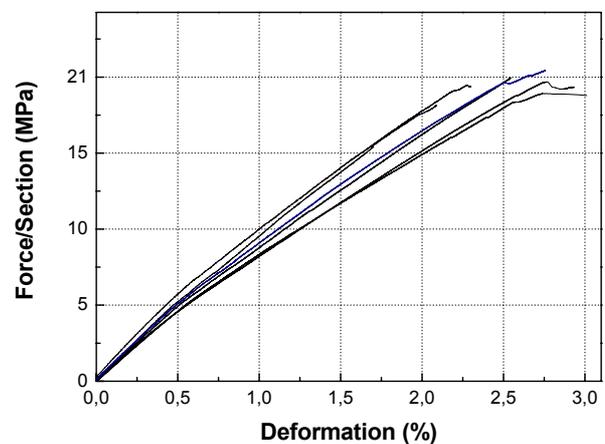
Fig. 3. Static tests for six specimens that are reported in table 1.

The specimens have been extracted from three plates obtained in the same work and environment conditions and marked with the letters A, F and G. From each slab, a total of 20 specimens have been obtained and numbered: first 10 in the $[0/90/0/90]_s$ configuration and second 10 for $[90/0/90/0]_s$ lay-up. Two specimens, randomly chosen for each slab and with different stacking sequence, have been statically tested and the results are reported in figure 3. The crossbar speed crossbar has been set at 0.5 mm/min. They show good reproducibility and coherence as can be seen in table 1.

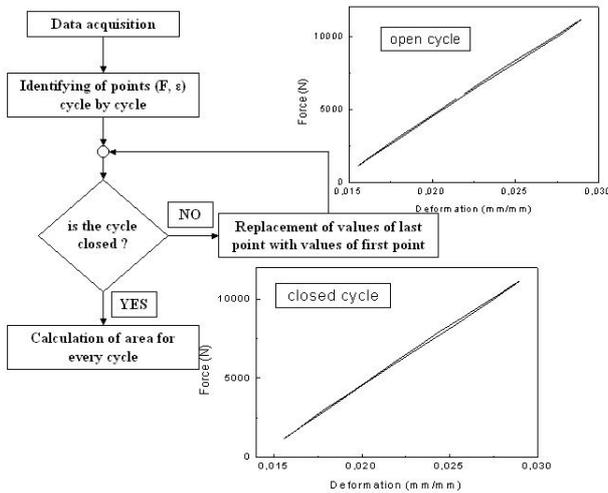
Fig. 4. Pseudo-code for calculation of H at each cycle.

Sinusoidal fatigue load has been applied with a frequency of 15 Hz and a load ratio R equal to 0.1. Two variables have been considered as significant index of damaged state of material: stiffness variation and dissipated energy per cycle into the specimen during fatigue test. The stiffness (E) has been calculated cycle by cycle averaging the value derived from ascending and descending sides of the load cycle. Deformation of a specimen under cyclic

load is a process that dissipates energy during the increasing load phase; a part of this energy is released back during the load decreasing and a residual part is consumed to create new defects or propagate the existing ones [8-10]. Therefore the hysteresis area per cycle during fatigue tests represents a not-direct index of general damage state: higher is the absorbed strain energy, more important is the damage process which takes place. Dissipated energy is henceforth indicated with symbols H and by means of a opportune algorithm (figure 4) it has been possible to consider each complete closed cycle and calculate it cycle by cycle. The other parameter considered as damage index is residual stiffness [11].

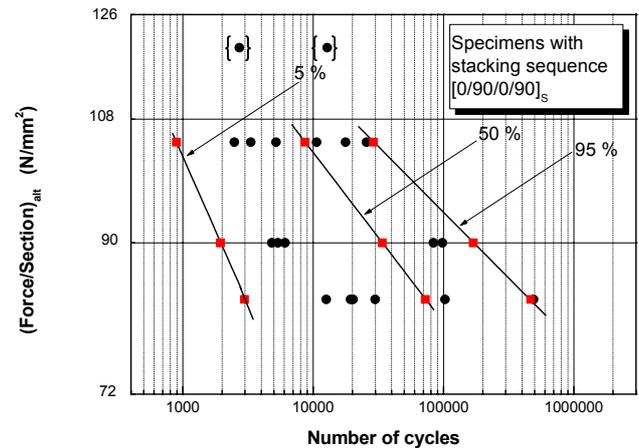
Fig. 5. S-N Curves for fatigue tests conducted on $[0/90/0/90]_s$ specimens. The points defining the probability curves of rupture are marked with red squares.

Adopting the “constant stress level method”, the fatigue life curves have been determined considering three load levels and, fitting this results according to Weibull statistical analysis [12] (fig 5 and 6). On graphs are also reported the experimental data not taken into account for statistical analysis and marked in curly brackets.

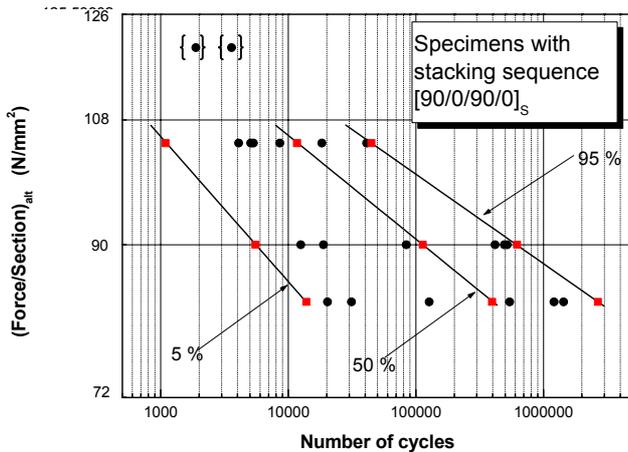
Fig. 6. S-N Curves for fatigue tests conducted on $[90/0/90/0]_s$ specimens. The points defining the probability curves of rupture are marked with red squares.

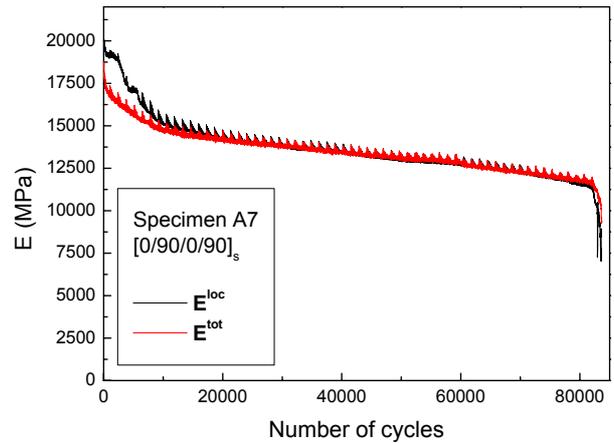
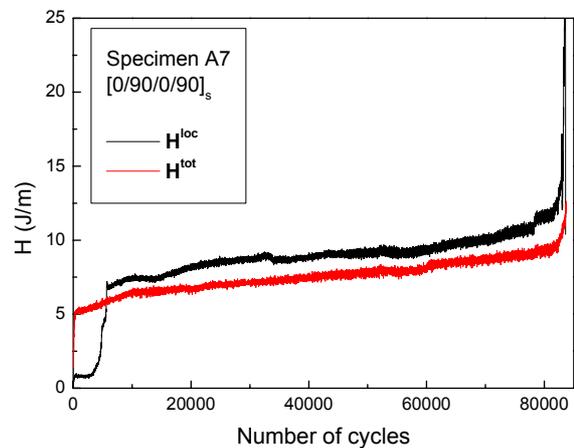
Fig. 7a. Measures of E elaborated for specimen A7 that presents rupture in its central zone.

Fig. 7b. Measures of H elaborated for specimen A7 that presents rupture in its central zone.

Comparing E^{tot} and H^{tot} with E^{loc} and H^{loc} , it is possible to also identify the damaged zone in the central monitored zone or outside it. Considering specimen A7 as example, the measures of dissipated energy as calculated for the central part and for the entire specimen have the same trend and similar values, indicating that damage mainly interests the central zone (figures 7a and 7b). This interpretation is confirmed by the trend of E^{tot} and E^{loc} : the two diagrams show very good agreement and it means that stiffness reduction mainly takes place in the portion of material with the extensometer.

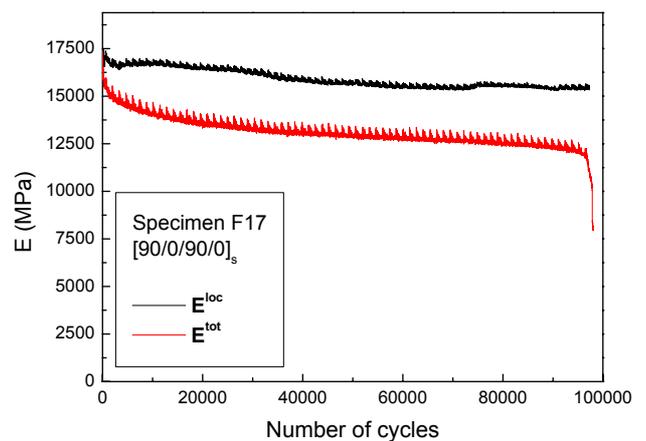
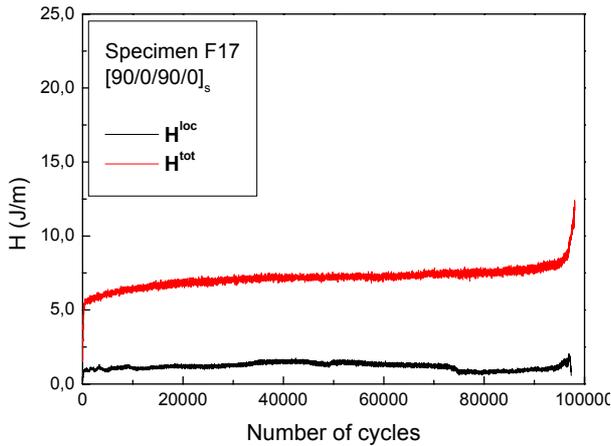
Fig. 8a. Measures of E elaborated for specimen F17 that presents rupture in its filleted zone.

Fig. 8b. Measures of H elaborated for specimen F17 that presents rupture in its filleted zone.

For other tested specimens, different behaviour has been observed and the damage mainly evolves also in the immediacy of filleted zone. Taking as significant example the specimen F17, it can be observed that E^{loc} and H^{loc} maintain constant values for the whole test duration while “tot” measures point out a clear decrease of E and a large increase of dissipated energy evidencing the continue and progressive evolution of fatigue damage.

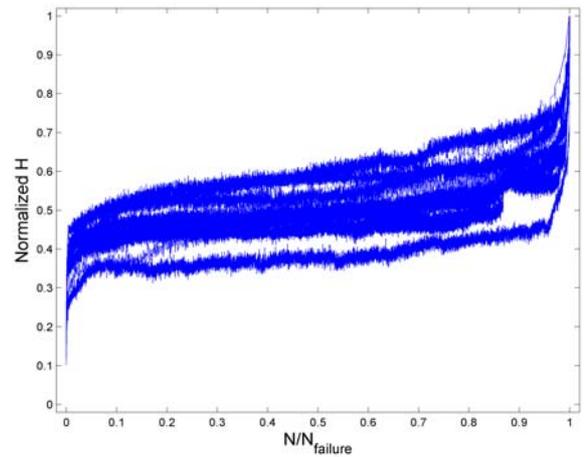
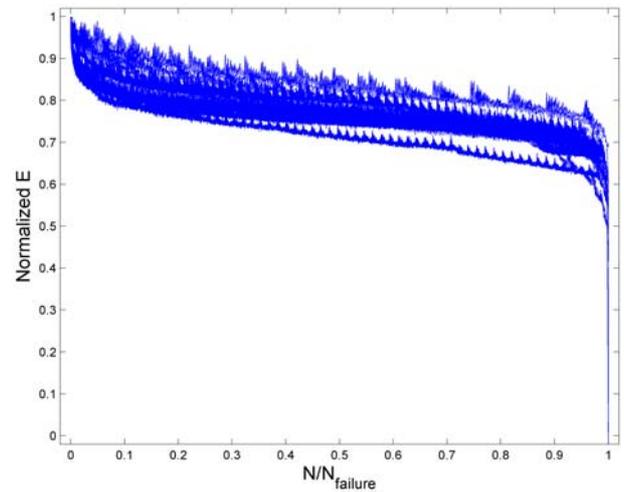
Fig. 9a. All measures for and H^{tot} reported as superposed and in normalized coordinates.

Fig. 9b. All measures for E^{tot} reported as superposed and in normalized coordinates.

Considering E^{tot} and H^{tot} normalized curves for all tests (figure 9a and 9b), two slope transition points can be observed at curves extremities; they exist in correspondence of a certain consumed life percentage level and therefore is possible to identify three zones corresponding to main stiffness and dissipated energy behavior. The following considerations can be easily highlighted from figures 9 a-b:

1. the slope transition points for H^{tot} and E^{tot} values in each test show good correspondence in term of consumed life; they are generally positioned around 5% and 95% of total time.
2. the damage curves can be approximated with three linear segments (one for each zone) as displayed for instance in figure 10 for test A20;
3. the coefficients a_2 b_2 c_2 and d_2 , defining the stabilized central part of the damage curves can be analysed for different specimens; they are found to be nearly constant and independent from the load level and from the stacking sequence as displayed in figures 11, 12, 13 and 14, in which low dispersion for H^{tot} and especially for E^{tot} coefficients is observed.

Concerning with figures 9a and b, the initial phase is dominated by elevated stiffness E assessment with a sensible and fast decrease in the order of 15÷20 %, until a stable value is reached; this fact points out that the performances of composites strongly depends on time and initial fluctuating load values and this is presumably induced by internal matrix-fiber interactions with localized micro-slippage phenomena among plies until equilibrium of forces is reached. According to this, a visible energy dissipation increment is generated before a stable damage evolution process takes place.

consumed life and is clearly placed in the same percentual life interval for all the specimens (figures 9a and 9b) either for E data trend, either for dissipated energy variations H . In addition, the monitored data seem to converge to constant values in this phase and the damage behaviour can be considered as linear with constant slope for each load level; the knowledge of the extrapolated damage data however may be useful to estimate the damage state in the component in terms of residual life to failure, provided that constant load amplitude is applied and consistent stiffness and energy measures are performed.

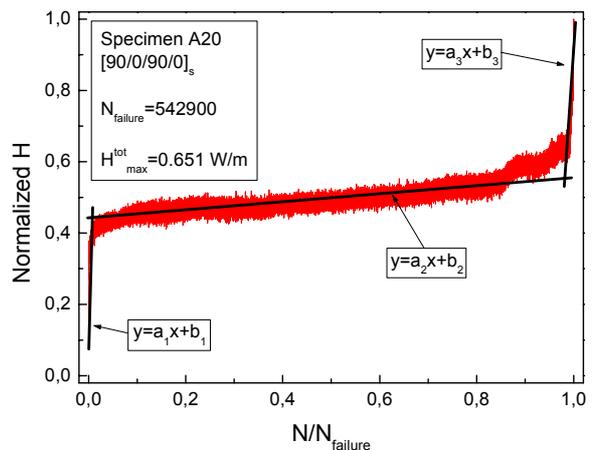
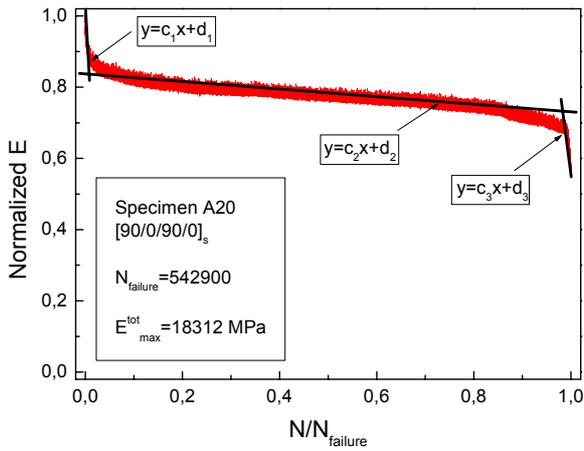
Fig. 10a. Linear approximation of normalized H curve for specimen A20.

Fig. 10b. Linear approximation of normalized E curve for specimen A20.

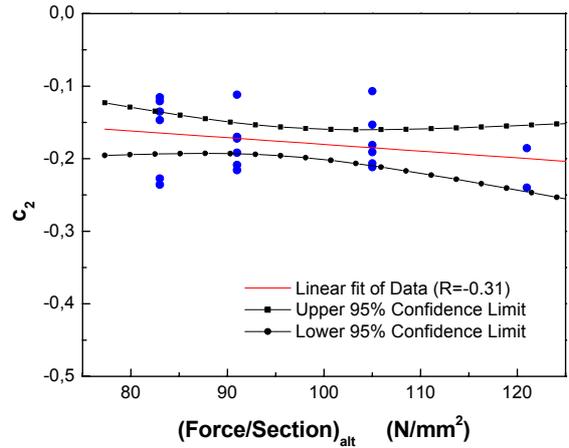
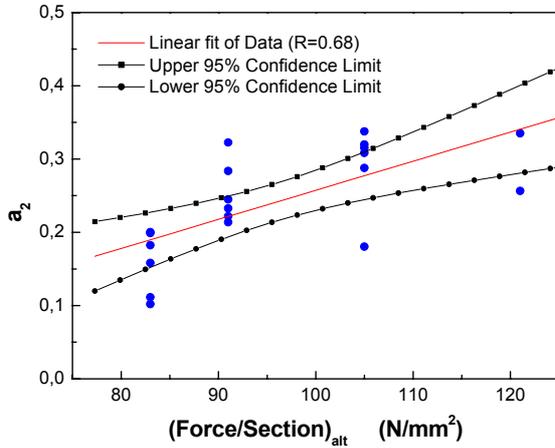
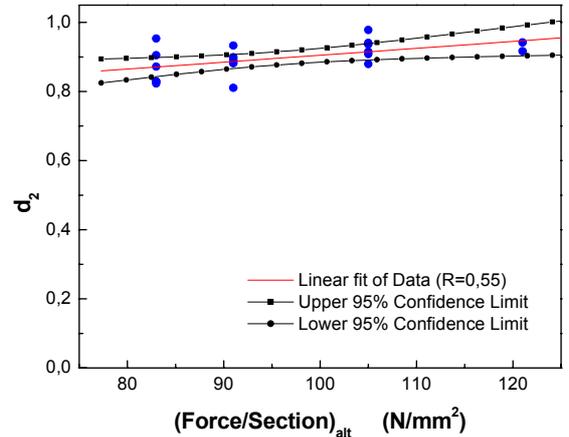
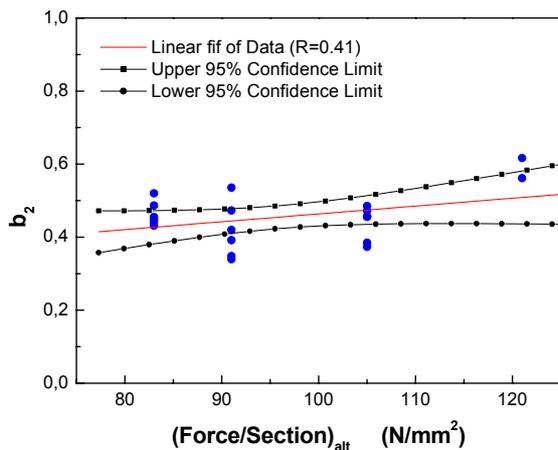
Fig. 13. Parameter c_2 calculated for all conducted fatigue test (rif.: fig 10b).

Fig. 11. Parameter a_2 calculated for all conducted fatigue test (rif.: fig 10a).

Fig. 14. Parameter d_2 calculated for all conducted fatigue test (rif.: fig 10b).

Fig. 12. Parameter b_2 calculated for all conducted fatigue test (rif.: fig 10a).

Diagrams in figures 11 and 13 resume the slope data trend a_2 and c_2 (fig. 11-a, 11,c) and the coefficients b_2 and d_2 calculated for H measures and stiffness E variations in the stable phase versus applied load. Though data are referred to specimens with $[0/90/0/90]_s$ and $[90/0/90/0]_s$ stacking sequences and differently loaded, b_2 , c_2 and d_2 coefficients seem to settle at a constant level ($b_2 = 0.45$ and $d_2 = 0.9$) within 95% confidence limits, while a_2 seems to have a light increase for higher load. Other tests with intermediate level with respect the considered ones could lightly modify the obtained results but anyway the most important result which emerges from the experimental data and their computation is a common evolution of all specimens damage state that results independent from load condition (in the considered range), lay-up sequence and number of cycles to failure.

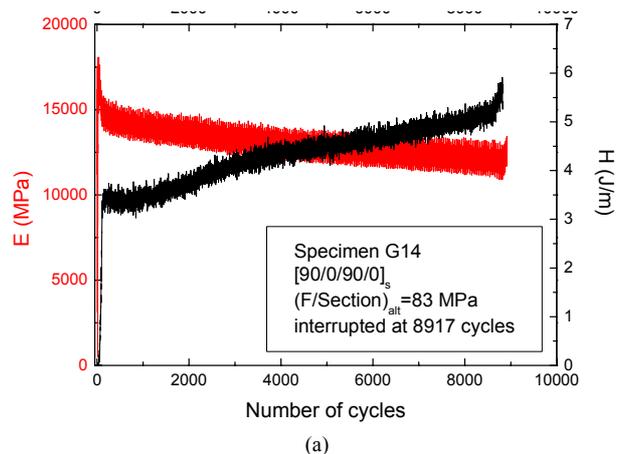
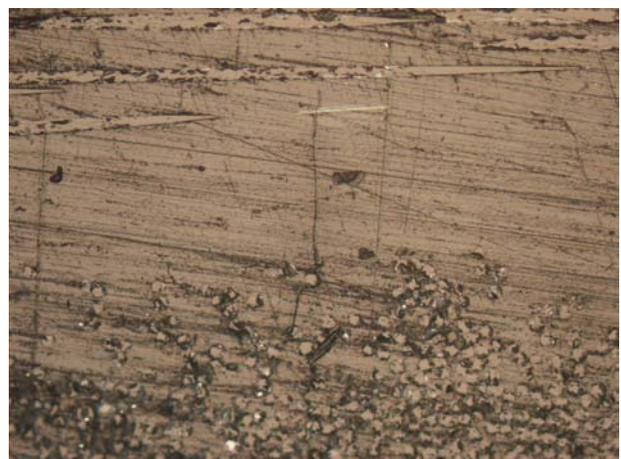
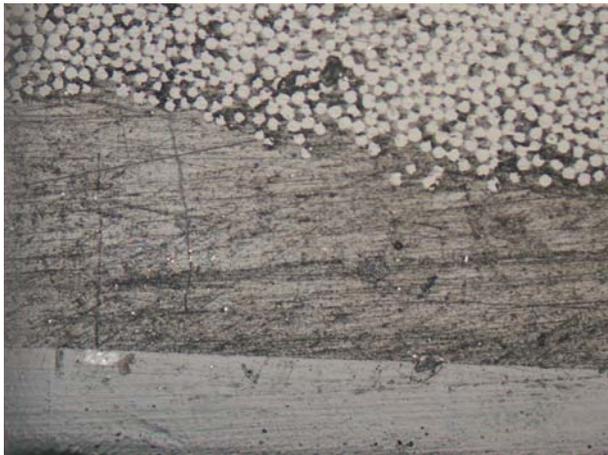
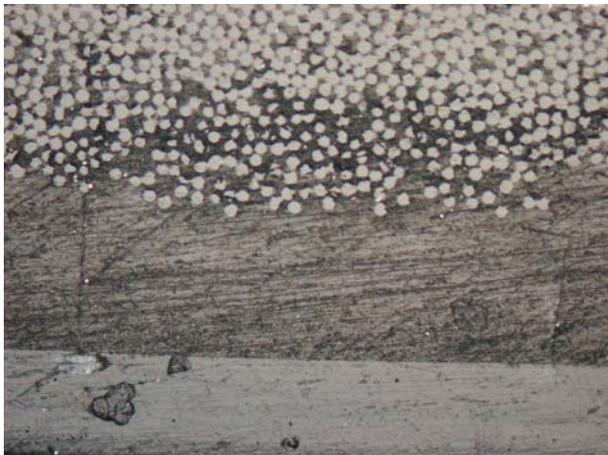
Fig. 15. (a) E^{tot} and H^{tot} of G14 test interrupted at 8917 executed cycles; (b,c,d) micrographies of the surface obtained by a longitudinal cleavage of specimen G17.

A possible confirmation of this concept is given by the analysis of micrographies for partially damaged specimens. Some tests have been carried out and interrupted in correspondence of the central zone. In figure 15, small cracks can be observed for specimen G14. They seem to have origin from micro-defects (microvoids or impurities) or from fiber in off-axis plies but do not initiate from the interface of adiacent plies; no crack progapagate beyond a single layer and they are stopped by the fibers of on-axis plies.

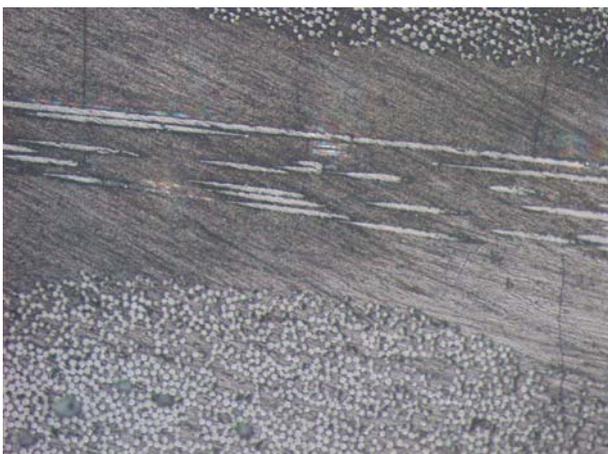
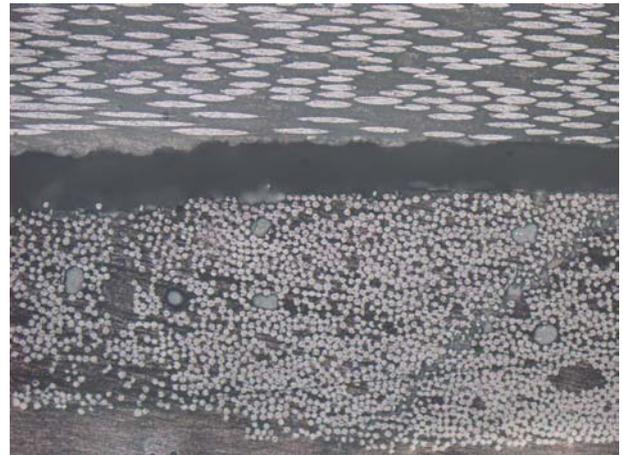
Fig. 16. Two micrographies of the surface obtained by a trasversal cleavage near fillet of specimen A11. In the (a) figure the presence of important crack can be observed; in (b) figure a wide delamination among plies has been caught.

A different situation is observable for specimen A11 (see table 2) for which a section in proximity of rupture surface has been investigated. Micrographies show important cracks that cross the section of specimen in all its layers. Moreover a wide delamination among plies is also visible. These observations show that the most important events that bring GFRC to fatigue failure take place only in the last part of life and that they become catastrophic in few cycles.
