PROGRESSIVE FAILURE AND REHABILITATION OF RC DECK SYSTEMS WITH COMPOSITES

Kumar K. Ghosh*, Vistasp M. Karbhari**

***California Department of Transportation, **University of California San Diego**

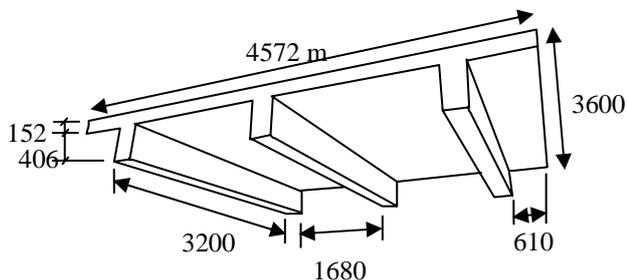
The test specimen consists of a three-girder two bay bridge deck segment with center-to-center distance between the longitudinal girders of 1.68 m (5.5 feet) and a slab thickness of 152 mm (6"). The girders had a total depth (including the slab flange) of 559 mm (22") and width of 203 mm (8"). The total longitudinal span length of the specimen is 3.6m (12'4"). An overhang of 607 mm (24") was also constructed on either side of the longitudinal edge girders. Details of specimen geometry are shown in Figure 1.

Fig. 1: Overall configuration (all dimensions in mm)

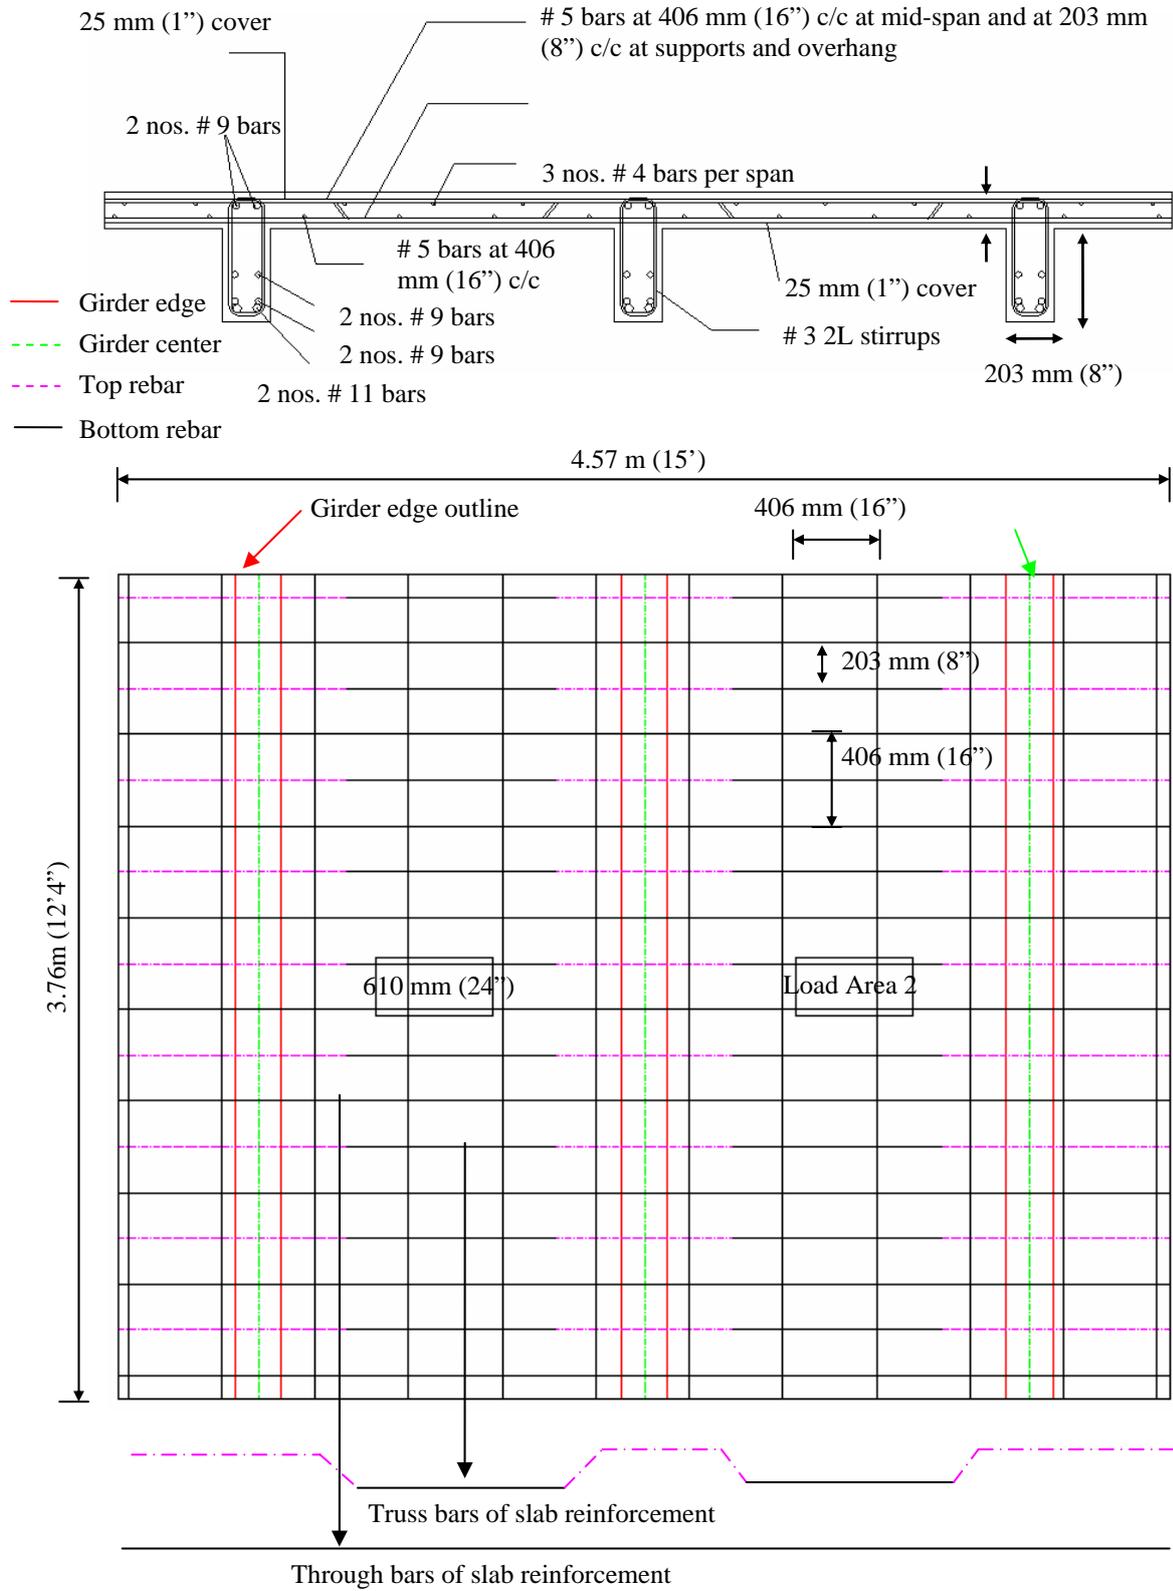
For the girders, #9 and #11 bars were used for the longitudinal reinforcement and #3 bars were used for the stirrups. The reinforcement details are presented in Figure 2. The specific stirrup spacing, and high longitudinal reinforcement ratio were used in the girders to simulate shear deficiency in the middle girder. A closer stirrup spacing of 76 mm was used near the support regions of the middle longitudinal girder to avoid an undesirable premature local failure in this region. This was because the test specimen was supported on load cells placed at each end of the girders and the shear demand was highest at these locations. However in the case of shear strengthening of the middle longitudinal girder with externally bonded U-shaped FRP composite stirrups, the presence of the load cell below the girder at the support makes it impossible to use a continuous U-stirrup to wrap around the web of the beam at the support locations. Thus the closer internal steel stirrup spacing of 76 mm was used at the support so that the shear capacity at the support even without the composite strengthening was higher than the maximum design shear demand. The longitudinal reinforcement was kept similar in all the three girders to ensure that none of the girders would fail in flexure. However on account of lower shear demand on the edge girders a uniform stirrup spacing of 305 mm was used. Grade 60 steel was used for all the reinforcing bars.

Fig. 2: Reinforcement Details

The main transverse reinforcement in the slabs consisted of #5 bars spaced at 203 mm center-to-center and the main longitudinal reinforcement consisted of #5 bars spaced at 406 mm, which resulted in a longitudinal to transverse reinforcement ratio of 2. This design simulated pre-1970 designs of slab-girder bridges in which typically a transverse to longitudinal reinforcement ratio of 2 was also used. This was observed in the slab sections cut-off from the Watson Wash Bridge and tested earlier [1,2] in which, the transverse reinforcement consisted of #5 rebars spaced at 140 mm and the longitudinal reinforcement consisted of #5 rebars spaced at 280 mm. However the spacing of the main transverse reinforcement in the test specimen was chosen to be about 1.5 times larger than the spacing of pre-1970 representative bridge deck [203 mm as compared to 140 mm] to cause a reduction of the maximum

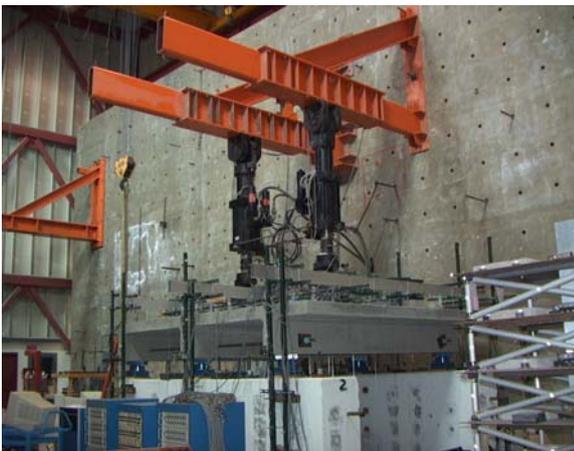
The center-to-center distance between the supports in the longitudinal direction was 3.2 m (10.5 feet). The specimen was tested under monotonically increasing load applied by two 979 kN (220 kips) capacity hydraulic actuators and the load was cycled at predetermined levels to check for structural stability and to perform NDE. The load from the actuators was transferred to the test specimens through load bearing plates having a loading footprint area of 508 mm (20 inches) x 254 mm (10 inches) that represents typical design wheel load contact areas. The center-to-center distance between the load contact areas was used as 1.83 m (6 feet) to simulate typical design axle distance of a permit truck. A 76.2 mm (3-inch) thick elastomeric bearing pad was also placed between the load bearing plates and the concrete surface to obtain a uniformly distributed constant pressure on the slab. The test setup is presented in Figure 3.

Fig. 3: Test Setup

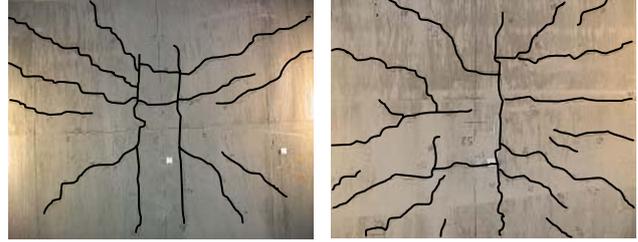
The theoretical punching shear capacity computed using AASHTO design equation [4] was 534 kN. The initial and longitudinal and transverse cracks below the load areas were observed at 214 kN. With further loading the cracks diverged diagonally away from the load area towards the ends of the girders indicating punching shear deficiency in the slabs (Figure 4). Also the strains in the transverse steel reinforcement of the slabs were less than 40% of yield strain (Figure 5). The first hairline shear cracks in the middle longitudinal girder were observed around 356 kN. At 400 kN the slabs had extensive cracking and since this load also corresponded to 75% of punching shear capacity,

Fig. 4: Crack Patterns in the two slabs

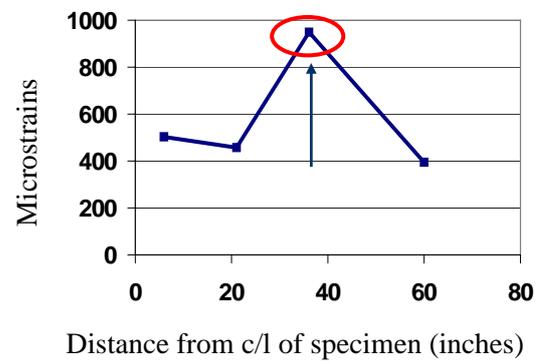
Fig. 5: Strain in transverse steel rebar below load area of slab 1

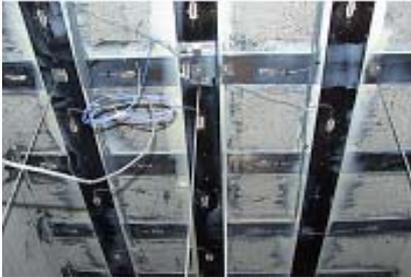
Two strengthening schemes were used for the two deck slabs, namely FRP composites in the form of site impregnated carbon fabric laminates and prefabricated carbon epoxy strips, to test the comparative effectiveness of the two systems. The design was based on the criteria of having a strength enhancement ratio of 2 and to have the strain in the composite within reasonable bounds to restrain the opening of the cracks in the deck slabs. Based on the properties obtained from material tests and limiting debonding strains of 3674 and 3278 microstrains computed from a debonding strain prediction model [5], the strengthening in slab 1 was computed as 1 layer of prefabricated strip at 381 mm center-to-center in both the longitudinal and transverse direction. Slab 2 was designed to be strengthened with site impregnated fabric laminates with 2-layers spaced at 533 mm in the transverse direction and with 1-layer spaced at 381 mm in the longitudinal direction. Different spacing for the two systems was used to obtain equivalent transverse flexural capacity. The installation procedure simulated field practices and the strengthening schemes are

Fig. 6(a): Section of deck rehabilitated with prefabricated strips

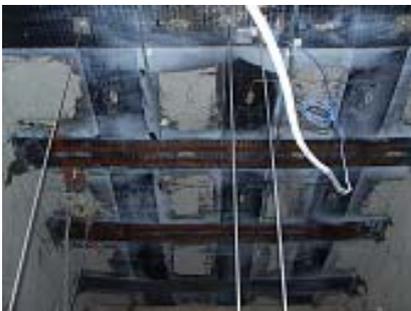
Fig. 6(b): Section of deck rehabilitated with wet layup of unidirectional fabric

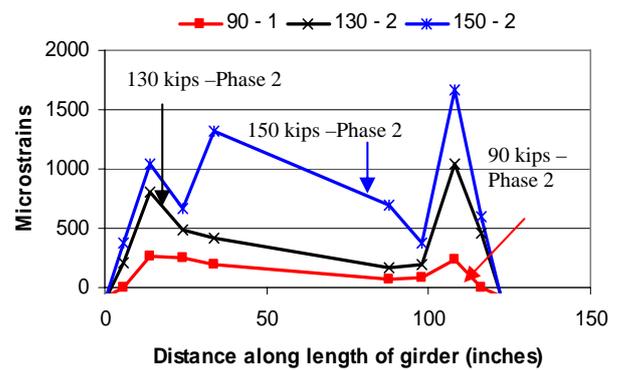
In Phase 2 the specimen was loaded to 667 kN at which point the middle girder was predicted to reach shear criticality. Shear cracks were observed in girder near support areas (Figure 7) and the strain in the steel stirrups reached ~ 75% of yield strain (Figure 8).

Fig 8: Strain in girder stirrups

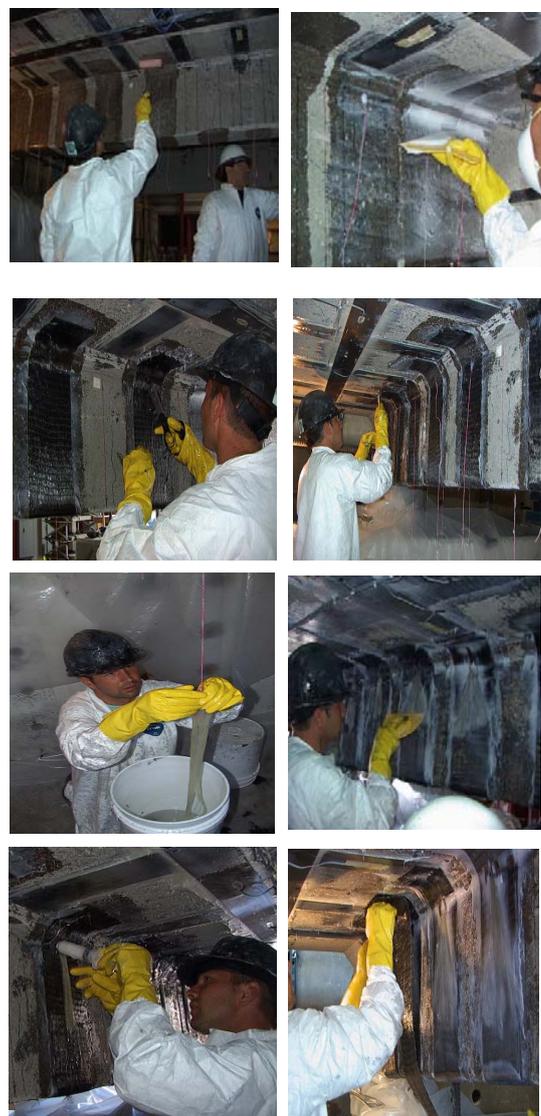
Loading was stopped and the girder was strengthened with 3 layers of CFRP composite U-stirrups at a spacing at which the strengthened girder was predicted to have a shear capacity exceeding the demand at failure of the strengthened slabs. Glass fiber bundles impregnated with resin were installed through holes drilled in the chamfer of the girder and were played between the second and third CFRP layers to anchor the composite stirrups (Figure 9).

Fig 9: Placement of FRP stirrups and anchors
At this stage the strains in slab composite were below predicted debonding strains. Also after strengthening, there was a reduction in the mid-span deflection by 15% and reduction in the strain in the

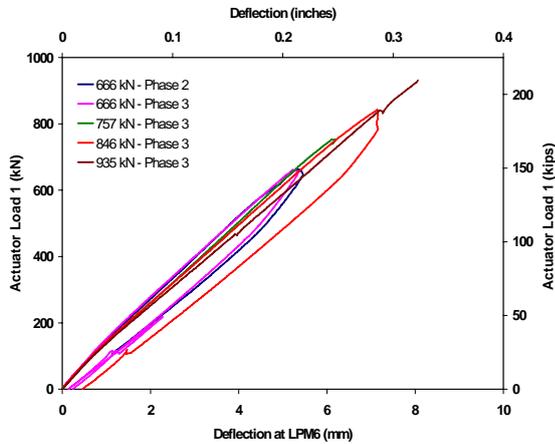
In Phase 3 the specimen was loaded to failure of the strengthened slabs predicted to occur at 934 kN. In both the slabs the failure was initiated by debonding of the composite strips at the locations of the primary punching shear cracks. Load-deflection response as measured under the central girder with a comparison to the end of Phase 2 loading is shown in Figure 10.

Fig. 10: Load-deflection response under the middle girder

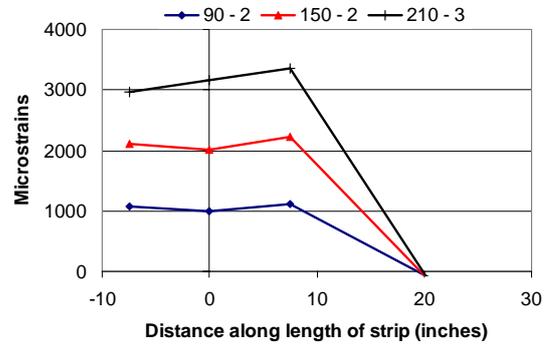
The strain profiles in the composite are presented in Figures 11(a) and 11(b) and the measured debonding strains were 3526 μs and 3354 μs , for the prefabricated strips and the fabric laminates respectively, which compared well with the predicted debonding strains. The debonding of the composite was followed by punching shear failure around 934 kN, as predicted. In slab 1 at failure there was large opening of cracks around the punching shear perimeter and some of the prefabricated strips had interlaminar failure. For Slab 2, failure was more gradual and the larger punching shear perimeter indicated load distribution over a wider area. Also at end of phase 3 loading, the composite stirrups in the girder had strains below debonding strains indicating effectiveness of the composite in shear strength enhancement. No new cracks appeared in the deck slabs over the load cycles of phase 3. Both the composite systems were effective in restraining the opening of the existing cracks and thus prevented the occurrence of

Fig. 11(a): Strain along transverse composite below load in Slab 1

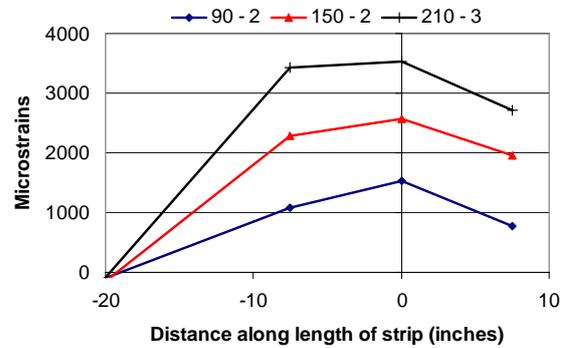
Fig. 11(b): Strain along transverse composite below load in Slab 2

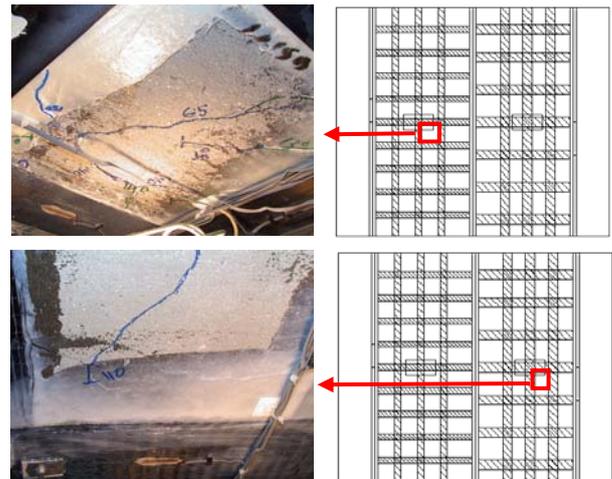
punching shear failure. Typical visual inspections of the deck slabs are presented in Figure 12.

Fig. 12: Damage in slabs at edges

The cracks were visible only in the unstrengthened area of the slabs and no visual damage was evident in the composite at the areas where they intersected the cracks. Continuous popping sounds were heard throughout the load

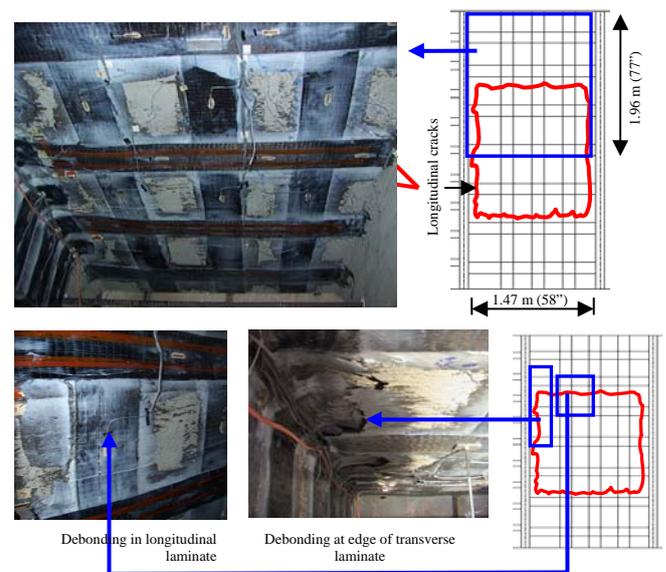
The debonding of the composite strips/laminates in the two slabs occurred simultaneously at 933 kN. Since the debonding of the composite resulted in loss of the strength enhancement of the slabs produced by the composite, the slabs could not resist the high wheel load demands. Since the ultimate punching shear capacity of the unstrengthened deck slabs was predicted to be 534 kN, as soon as debonding of the composite occurred at a load of 935 kN, which was 1.75 times higher than the unstrengthened punching shear capacity, the debonding was followed by simultaneous punch through of the load pad, representing the wheel load, through the concrete. All the composite areas at the intersection with the punching shear cracks were debonded at failure load. This included the areas in the longitudinal strips/laminates intersected by the cracks propagating in the transverse directions. The cracks propagating in the longitudinal direction intersected the transverse strips/laminates at the edges and caused debonding of the composite at these locations. Representative regions of failure in the two strengthened slabs are presented in Figures 13 and 14. However the mode of debonding was different in the two composite systems. The larger width of the fabric laminates resulted in gradual and smaller opening of the punching shear cracks. There were very few severely debonded areas and most of the debonding was localized at intersections with the punching shear cracks.

Fig. 13: Damage in slab 2

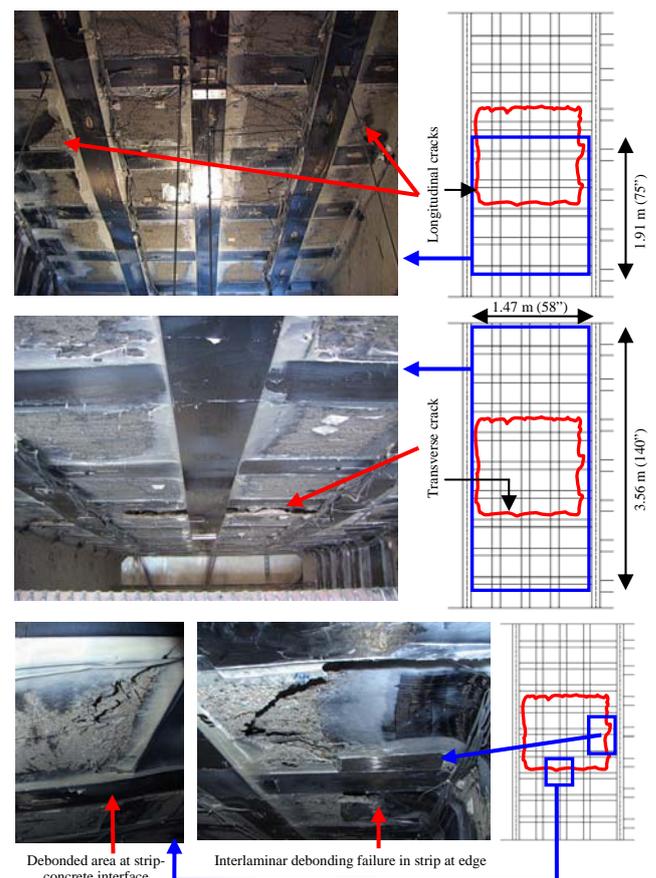
In contrast, for the prefabricated strips, large areas of the strip in the vicinity of the punching shear cracks were debonded.

Fig. 14: Damage in slab 1

Also at many locations of the debonded composite, the failure was interlaminar inside the composite strip itself rather than at the composite-concrete interface. This indicated that the

interlaminar bond strength of the prefabricated strip was lower than the bond strength between the composite and the concrete. This resulted in a more abrupt mode of debonding with large opening of the punching shear cracks as compared to the fabric laminates.

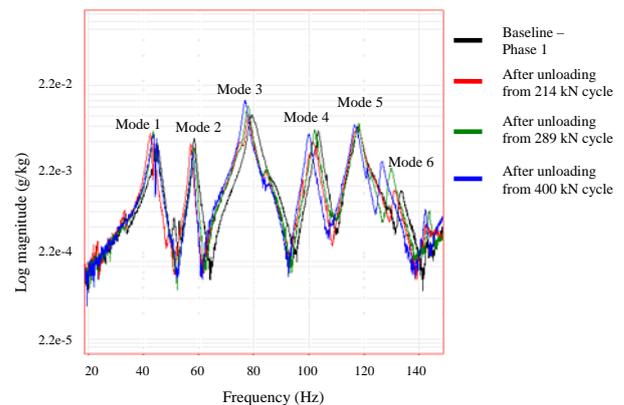
Fig. 15(a): FRF magnitude plots for Phase 1 of testing

intermediate load levels. The objectives of the vibration tests were: i) To use system ID technique to calibrate initial finite element model based on dynamic characteristics like natural frequencies (and mode shapes); ii) To use system ID and model updating to calibrate subsequent finite element models corresponding to various damage states and identify the impact of damage or strengthening on the structure; iii) To detect appearance and progression of damage as well as determine damage severity using damage detection algorithms based on frequencies and/or mode shapes. The FRF magnitude plots obtained over the three phases of loading are shown in Figures 15 (a)-(c). The frequency ratio, defined as the ratio of the frequency obtained at a particular load stage to the baseline frequency of the structure obtained prior to loading, was used to provide an estimate of the change in the natural frequency of the structure as compared to the baseline frequency of the virgin structure, caused by damage/strengthening over the load stages, and is presented in Figure 16.

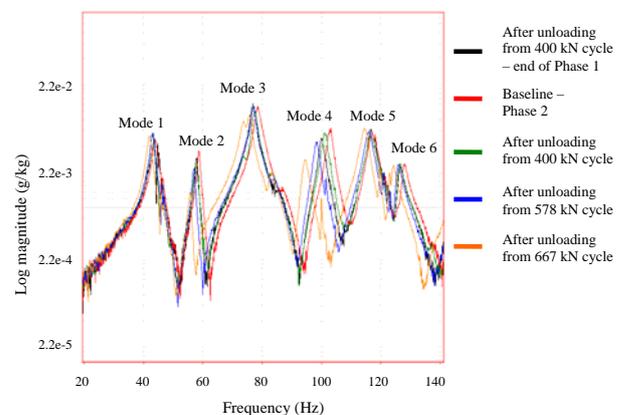
Fig. 15(b): FRF magnitude plots for Phase 2 of testing

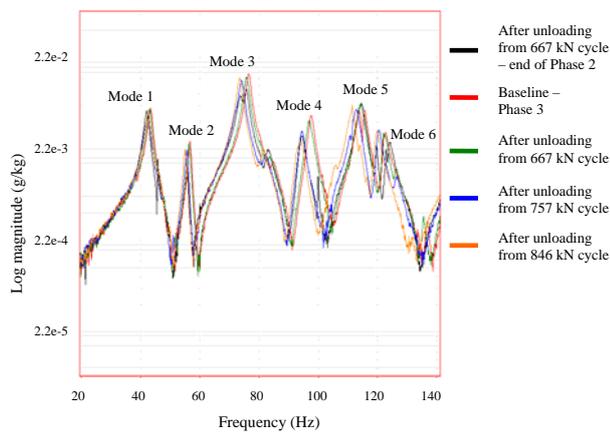
Fig. 15(c): FRF magnitude plots for Phase 3 of testing

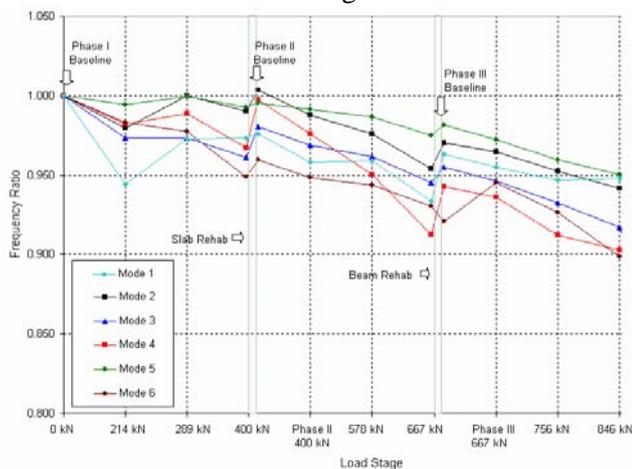
Fig. 16: Trend of frequency ratio over the load stage

A general trend of decrease of the natural frequency was observed over all the load stages indicative of damage progression in the test specimen since the frequency is directly related to the stiffness of the structure. Also an increase of the natural frequency was observed corresponding to results from baseline 2 and baseline 3, obtained after strengthening of the deck slabs and the center girder, respectively. However the stiffness degradations/enhancements in specific components of the structure due to damage/strengthening leading to such frequency changes could only be identified through model updating.
