IMPACT RESISTANCE OF CARBON/EPOXY L-SECTIONS REINFORCED THROUGH-THE-THICKNESS BY TUFTING

Steve D. Green and Giuseppe Dell'Anno
The National Composites Centre, BS16 7FS Bristol, United Kingdom
steve.green@nccuk.com giuseppe.dellanno@nccuk.com
www.nccuk.com

Keywords: Textile Composite, Through-Thickness Reinforcement, Tufting, Stitching, Preforming

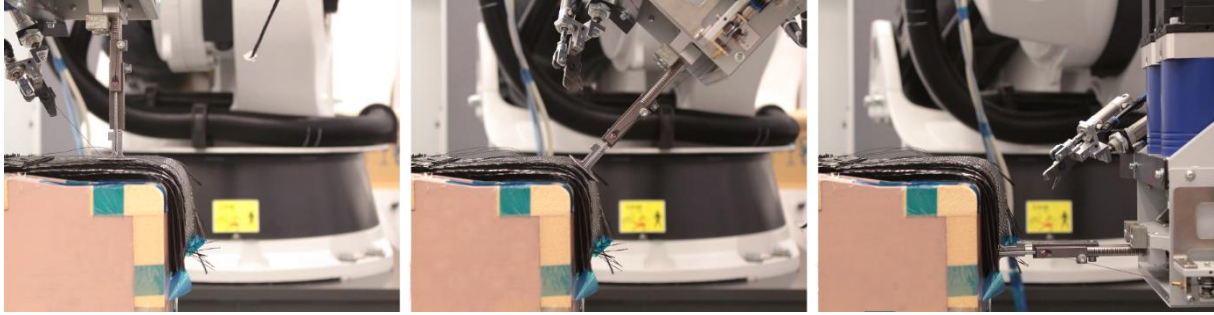
Figure 2: Control of tufting head around L-section radius, with needle penetrating the top flat section of the L profile (left), the corner apex (centre), and the bottom flat section (right). The base of the articulated KUKA robot is visible in the background.

The preforms were tufted at the NCC using a KSL RS522 tufting tool interfaced to a KUKA KR240-180L robot. The robot was programmed to insert the highly twisted, double yarn thread supplied by Schappe, perpendicular to the mean plane of the L-sections (see Figure 2). The 4k carbon fibre tufts were arranged in a square array with 4mm spacing, resulting in a tuft areal density of 0.96%. The preform was supported on a tufting tool featuring sacrificial foam inserts covered in layer of release film to allow insertion of needle and thread through the full preform thickness.

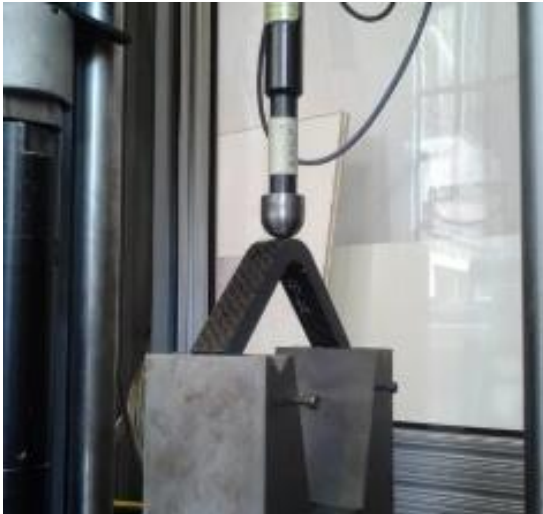
Figure 6: Specimen loaded in impacting rig.

Impact tests were conducted in an Instron Dynatup 9250 HV instrumented impact tower, with specimens secured in a bespoke fixture supporting both of their ends, as shown in Figure 6. A 10 mm radius steel hemispherical impactor impacted the apex of the external radius with an energy of 16J. Each impact event was monitored to verify consistency. The load measured by the load-cell at the back of the impactor was recorded; some representative load traces are shown in the plots of Figure 7. Post-processing of the load data allowed estimation of the total impact energy absorbed by the specimen; a scatter among specimens of less than 1.5% was observed.

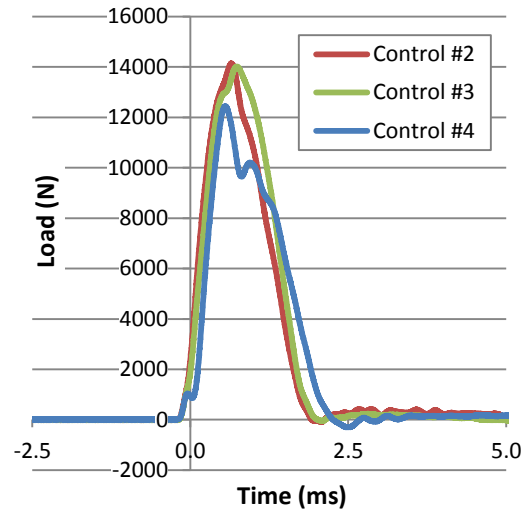
Figure 7: Load vs time plots for impacting of control specimens.

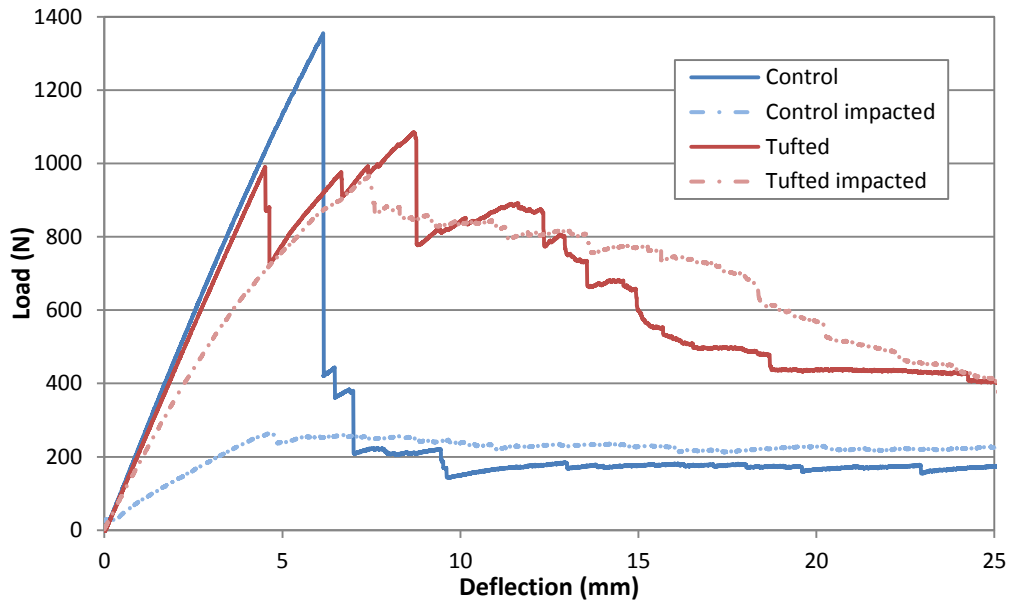
Figure 10: Representative load-deflection curves for as-manufactured and impacted specimens.

Representative load curves from the L-cantilever testing are shown in Figure 10. Considering first the behaviour of the as-manufactured specimens, both the control and tufted specimens displayed an approximately linear load response up until the first point of failure. Slight non-linearity is to be expected due to geometric non-linearity of the structure as it opens up under loading and does not necessarily indicate non-linear material response. However, the stiffness of the tufted specimens was 5% lower than the control as the introduction of tufts reduces in-plane properties, mainly due to the development of in-plane waviness in the base laminate. This value should be considered indicative only since it is not significantly greater than the standard deviation of each sample set.

Damage initiation in the specimens was not modified by the addition of tufts, in fact, the control specimens sustained a higher initiation load. The onset of failure in the control specimens showed an immediate sharp load drop to a low level of base load (85% reduction in peak load) as a result of unstable propagation of the delamination cracks. However, while the initial peak was lower than the control, the tufted specimens showed continued load carrying capability approximating a plateau region followed by a gradual drop in load. This indicates stable delamination and crack growth in these specimens, absorbing a significant level of energy and producing a pseudo-plastic response.

The damage resulting from the impact to the control specimens translated into significantly reduced stiffness, and peak load reduction of 81%. The results for the impacted tufted specimens were strikingly different, with a small reduction in initial stiffness compared to the as-manufactured specimens, followed by a non-linear softening response in the initial region of the load curve. The peak load of the impacted tufted specimens were within just 6% of the as-manufactured specimens and again produced a graceful pseudo-plastic failure.

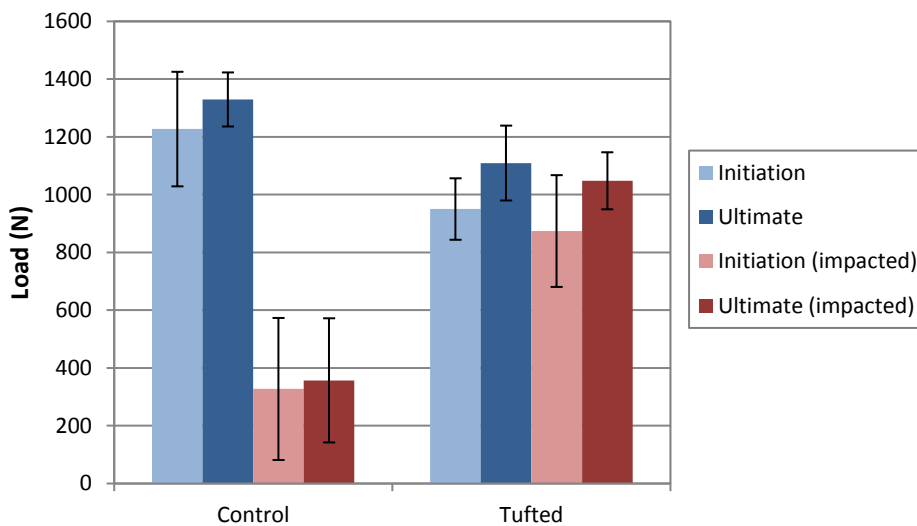
Figure 11: Chart summarising load values sustained for each reinforcement type (error bars represent one standard deviation).

Load values from each dataset are summarised in Figure 11. Note that the initiation loads shown here do not account for the non-linearity shown in the impacted tufted specimens as no clearly identifiable load drop was apparent until close to the ultimate load. It is not completely clear whether this non-linearity is because the impact damaged structure exhibits geometrical non-linearity under loading as cracks open up (but do not propagate) or because further damage is progressively accumulating. Further analysis of partially loaded specimens would be necessary to clarify this.

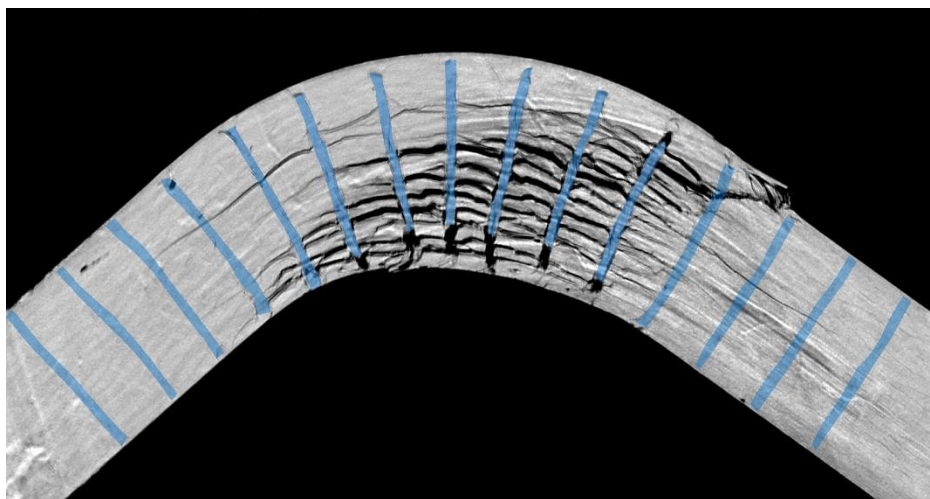
Figure 13: CT scan image of failed 2D tufted specimen (non-impacted), highlighting tufts in blue.

Microscopy images of the (non-impacted) L-section specimens after mechanical testing are shown in Figure 12. The 2D control specimen shows a high density of cracks and delaminations, some of which have spread far beyond the radius region. Conversely, the 2D tufted specimen showed delaminations which were much more localised to the radius region as well as a shift in the final failure mechanism to compressive fibre failure on the outer surface of the specimen close to the clamp. This 2D tufted specimen was subsequently CT scanned to provide a more detailed picture of the internal damage and failure mechanisms, with Figure 13 clearly illustrating the bridging action of the tufts. Many of the tufts

have fractured close to the concave surface of the section but continue to provide bridging forces and absorb energy upon further loading due to friction during pull-out. Some of the tufts have two points of fracture demonstrating that a significant tensile load can still be carried by the tuft after its initial fracture.
