# Evaluation of Recyclability through Pyrolysis of Composite Lashing bar Jae-Yang Kim<sup>1, 2</sup>, Jong-Rok Ha<sup>1, 2</sup>, Dong-Gi Seong<sup>2\*</sup>

#### Lashing bar

#### Recycling of CFRP

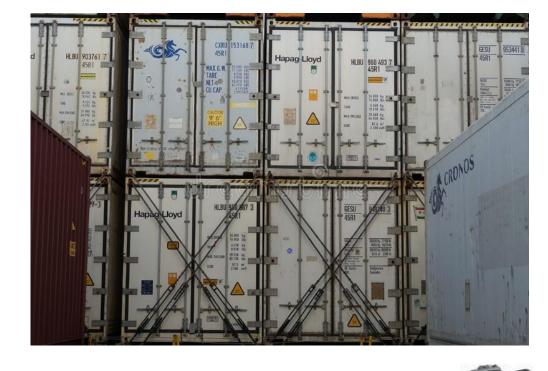
<Lashing bar>

- A lashing bar is a device used to fix containers on a container ship, and is fixed through tension applied to the lashing bar
- The lashing bar is made of metal and used, but due to its heavy weight during use, great damage occurs in the event of a safety accident
- In order to suppress accidents, we are researching the manufacturing of

Steel	Composites
Tensile Strength	100 MPa	200 MPa
Specific Gravity	7.8	2.0
Corrosion	10 Years	50 Years
Weight	20 kg	10 kg

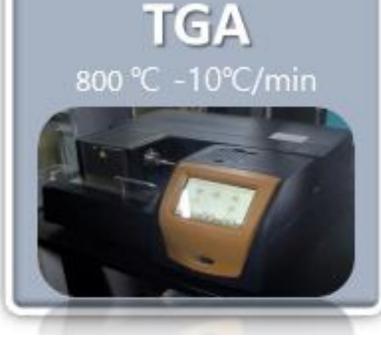
- Realization of pyrolysis using an electric furnace
- This equipment can raise the temperature to about 1100 °C
