Fatigue Damage Characterization of Non-crimp Fabric Reinforced Reactive Thermoplastic Composites at Room and Low Temperatures

[Erli Shi](#), John Montesano

Composites Research Group,
Department of Mechanical & Mechatronics Engineering,
University of Waterloo, Canada

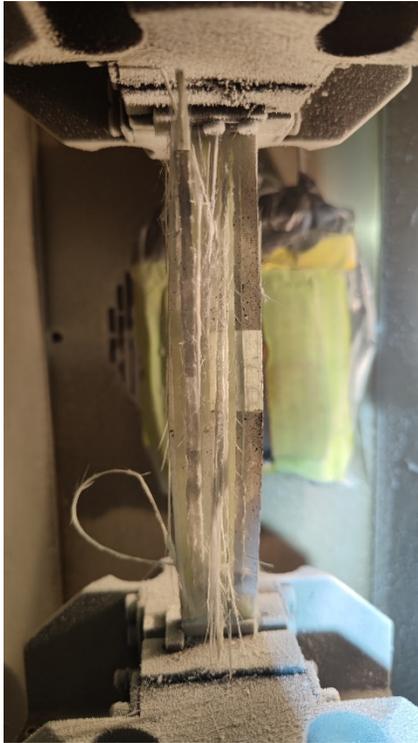
Rectangular specimen
(Failed at the end tab region)

4. For fatigue tests, the dog bone samples prevented premature failure, while the new strain measurement scheme enabled correlation of the damage evolution with stiffness degradation.
