A STUDY ON NONDESTRUCTIVE INSPECTION FOR VARTM COMPOSITE WING STRUCTURE

Sunao Sugimoto*, Yuichiro Aoki*, Yoshiyasu Hirano*, Yosuke Nagao* Japan Aerospace Exploration Agency (JAXA)

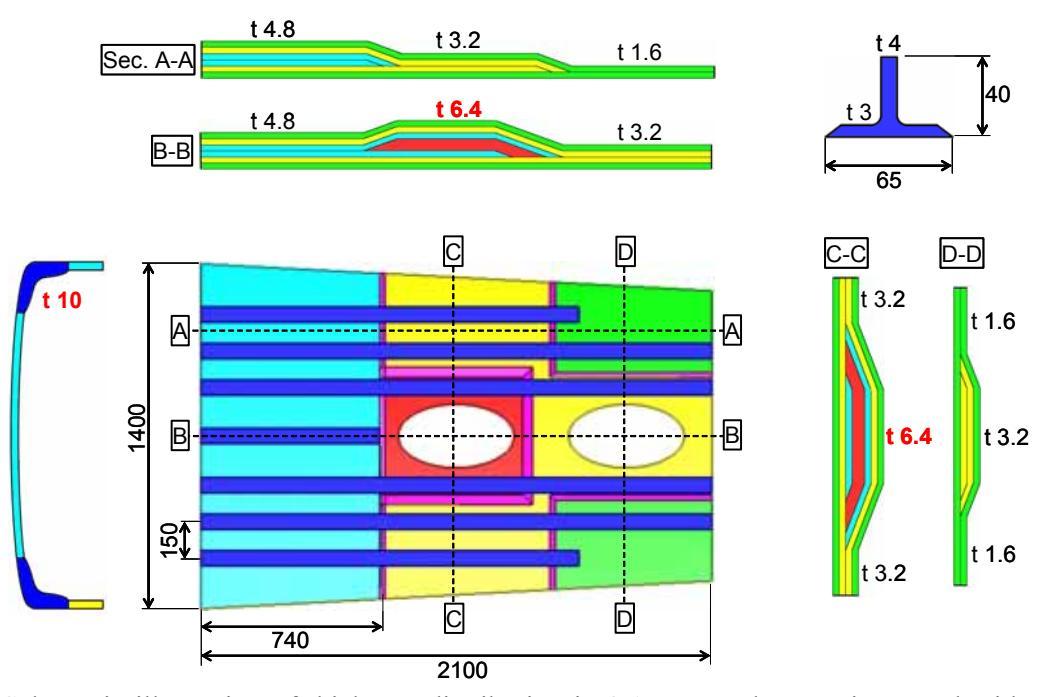
Fig. 1. Schematic illustration of thickness distribution in 2.1 m-span lower wing panel with stringers and maintenance holes.

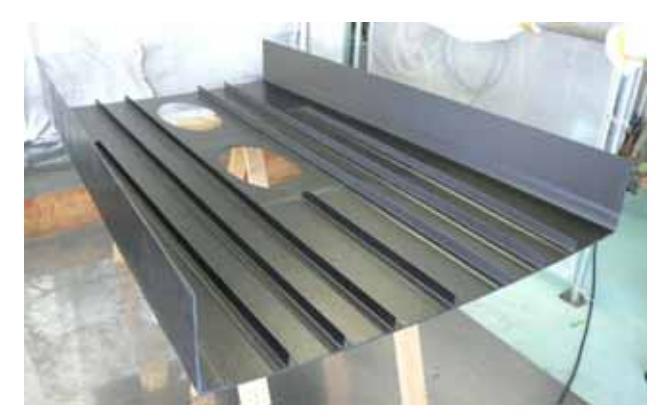
Fig. 2. Picture of an experimental production of lower wing panel integrated with spars and stringers by VaRTM process. (2.1 m X 1.4 m)

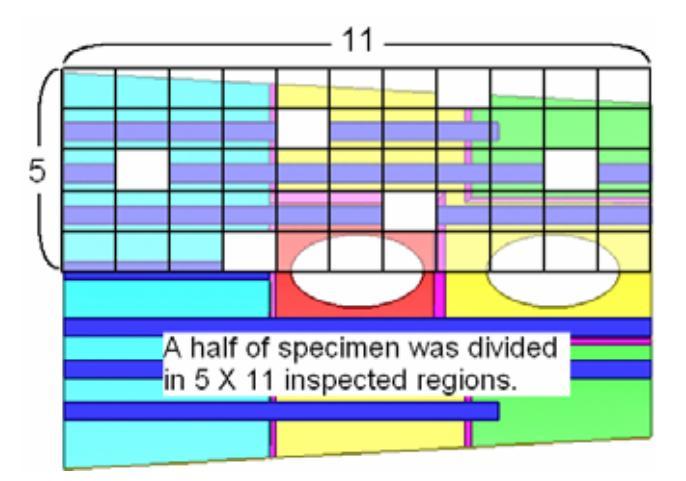
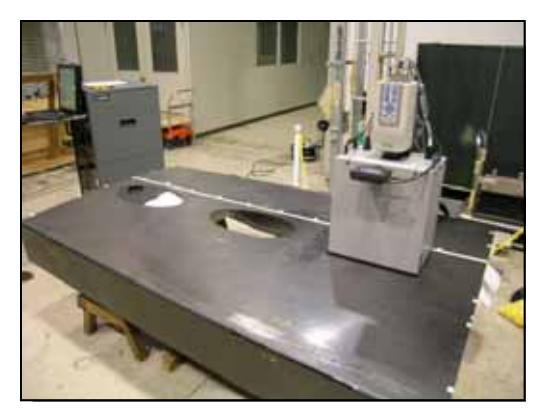
Fig. 3. Picture of inspection of 2 m VaRTM specimen by pulsed thermography.

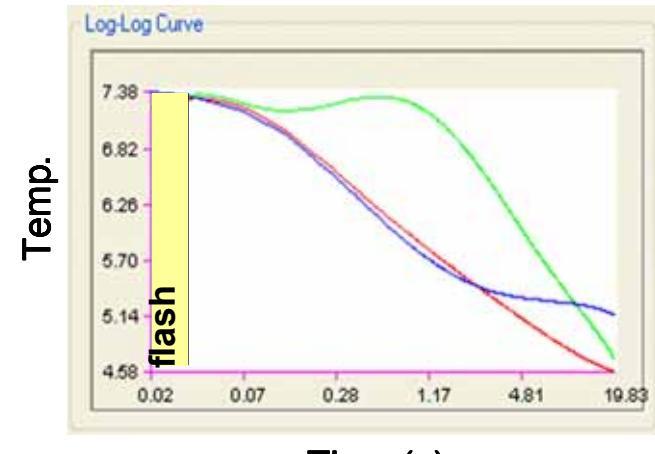
NDI result of pulsed thermography is shown in Fig. 5. This result indicates incomplete resin impregnation regions in the corner and under a stringer that were also obtained in the visual inspection. Fig. 6 shows Log-Log plot of surface temperature time history on the specimen at the marked points in Fig. 5. Evaluation of this time history of temperature change provides the incomplete resin impregnation is only several plies from surface. This NDI method is suitable for large area inspection because this method has very fast inspection feature.
