THE PRACTICAL USE OF NDE METHODS FOR THE ASSESSMENT OF DAMAGED MARINE COMPOSITE STRUCTURES

P. J. Sheppard¹, H. J. Phillips¹ & I. Cooper²

SUMMARY

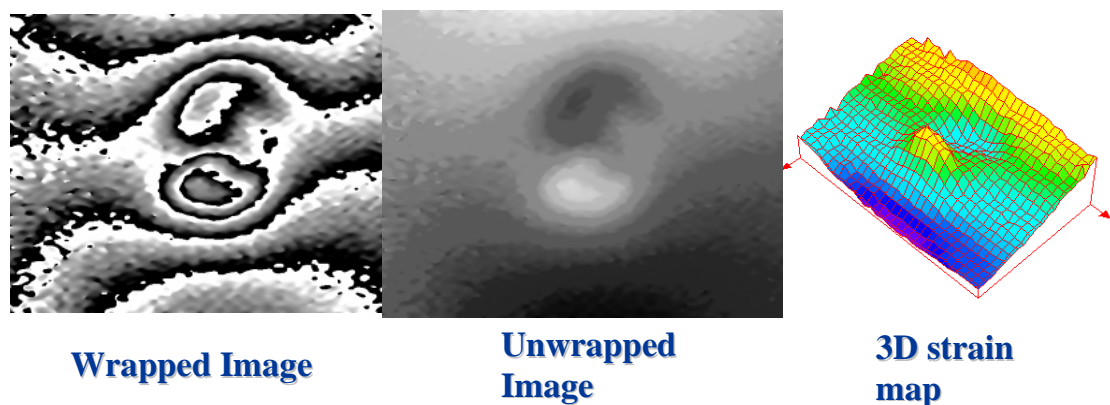
In order to improve the resolution where phase difference is close to 360 degrees, phase stepping may be used, where the laser path length is changed by fractions of a wavelength producing additional fringes. These can be processed further by the analysis software to make the fringe pattern easier to interpret through the use of ‘unwrapping’ or 3D effects as shown in Figure 2.

Figure 2 - Typical defect images produced by skin/core disbond in a honeycomb panel.
