BOLTED JOINT FRACTURE MODES IN GLASS-FIBRE REINFORCED POLYESTER

SUMMARY: The performance of bolted joints in composite materials can be optimized in many ways, including optimization of the joint geometry and optimization of the fibre orientation and stacking sequences. In this investigation, the performance of different material configurations is evaluated using the standard ASTM D5961 coupon geometry. The standard advises however the use of a quasi-isotropic lay-up for the bearing response test. Since other lamination sequences are used in this investigation, the preferred bearing failure is not guaranteed and other failure mechanisms are observed. Moreover, it is intended to show that in general purpose composite laminates, the performance of a bolted joint is a complex procedure that should be assessed by a careful examination of the whole mechanical response along with a clear description of the damage growth.

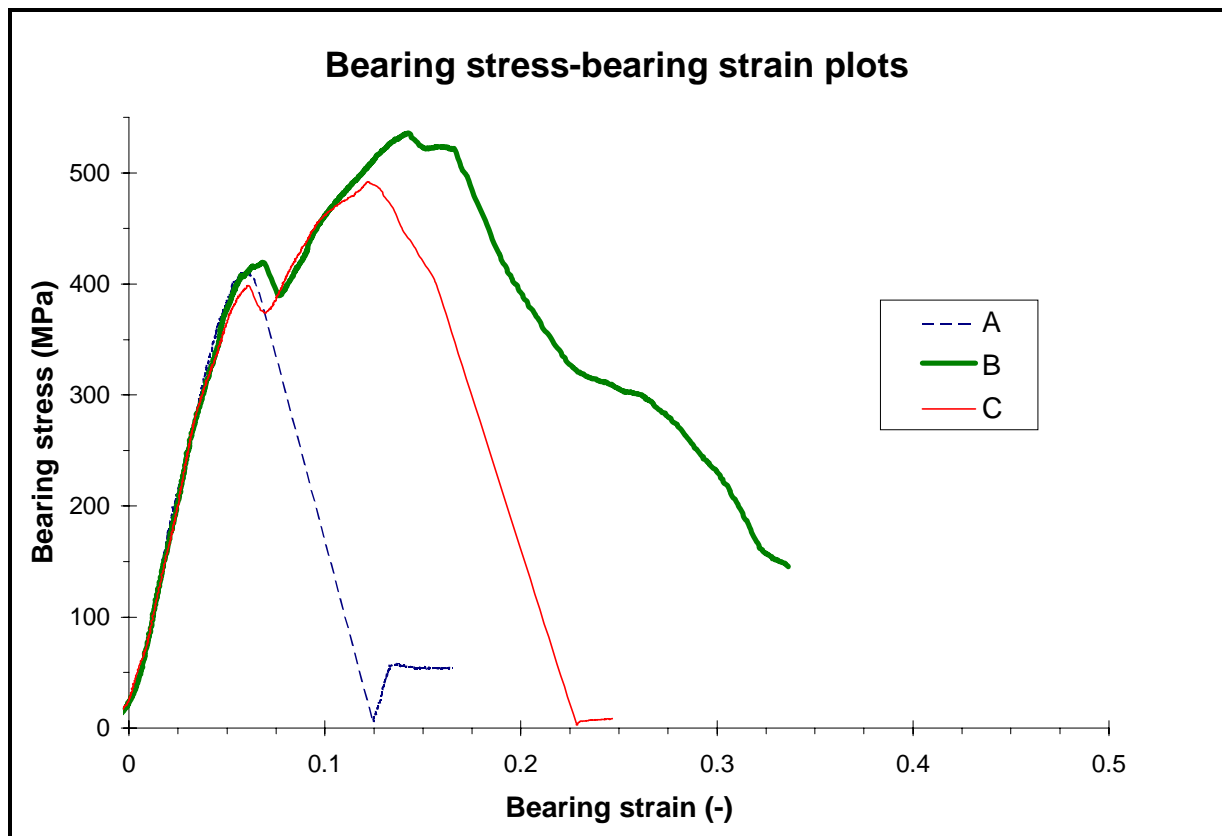
Fig. 3: Bearing stress - bearing strain curves for laminates A, B and C.

Typical σ_{br} - ϵ_{br} plots for laminates A, B and C are shown in Fig. 3. Fig. 4 shows plots for laminates D, E and F. Both are for longitudinal tests. The stress-strain behaviour of the different laminates is very similar until a bearing strain of 0.06 where a first damage mechanism occurs. This damage is confined under the washers. Since mat plies are present in all the laminates and the phenomenon is observed in all laminates, this first damage sign can probably be attributed to a damage mechanism in the mat reinforcements. Since the bearing stiffnesses of the laminates are close to one another, this corresponds to a bearing stress between 400 MPa and 480 MPa for the laminates under consideration.

Laminate B consisting of nearly equal amounts of 0° rovings, 90° rovings and mat was thought to be a good choice because the presence of 90° fibres is known to be beneficiary to the bolted joint strength. Fig. 3 shows that the laminate does not fail at the low strains of laminates A or C that do not have 90° fibres but nevertheless, the failure stays catastrophic. Inspection of the failure in Fig. 5 shows that the final failure mode is shearout and that more damage mechanisms have been involved than in the former laminates. Burn-off of the resin showed that the area close to the bolt was crushed, which indicates the beginning of bearing failure. The end distance was too short however for the bearing failure to fully develop and catastrophic failure was caused by shearout.

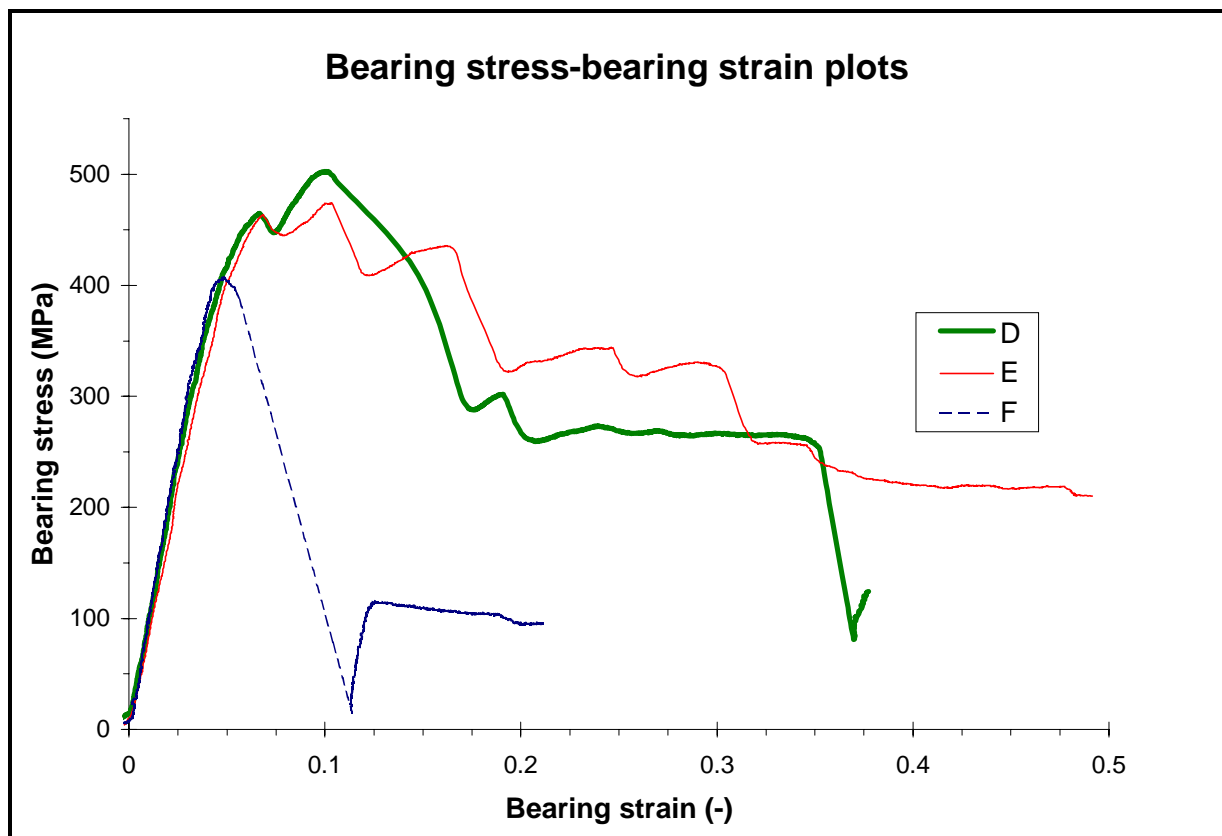
Fig. 4: Bearing stress - bearing strain curves for laminates D, E and F.
