ASSESSMENT OF LOCAL/GLOBAL STRUCTURAL HEALTH MONITORING OF COMPOSITE PIPES

Nicolae S. Constantin, Alexandrina I. Mihai, Ștefan F. Sorohan, Mircea C. Găvan,
Viorel I. Anghel, Constantin D. Dumitrașcu: naec@form.resist.pub.ro
University “Politehnica” of Bucharest, Romania

Keywords: composite pipes, Lamb wave method, IR thermography.

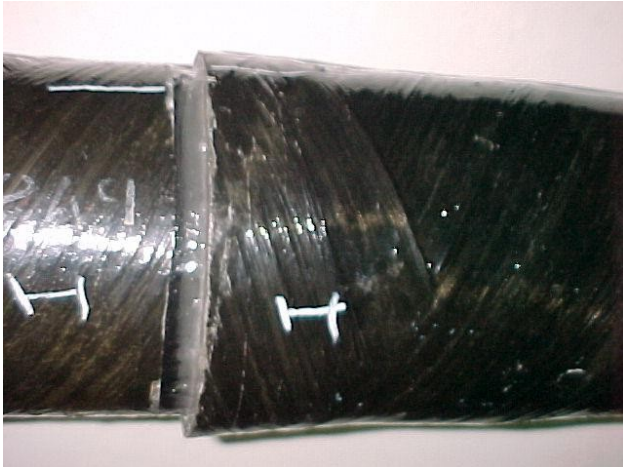
Fig. 2. Tapered type coupling

The research was performed on glass/epoxy 6” pipes, with an average 4.5 mm wall thickness. Basically, two coupling sections were considered in for these pipes: collar couplings (fig. 1) and tapered couplings (fig. 2).

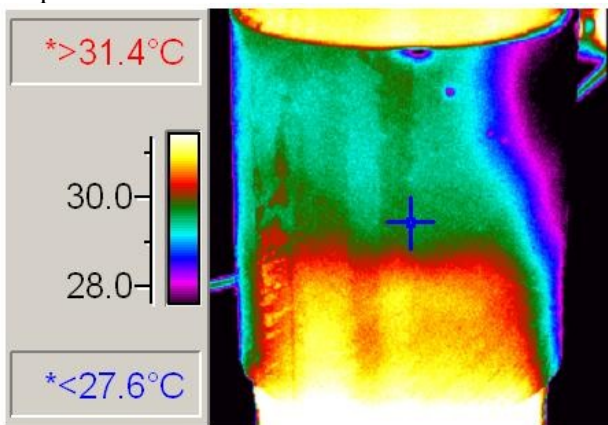
Fig. 6. IRT image of defects in a collar type coupling, passive-like variant

The passive variant was able to put in evidence imperfections/defects in the collar coupling area (Fig. 6), where the local total thickness of the wall should make quite impossible the use of the active variant. The tapered type coupling proved to be better made (fig. 7).

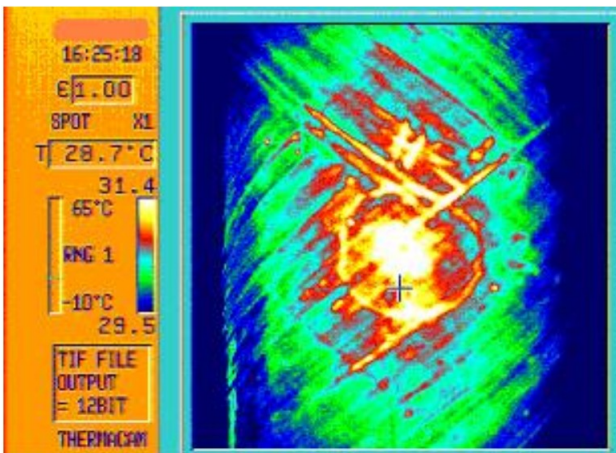
Fig. 10. IRT scan of the damaged area produced by a 20 J low velocity impact event, active variant

IRT scans using this method for the damaged areas previously inspected with the passive like method can be followed in figures 10 and 11 with careful avoidance of excessive reflections.
