IMPACT DAMAGE DETECTION ON SCARF-REPAIRED COMPOSITES USING LAMB WAVE SENSING

Ichiya Takahashi*, Yusaku Ito*, Shin-ichi Takeda**, Yutaka Iwahori**, Junji Takatsubo***, Nobuo Takeda*

*The University of Tokyo, **Japan Aerospace Exploration Agency, ***National Institute of Advanced Industrial Science and Technology

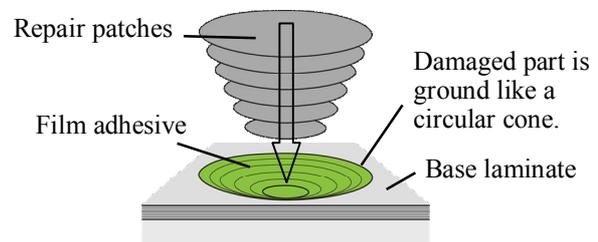
Fig. 1 Schematic of scarf repair on aircraft skin structures.

Carbon fiber reinforced plastics (CFRPs) have excellent mechanical properties such as high specific stiffness and specific strength. Therefore, they have been applied to airplane structures and have contributed to the weight reduction of such aircraft. More than 30 years have passed since composite materials were first introduced to civil aviation aircrafts. During this span of time, the weight percentage of composites to the whole weight of airplane has increased. Such drive will affect not only the design of aircrafts but also their maintenance. As the laminated composites are widely used in airframes, the number of repair cases on composite airframes will increase. Therefore, repair techniques are also required for laminated composites because the complete replacement of damaged parts with new parts is an expensive proposition. Scarf repairs as shown in Fig. 1 are one of the representatives of actual repair of composite airframes. Scarf-repaired parts will increase as

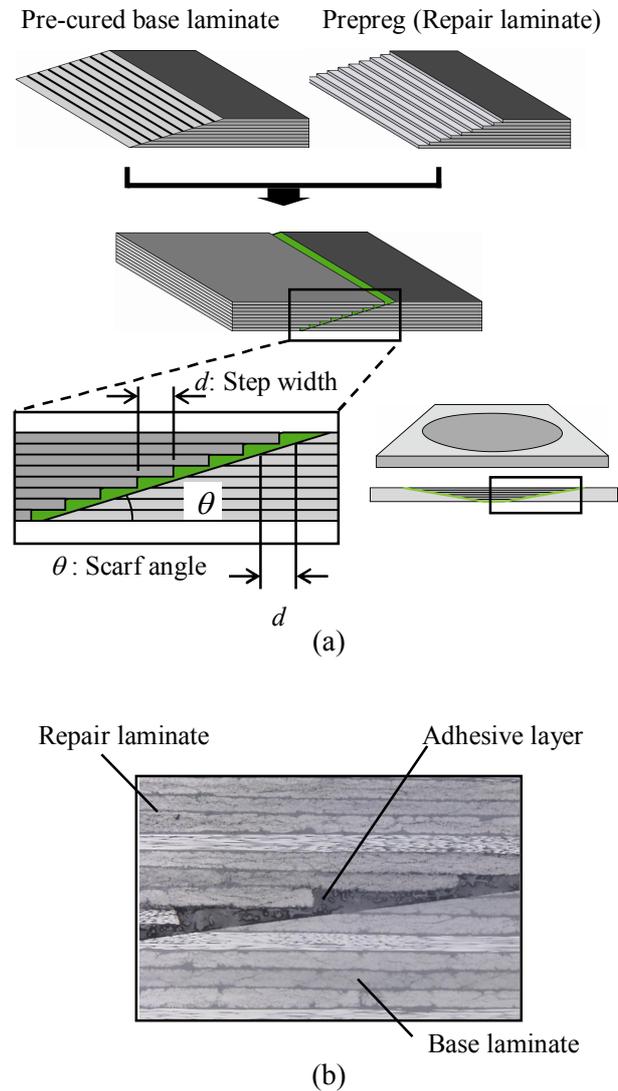
Fig. 2 (a) Schematic of the manufacturing procedure of the scarf joint specimen. (b) Cross-sectional micrograph of the specimen cross-section.

The main material of specimens was laminated composites made of CFRP prepregs (IM600/#133, Toho Tenax Co., Ltd.). Epoxy film adhesive (FM1515-3M HT, Cytec Engineered Materials Inc.) was used for the bonding at the repair joint. The manufacturing procedure of specimen is shown in Fig. 2(a). CFRP composites were molded as the base laminates in advance. These laminates were ground at a certain taper angle in preparation for the base laminates. The taper angle is called "scarf angle". After that, prepregs were stacked as their edges shifted stepwise. These stacked laminates were called "repair laminates." Material and stacking sequence of the repair laminates are identical to those of base laminates. The film adhesive was attached on the surface of the tapered section in order to join the base laminate and the repair laminate. All the laminates were then molded using an autoclave. The curing temperature and time are 180 °C and 2 hours, respectively. Fig. 2(b) shows the cross-sectional micrograph of the specimen. The shape of step-like interface between the repair laminate and the adhesive layer is maintained after curing. The specimens used in this research can be seen as the combination of scarf joints and step-lap joints. As shown in Fig. 2(a), the cross-sectional geometry of the specimen corresponds to that of a half part of the actual scarf-repaired part. The stacking sequence of the specimens is $[+45/0/-45/90]_{2S}$. Scarf-angle was set to 2°.

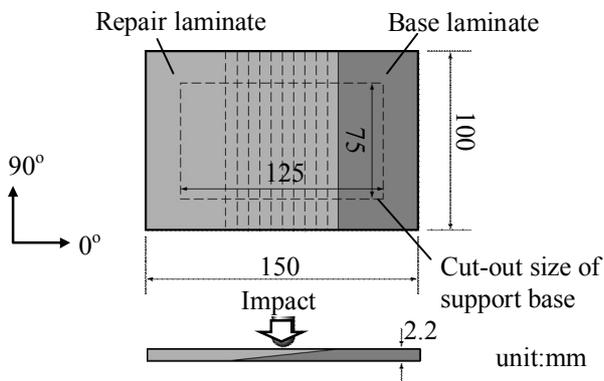
Fig. 3 Geometry and dimensions of the scarf-repaired specimen.

properties of oriented fiber resin composites. Fig. 3 shows the geometry and dimensions of the specimen used in the impact test. The dimensions of the specimens were set to 150 mm long and 100 mm wide according to the SRM 2R-94. Specimens were cut so that the center of adhesive part corresponds with that of specimen. An instrumented falling-weight impact machine (Dynatup 9250HV, Instron Corporation) was used for the impact tests. The diameter of the impactor is 15.8 mm. We prepared four specimens in the procedure mentioned in section 2.2. Impact load with different impact

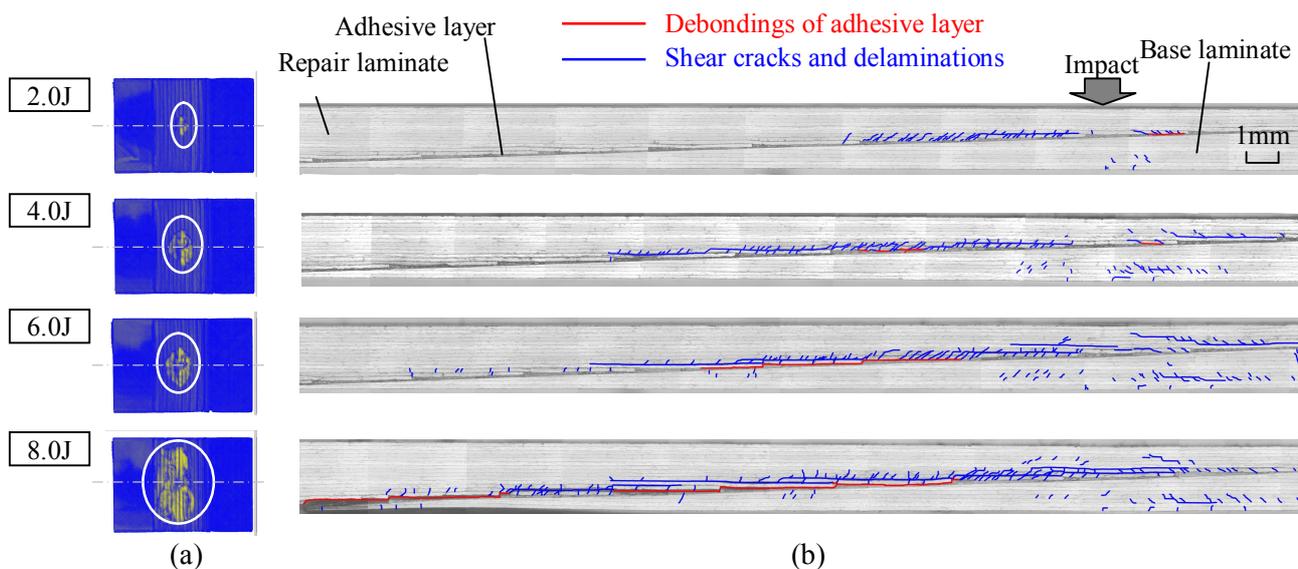
Fig. 4 Experimental results of the low-velocity impact test: (a) ultrasonic inspection results. (b) Micrographs of the central cross-section of specimens

Fig. 4(a) presents the ultrasonic inspection results. Impact damages were observed in all the results. Moreover, the damage area spread with the increase in applied impact energy. Fig. 4(b) shows the cross-sectional micrographs of the specimens. In the case of 2.0J, shear cracks and delaminations were observed near the impact point. These damages are typical impact damages in the CFRP laminates. In addition, the debonding at the interface between the adhesive layer and the repair laminate was observed on the upper side of the step-like adhesive interface. In the case of 4.0J, the debondings at the interface between the adhesive layer and the repair laminate were observed at two areas on the interface. Moreover, debonding on the lower side of the interface is found to be longer than that on the upper side. In the case of 6.0J, although the damage area in the C-Scan is about as large as that in the case of 4.0J, the debonding length became longer on the downside than that in the case of 4.0 J. In the case of 8.0J, the debonding of the adhesive layer reached the bottom surface. These results demonstrate that the debonding at the interface between the adhesive layer and the repair laminate arises from the shear cracks and delaminations near the impact point and propagates toward the bottom surface.

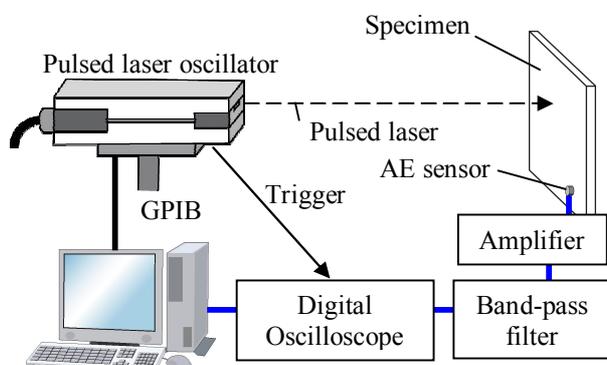
Fig. 5 Schematic of the measurement system for the visualization of the elastic-wave propagation.

We used the wave-visualization system proposed by Takatsubo et al. [10]. A schematic of the wave-visualization system is illustrated in Fig. 5. Elastic waves are generated by illuminating a pulsed laser (YAG 1064nm, pulse duration 10nsec, beam diameter 2mm, and energy 5mJ) on the surface of specimen and received by a piezoelectric transducer attached on the surface. A pulsed-laser oscillator on a mechanical stage scans a given area on the surface. Waveforms at grid points in the scanned area are stored in a PC through an amplifier, a band-pass filter (BPF) and a digital oscilloscope. In this technique, it is not necessary to adjust the incident angle of the laser or focusing because pulsed-laser is used for the elastic-wave excitation. This technique is based on the assumption of "wave reversibility", which is mentioned in section 4. From this assumption, the time-history contour maps on the

wave amplitude at all grid points provide an image of elastic wave propagation in which as if they were oscillated at the fixed receiving point. When damages exist in the scanned area, scattering or reflection of elastic waves occur at the damage boundary, by which the damage can be detected.

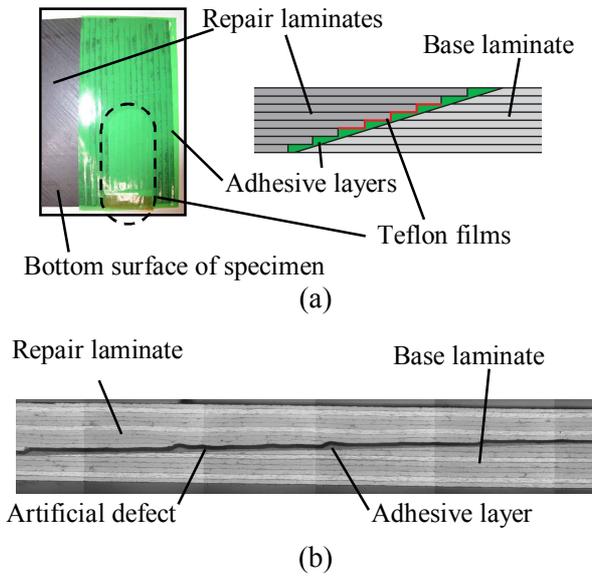
Fig. 6 (a) Manufacturing procedure of the specimen with artificial defect. (b) Micrograph of the cross-section of specimen.

Materials and basic manufacturing procedure are the same as those mentioned in section 2.1. The stacking sequence of specimen is $[+45/0/-45/90]_{2S}$. Scarf-angle was set to 2° . Before attaching a film adhesive, we inserted a silicon rubber film (50 μm thick) between the repair laminate and the film adhesive as shown in Fig. 6 and pulled it out after curing. Fig. 6 (b) shows the cross-sectional micrograph of the specimen. Debonding was formed along the step-like interface between the repair laminate and adhesive layer. We manufactured two kinds of specimens with different-sized defects. Geometry and dimensions of the specimens and their defects are illustrated in Fig. 7 (a). Fig. 7 (b) shows the ultrasonic inspection of the specimens. Larger defect reached the bottom surface of the specimen. Adhesive part of the specimen was scanned with pulsed-laser oscillator. Scanning pitch was set to 0.5 mm x 0.5 mm.

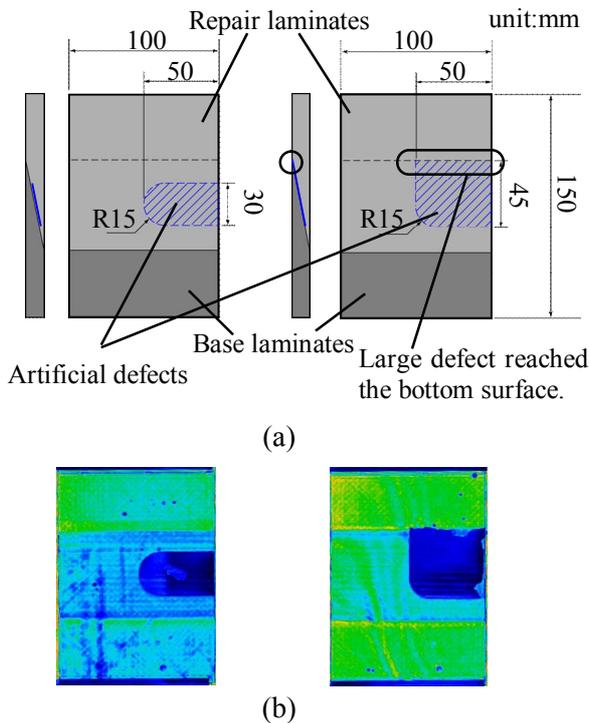
Fig. 7 (a) Geometry and dimensions of the specimens and artificial defects. (b) Ultrasonic inspection results of the specimen.

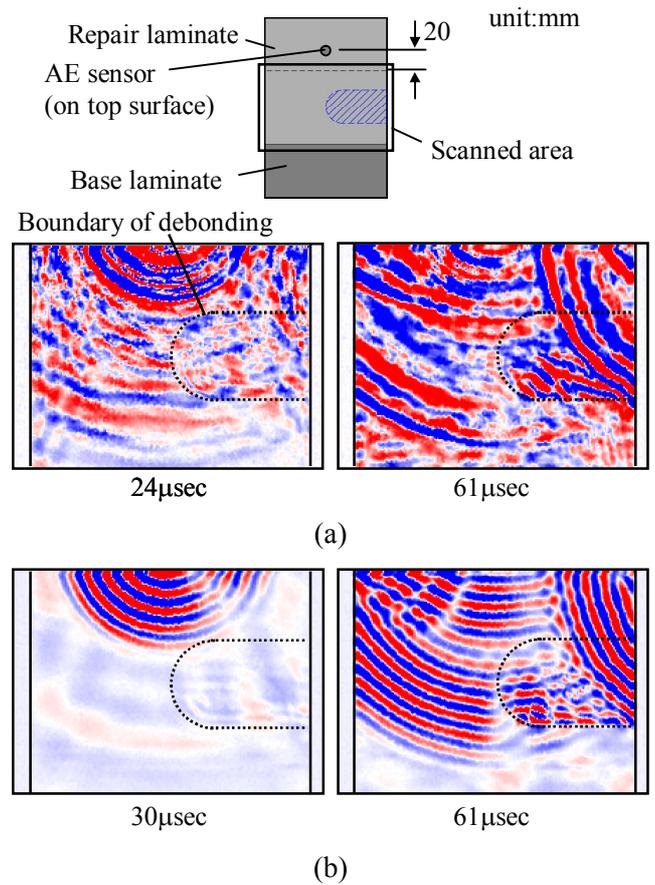
Fig. 8 Visualized results of elastic waves propagating in the scarf-repaired specimen. (a) without filtering. (b) through a 200kHz BPF.

Fig. 8 (a) and (b) show the visualized results without filtering and that through a 200kHz BPF, respectively. Specimen used in this experiment is that with small defect. A transducer is attached on the top surface of the specimen as shown in Fig. 8. The value of t in each figure shows the time from when pulsed lasers were illuminated. As mentioned in section 3.1, elastic waves were visualized as if the waves had been generated at the received point. Moreover, the reflection and scattering of elastic waves were observed at the boundary of artificial debondings in both results. A variety of elastic waves with different velocities were observed in Fig. 8 (a). This is because the input wave generated by a

pulsed laser has a wide range of frequency components and the generated waves have dispersed when propagating in the specimen. In contrast, the result measured after filtering shows two kinds of

waves with different velocities. The reflection and scattering of the faster wave was observed at 30 μsec. The slower wave, which has a larger amplitude than the faster one, reflected at the one-half of boundary more distant from the received point (lower side in the figure) at 61 μsec. Comparison of both results show that the shape of debonding was more difficult to detect in the result without filtering than that with filtering due to the existence of various kinds of waves, leading to the conclusion that the frequency components need to be selected by filtering the received wave signals before visualization.

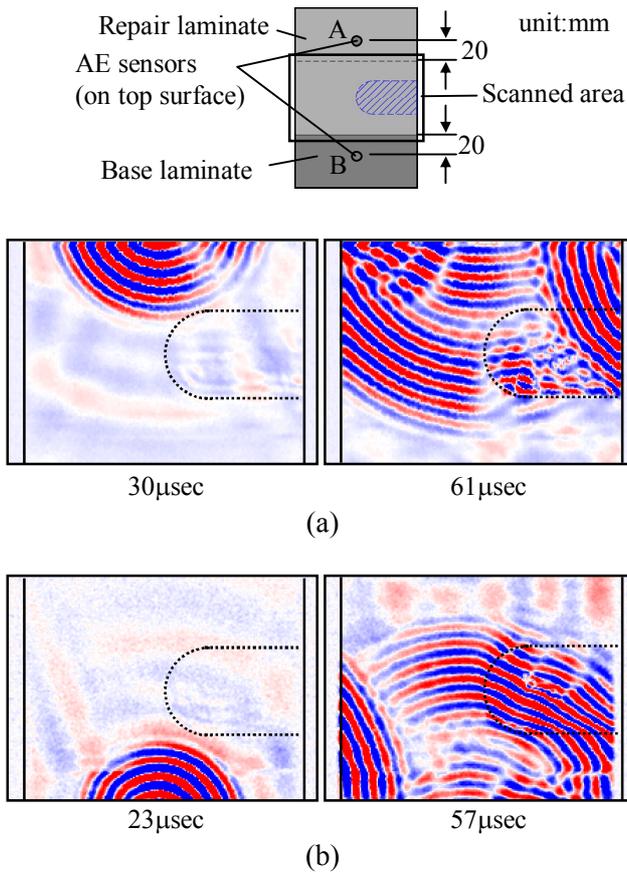
Fig. 9 Visualized results of elastic waves propagating in the scarf-repaired specimen: (a) sensor A and (b) sensor B.

Fig. 9 (a) and (b) show the visualized results measured at two sensor positions. Fig. 9 (a) is identical to Fig. 8 (b). In the result of sensor B, almost no reflection and scattering of elastic waves were observed at the boundary of debonding. Instead, the stripe pattern like a concentric circle was skewed

at the boundary of debonding. Moreover, spacing between stripes lying on the debonding area became shorter than that out of the debonding. This is because the wave velocity decreases in the debonded region with the decrease of thickness.

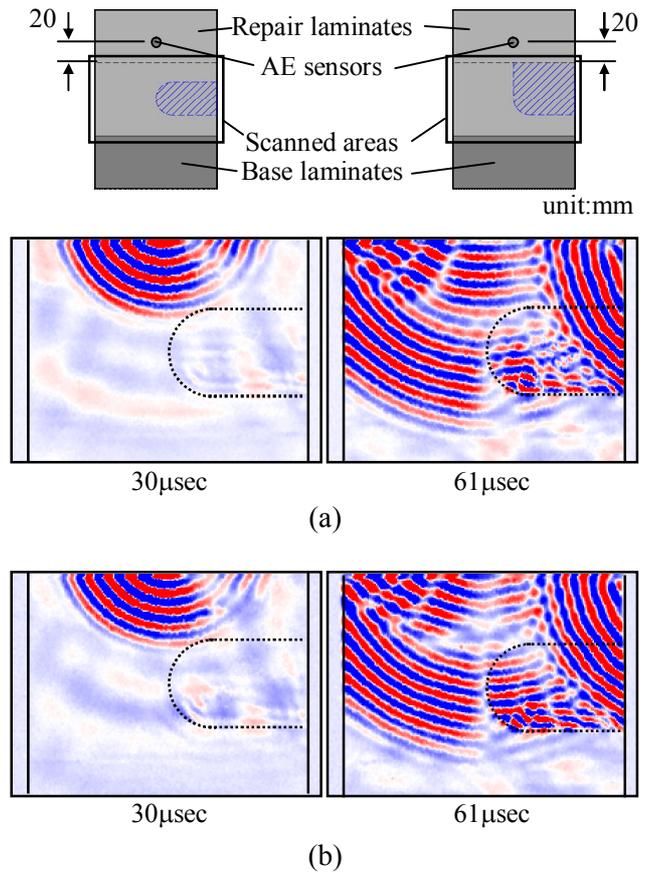
Fig. 10 Visualized results of elastic waves propagating in the scarf-repaired specimen: (a) small defect and (b) large defect.

Visualized results of the specimens with different-sized debondings are presented in Fig.10 (a) and (b). Two kinds of waves were observed in the results. They reflected and scattered at the one-half of boundary more distant from the received point, while almost no reflection and scattering were observed at the other half of boundary: there is the sensitivity difference in the debonding boundary. As a result, both visualized results are quite similar to each other, which means that it is difficult to identify the damage size in the structures on this test condition. Therefore, it is necessary to investigate the cause for the difference in sensitivity to damages.

There is a possibility that the difference in debonding depth from the top surface has an influence on the sensitivity. Debondings of adhesive layers occurs along the step-like interface, which brings the difference in the debonding depth. In our future works, the influence of debonding depth on the sensitivity is investigated.

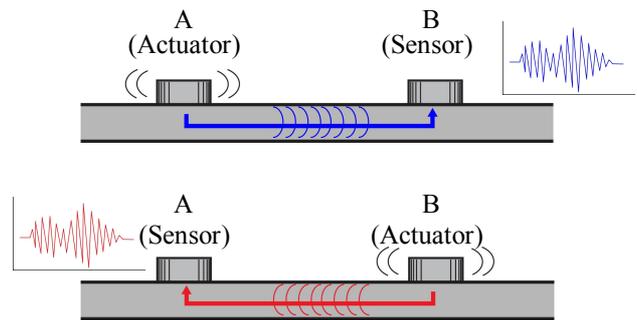
Fig. 11 Schematic of the reversibility of the ultrasonic waves.

Visualization technique used in this research is based on the assumption of the reversibility of propagating waves: the waveform propagating between two points (A to B in Fig. 11) does not change even if the actuator and the sensor are exchanged (B to A). Takatsubo et al investigated the validity of this assumption in the case of aluminum plates and CFRP cross-ply laminates [10][11]. We experimentally investigated whether the assumption is valid even when this technique is applied to the scarf-repaired composites. Specimen used in this experiment is identical to that used in section 3 (with

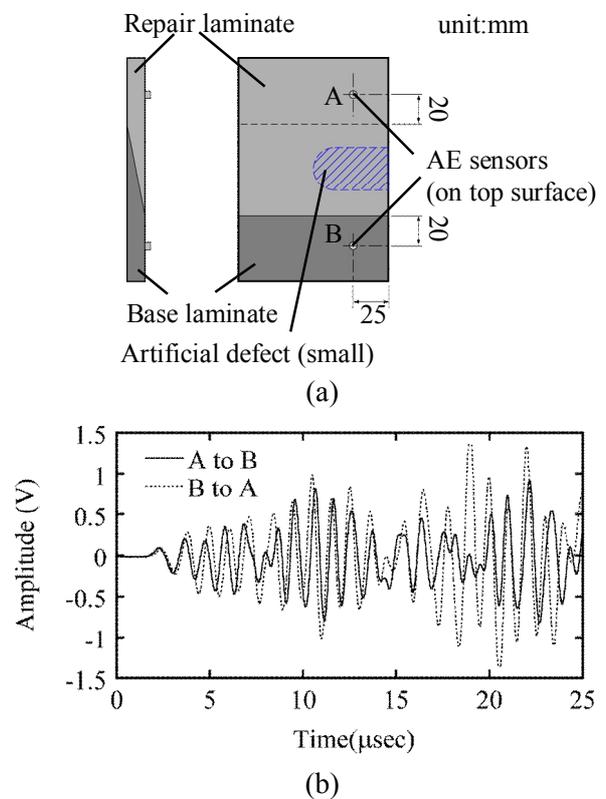
Fig. 12 (a) Position of the laser oscillation and the receiver for the verification of the wave reversibility. (b) Comparison of the waveforms between two propagation paths.

smaller debonding). The positions of laser illumination and the transducer are illustrated in Fig. 12(a). Wave signal generated at point A by a pulsed laser was received at point B by a transducer, and stored without filtering. After that, we measured wave signals in the same procedure after exchanging the positions of laser illumination and the transducer. Fig. 12 (b) shows the comparison of two waveforms measured in this experiment. Although there is the difference in the amplitude at each time, waveforms are quite similar to each other. The main causes for the difference in amplitude of waveforms are (1) the difference in the configuration of wave-generating and receiving system such as the diameter of laser beam spot and that of the transducer and (2) the difference in the attachment condition of transducer and the position of two (generating and receiving) points between two measurements. Visualized image is characterized mainly by the relative difference in amplitude: positional relationship between the wave top and bottom. The amplitude value itself has little influence on the visualized images. Consequently, this result indicates that the assumption of wave reversibility is valid in the case of the application to scarf-repaired composites.
