SELF-HEALING CFRP FOR AEROSPACE APPLICATIONS

**Dr Ian P Bond, Mr Gareth J Williams
& Dr Richard S Trask**

**Advanced Composites Centre for Innovation
and Science, University of Bristol,
Department of Aerospace Engineering,
Bristol, BS8 1TR, UK.**

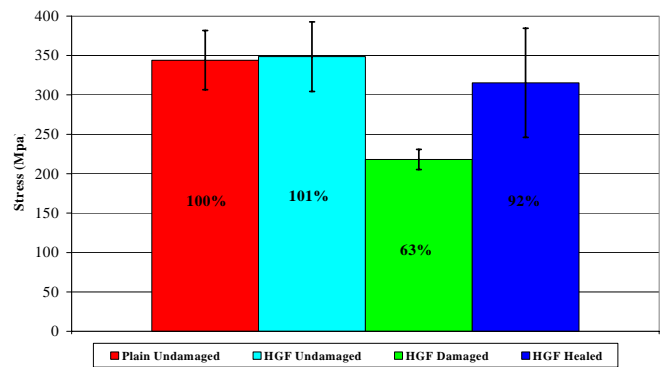
Fig. 3. Comparison of compression after impact strength for plain baseline laminate and self-healing CFRP.

The results from CAI testing are shown in Table 2 and Figure 3. Table 2 shows that under compressive loading there was no apparent reduction in failure stress due to the presence of HGF, regardless of the visible disruption to the laminates that is evident in Figure 4a. The majority of this disruption was due to the un-optimized manufacturing process and could be improved to achieve the ideal HGF distributions that can be seen in Figures 4b and 4c. This may be due to the failure mode of the undamaged samples being more sensitive to the boundary conditions of the testing rig. Any fluctuations in laminate thickness or clamping force of the supports could initiate a failure at high loads. However, that is not to say that the presence of HGF in the laminates would cause a

It can also be seen that after laminates were damaged and healed, they recovered on average 92% of their undamaged strength. Figure 3 portrays the scatter present at each stage of testing. It is evident that the undamaged samples experience a large variation in failure stress, this is due to the sensitivity of the failure on clamping boundary conditions therefore any fluctuations in laminate thickness or dimensions can reduce/increase the effectiveness of the boundary conditions thereby affecting the load at which failure occurs. The damaged samples exhibit significantly reduced fluctuations in failure stress as impact damaged laminates are very sensitive to compressive loading as delaminations are propagated causing formation of sub-laminates, instability and ultimately leading to buckling failure. Healed samples exhibit the largest fluctuations in failure strength, this is largely due to two samples which exhibited limited healing and are considered later.
