# STUDY ON REPAIR OF CFRP LAMINATES FOR AIRCRAFT STRUCTURES

Hikaru Hoshi\*, Keisuke Nakano\*\*, Yutaka Iwahori \*

\*Japan Aerospace Exploration Agency, \*\*Tokyo University of Science

## Abstract

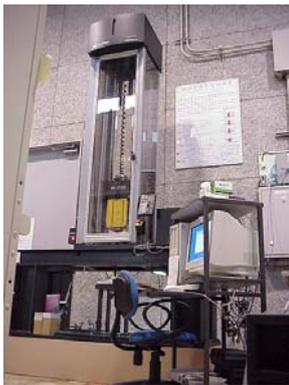
Fig.6 Photo of impact test machine

The objective of the impact test is to investigate the damage characteristics of the scarf joint under the low velocity impact loading. The impact load was applied by a drop-weight impact tester of the Instron Dynatup 9250HV to the center of the scarf joint as shown in Fig.6. The striker weight including an load-cell and an adjustable mass system is approximately 5.8 kg. The specimen support base was used as a picture frame type with a circular cut-out of 35 mm in diameter for the tensile specimen,

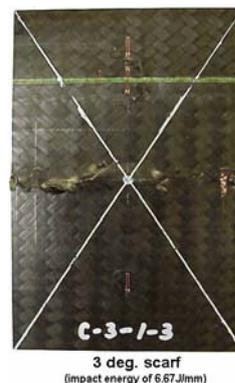
Fig.13 Typical failure mode of compressive scarf joint specimen

After impact, residual compressive strength tests were carried out with same method of compressive test. Results of residual tensile strength test are shown in Fig.12. Failure modes of the impacted scarf joint were almost typical CAI failure on center of specimen as shown in Fig.13. Other failure modes showed that were end brooming failure and cohesive failure when only impact energy at 1.67J/mm. Each residual compression strength of specimens were decreased with increase of impact energy. The residual strength of parent material and 3 degrees specimen showed almost same tendency with increase of impact energy. But, residual compressive strength of 4.5 degrees specimen was not same tendency compared with parent material and 3degrees specimen that reduced slightly at 6.67J/mm. But, residual compressive strength of 4.5 degrees specimen was not same tendency compared with parent material and 3degrees specimen when impact energy is 6.67J/mm. In case of 6degree, the residual compressive strength was reduced significantly when impact energy is more than 3.34J/mm. Therefore, it is found that residual compressive strength of scarf joint was changed by relation between scarf angle and impact energy.
