# EXPERIMENTAL EVALUATION FOR CFRP STRENGTH AFTER VARIOUS PAINT STRIPING METHODS

Yutaka Iwahori\*, Tomohiro Hasegawa\*\*, Kozue Nakane\*  
\* JAXA, \*\* NIPPI Co. Ltd.,

Paint strip technology is one of the fundamental processes for aircraft maintenance operations. This paper shows an experimental evaluation of mechanical properties of paint-stripped CFRP laminates. Tensile and compressive strength tests were conducted on CFRP laminates which had gone through paint strip by various paint strip methods, including sanding, chemical strip (methylene chloride type), plastic media blast (PMB) strip, and TEA-CO<sub>2</sub> laser coating removal method. The surface observations of the paint stripped CFRP laminates were conducted by optical microscope. The TEA-CO<sub>2</sub> laser coating removal methods were also demonstrated in sectional cut observation of the surface. In tension strength test results, obvious mechanical properties (strength and elastic modulus) changes were not obtained, except for the fact that the chemical-stripped CFRP laminates showed large coefficient variation in tensile strength. Compressive strength results also did not show much difference in their mechanical

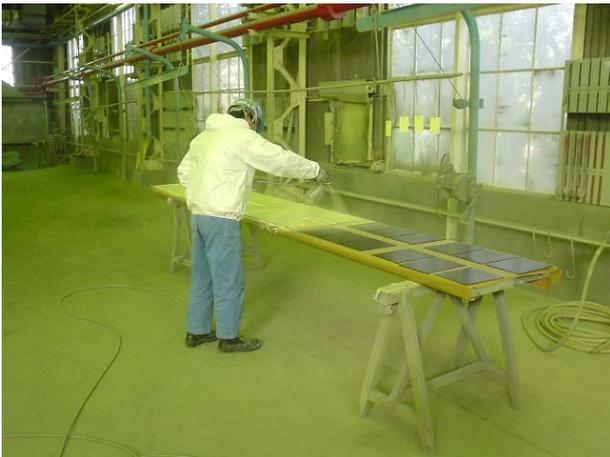
Fig. 1 Paint process

Masking and lightly sanding were applied to the CFRP laminates. An epoxy primer (Epora 3000S) was applied to the CFRP laminates surface as undercoating. After undercoating, polyurethane enamel paint (V-100) was painted on the undercoated CFRP laminates. The total thickness of painted CFRP laminates was 30-50 micrometer. Figure 1 shows an example of a painting process picture in a field.

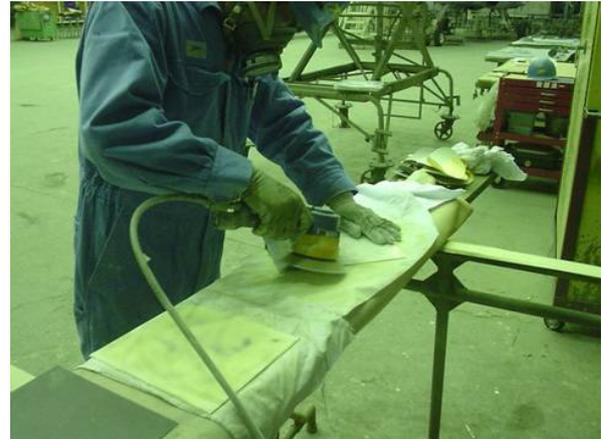
Fig. 2 Paint stripping by sanding

The sanding method is the most common paint stripping method for composite aircraft structures. The topcoat and undercoat were removed from these specimens and referred to as Sanding 1 (complete). Those with only the topcoat removed were prepared as Sanding 2. In the Sanding 2 case, the painting and stripping of the topcoat were repeated three times. Figure 2 shows a picture of the paint stripping by the sanding method.

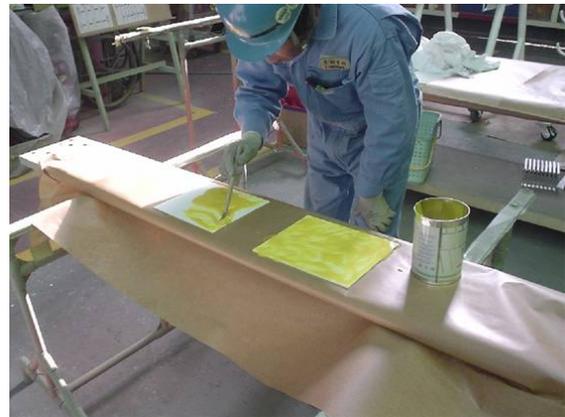
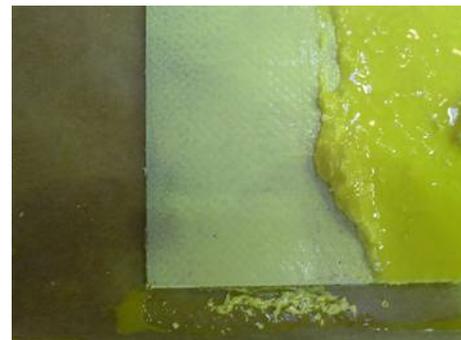
Fig. 3 Paint stripping by chemical paint remover  
(a) Paint stripping, (b) Surface of stripping CFRP laminates.

A chemical stripping method, methylene chloride type paint remover, was used for paint removal on the CFRP laminates, deliberately. Normally, the methylene chloride type of paint remover is not applied on the paint stripping of CFRP laminates and bonded structures. Using the paint remover, after 55 minutes, the topcoat and undercoat were completely removed from the CFRP laminates. Figure 3 shows a picture of a paint stripping operation by the paint remover and paint stripping surface of the CFRP laminates.

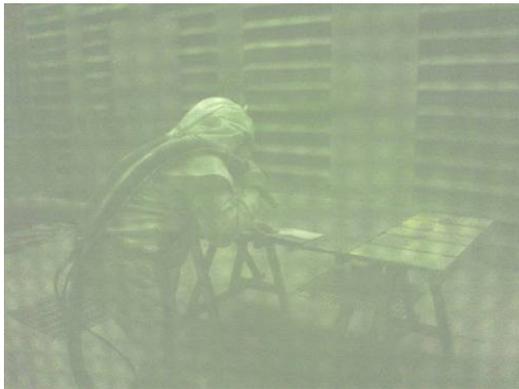
Fig. 4 Paint stripping by PMB.

The PMB method was employed to the CFRP laminates, deliberately. This method also is not used on composite aircraft structures, in general. The size of PMB was 30/40 mesh. The pressure of blasting was set to 30 psi for complete paint removal as PMB 1 and 20 psi for the topcoat only removal as PMB 2. In PMB 2, the painting and removal process were repeated 3 times in the same CFRP laminates. Figure 4 shows a picture of PMB operation in the PMB work space.

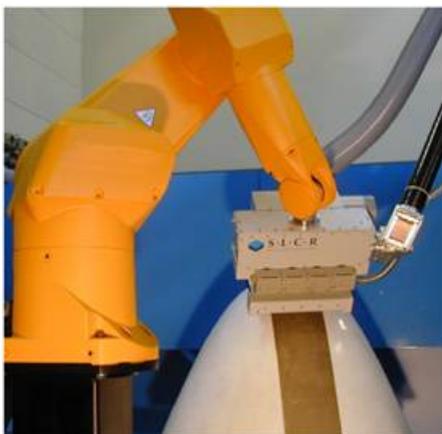
Fig. 5 Paint stripping by TEA-CO<sub>2</sub> coating removal method.

A TEA-CO<sub>2</sub> laser coating removal system was developed by SLCR in Germany. Figure 5 shows a picture of the SLCR machine which equipped a robot hand for paint stripping aircraft parts. Three levels of the laser strength were set in this study: complete, selective, and further. The complete level can remove the topcoat and undercoat on the CFRP laminates at the same time, the selective level only removes the topcoat, and the further level is a stronger level of laser beam condition than the complete level. Figure 6 shows the paint stripping on the CFRP laminate surface by laser coating removal method in which levels were complete, selective, and further.

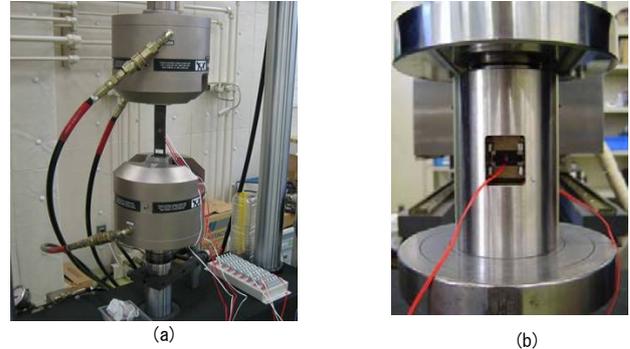
Fig. 7 Test setups. (a) Tension, (b) Compression

After various paint-stripping methods were applied, static test specimens were cut from the CFRP laminates. Eight-ply specimens were for tension, 12-ply specimens were for compression. The tension test specimen size was 250 mm (length) and 25.4 mm (width). Compression test specimen size was 80 mm (l) and 15 mm (w). Figure 7 shows pictures of tension and compression test setups.

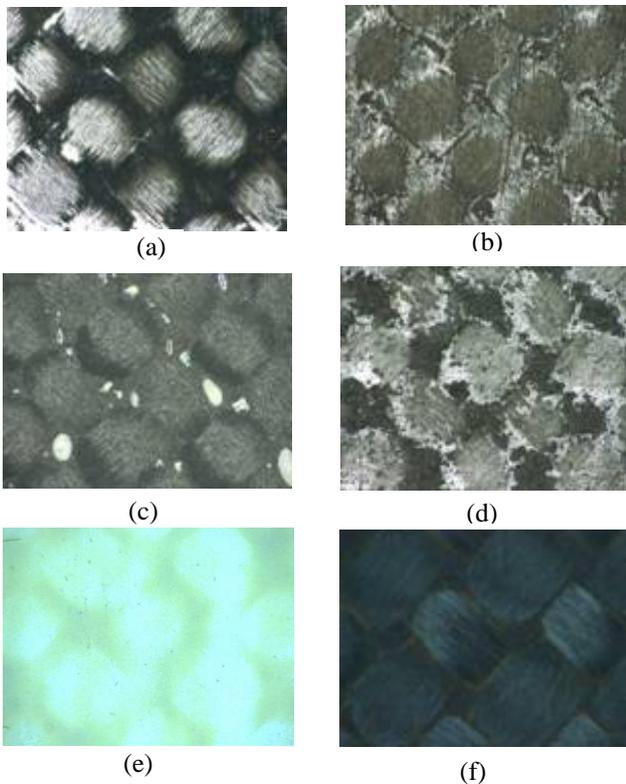
Fig. 8 Surface observation results.

Figure 8 shows the surfaces of applying several paint stripping methods for CFRP laminates, including the no paint case. An optical fiber digital microscope (Keyence VHX-200) was used for the observations. The magnification is 40. Figure 8(a) is the no-paint CFRP laminates. Figure 8(b) is the surface after paint stripping by chemical remover. The undercoat remained a little in the textures of the fabric. Figure 8(c) is the surface after paint stripping by sanding (complete). The undercoat remained a little on the surface, and it was observed that the

surface was flat in comparison to other stripping methods. Figure 8(d) is the surface after paint stripping by PMB (complete). Many pits were observed and the surface was uneven. Figure 8(e) and (f) were using TAE-CO<sub>2</sub> laser coating removal method, selective and complete. A white surface was observed in figure 8(e), because the undercoat remained by using the selective level of the laser beam. On the other hand, the undercoat did not remain by using the complete level.

From these surface observations, obvious fiber breakage and resin starvation on the CFRP surface by microscope observations was not observed.

(a) No paint, (b) Chemical remover, (c) Sanding (complete), (d) PMB (complete), (e) Laser coating removal method (Selective), (f) Laser coating removal method (complete).

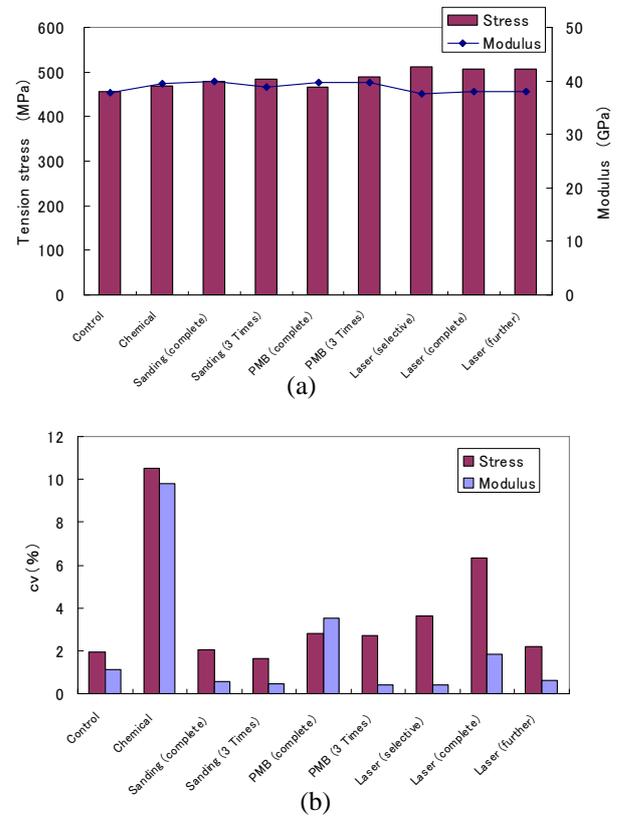
Fig. 9 Tension test results.

Tension strength tests were conducted after various paint stripping methods of CFRP laminates. Figure 9 shows the averaged static strength and modulus of tension tests. The number of the test specimens was 5. It was found that the tension strength of several paint stripping methods were not much different in strength and modulus. The only difference was that the chemical stripping CFRP laminates strength had

larger coefficient of variation (Cv) than other stripping methods.

(a) Tension strength, (b) Coefficient of variation (Cv)

The strength effect on several paint stripping methods were investigated for CFRP laminates. These paint-stripping methods include those used for metal aircraft structures. The result that tension and compression strength and modulus were almost equivalent even after paint stripping the CFRP laminates. Only one case of tension strength coefficient of variation was larger than others in the

chemical stripping method. It was suspected that the CFRP surface resin was damaged by chemical attack and there was no resin layer near the CFRP surface in this method. The sanding method also had observed damage of fiber and resin by sanding operation. It is suggested that special attention be paid by the operator to remove the undercoat without damage to the CFRP laminates. An uneven resin layer on the CFRP surface was observed on the PMB method. Some disappearance of the resin layers was also observed. Figure 12 shows a sectional observation result as a comparison of the surface after the PMB (complete) and laser coating removal method (complete and further). All of the methods give an uneven resin layer and fiber exposure after paint stripping the CFRP laminates, though there was not much effect on the static strength and modulus in this test results. However, there is not evidence of strength effects by fatigue or environmental effect. These strength effects must be considered in future works.

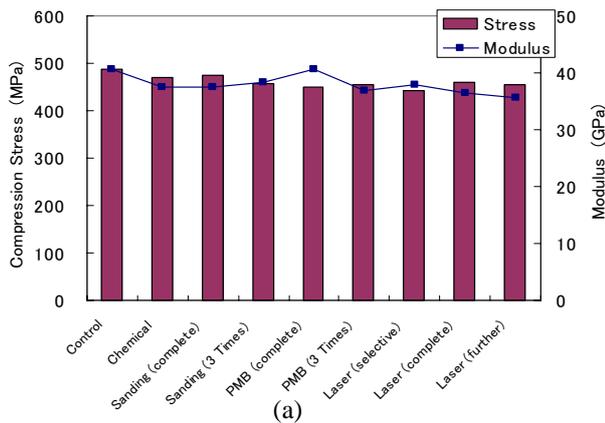
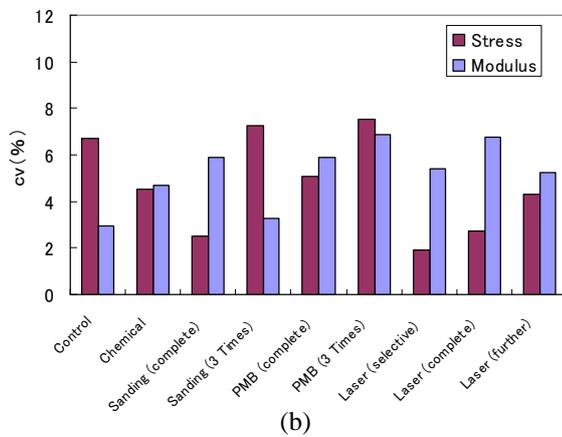
Fig. 10 Compression test results.

Compression strength tests were conducted after various paint-stripping methods on the CFRP laminates. Figure 10 shows the averaged static strength and modulus of compression tests. Small strength deteriorations were observed in the PMB (complete) and laser stripping (selective) case. However, it was not determined that those of deteriorations were caused by paint stripping effects. There were no obvious differences in compression strengths, modulus, and coefficient of variation.

(a) Compression strength, (b) Coefficient of variation (Cv)

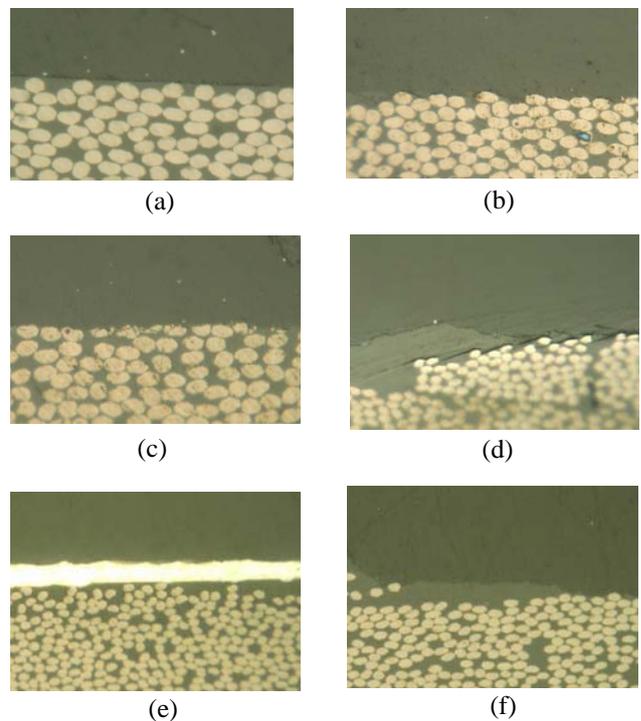
Fig. 11 Sectional cut observation results.

Sectional cut observations by microscope were conducted near the CFRP surface after paint stripping. An optical fiber digital microscope (Keyence VHX-1000) was used for the observations, and the magnification was 500 or 1000. Figure 11 shows various paint stripping methods-applied CFRP laminates surfaces: no paint (a), chemical stripping (b), sanding (complete)(c), PMB (complete)(d), and laser coating removal methods (selective (e) and complete (f)).

The no-paint CFRP surface (a) was observed that the resin layer remained on the CFRP surface and carbon fibers were ordered precisely. In the chemical remover stripping (b), there was no resin layer on the surface and carbon fibers were exposed of the CFRP laminates. In the sanding method, there was not only resin layer disappearance but also the carbon fiber was worn out (c). This means that the carbon fiber and resin are damaged by the sanding method. In the PMB method (d), there was resin layer disappearance and an uneven surface, caused by media hit, on the CFRP laminates

surface. In the laser method (selective)(e), a remaining layer of the undercoat was observed. There was a slight uneven surface on the undercoat surface. Though, it was suggested that the laser coating removal method could be carried out for precise paint removal, such as only topcoat removal, without CFRP surface damages. In the laser (complete and further) case (e and f), all of the paint was removed and carbon fibers exposure on the CFRP surface and uneven surface were observed, as with the PMB case.

(a) No paint, (b) Chemical remover, (c) Sanding (complete), (d) PMB (complete), (e) Laser coating removal method (Selective), (f) Laser coating removal method (complete).

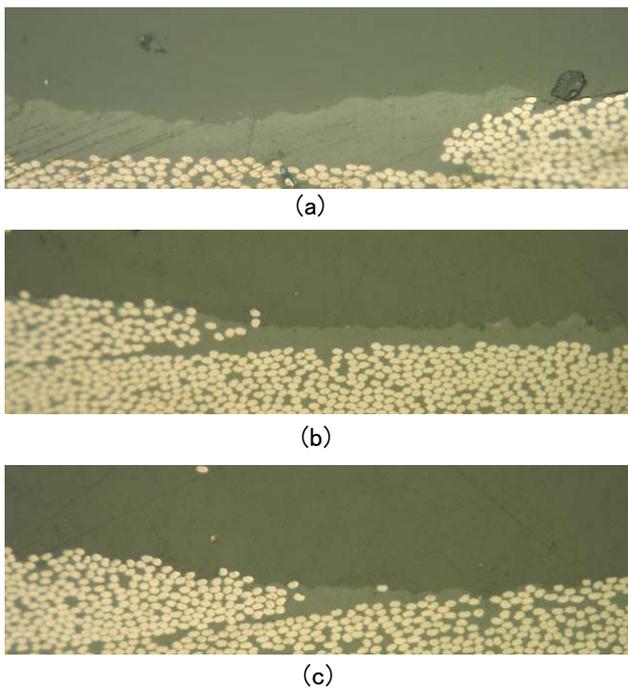
Fig. 12 The comparison of CFRP surfaces, PMB and laser coating removal method.

(a) PMB (complete), (b) Laser coating removal method (Complete), (c) Laser coating removal method (further).
