COMPRESSION FATIGUE FAILURE OF CFRP LAMINATES WITH IMPACT DAMAGE

Nobuhide Uda and Kousei Ono
Department of Aeronautics and Astronautics
Kyushu University, Fukuoka, Japan

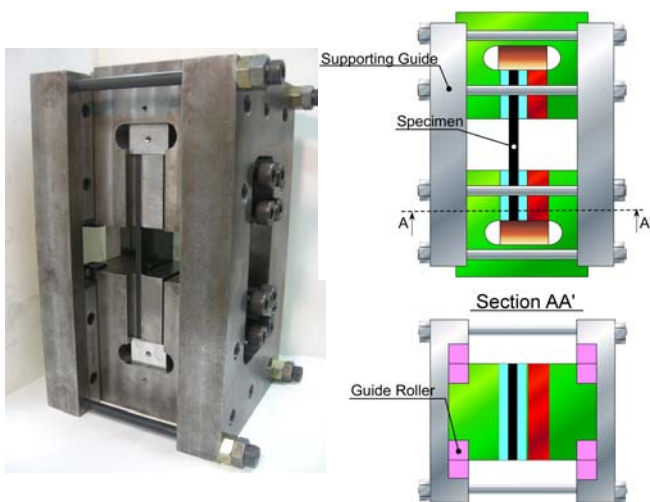
(a) Overview (b) Schematic
Fig. 1. Compression test fixture

Static compression tests and compression fatigue tests were conducted in the servo-hydraulic testing machine with an end-loading fixture as shown in Fig. 1, which was built based on Shimokawa's work [11]. The specimen was placed in the fixture without tabs and was tightly clamped with binding grips. This fixture does not have an anti-buckling device as prescribed by ASTM D 695, but prevents an out-of-plane direction moving of the specimen by a pair of supporting guides for the whole of the fixture. The compression load is applied through end-sections of the specimen with the binding grips. A gage length of 35 mm for the compression specimen was chosen to prevent global buckling.

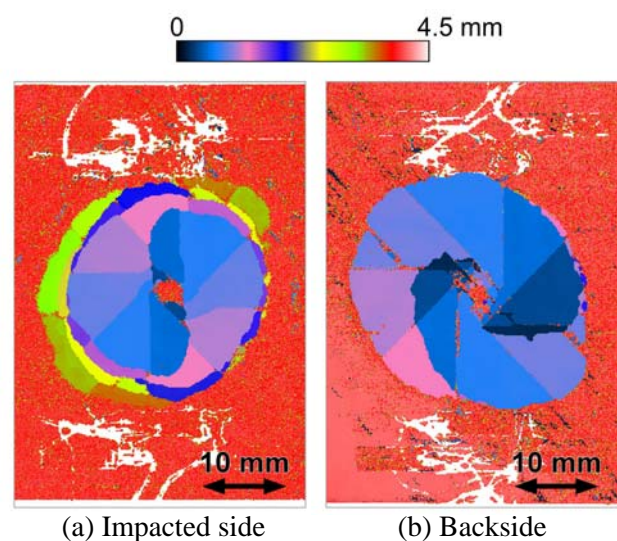
(a) Impacted side (b) Backside
Fig. 2. C-scan images of a UT500/Epoxy specimen subjected to 1.91 J/mm impact

The impact-induced damage was mainly delaminations. Figure 2 shows the ultrasonic C-scan images of damage induced in a UT500/Epoxy specimen subjected to 1.91 J/mm impact. The C-scan images in Figs. 2(a) and (b) were taken from the impacted side and the backside of specimen, respectively. The depth of the delamination was indicated using the color gradation shown in Fig. 2. The delaminations are formed in a spiral stair manner in the through-the-thickness direction with each step corresponding to a change in ply orientation. Therefore, the spiral direction is clockwise from the impacted side until the midplane and changed to be counterclockwise below the midplane. The delamination size was measured with an image processing. Figure 3 shows the delamination size at each interface. In Fig. 3, we described the delamination size using the diameter

of a hypothetical circle on the assumption that the envelope of the damaged area was circular at each interface. The delamination size increased away from the impacted front face until the interface between the 19th 0-degree ply and the 20th +45-degree ply, and then decreased toward the backside, as shown in Figs. 2 and 3.

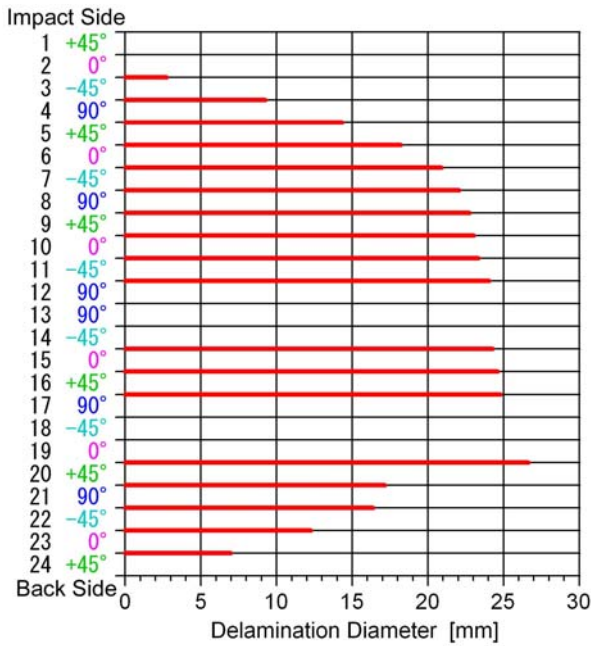
Fig. 3. Delamination size at each interface of a UT500/Epoxy specimen subjected to 1.91 J/mm impact

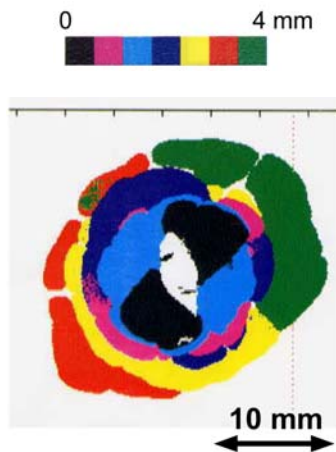
Fig. 4. C-scan image of the impacted side for an AS4/PEEK specimen subjected to 1.03 J/mm impact

In the case of the AS4/PEEK specimen subjected to 1.03 J/mm impact, the delamination area monotonically increased away from the impacted front face towards the back face and three-dimensional envelope of the multiple delaminations created geometrically a truncated cone shape in through-the-thickness direction, as shown in Fig. 4.

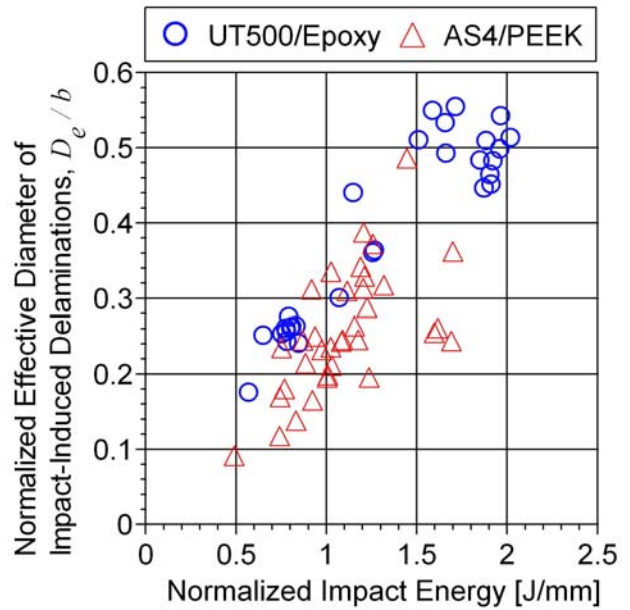
Fig. 5. Relationships between effective delamination diameter and normalized impact energy

Figure 5 shows relationships between the effective diameter of delaminations D_e and the normalized impact energy. Impacted specimens displayed a large scatter in the delamination diameter. The normalized effective diameter of delaminations of the UT500/Epoxy was relatively larger than that of the AS4/PEEK. This difference in observed damage extents may result from the fracture toughness of each material system.

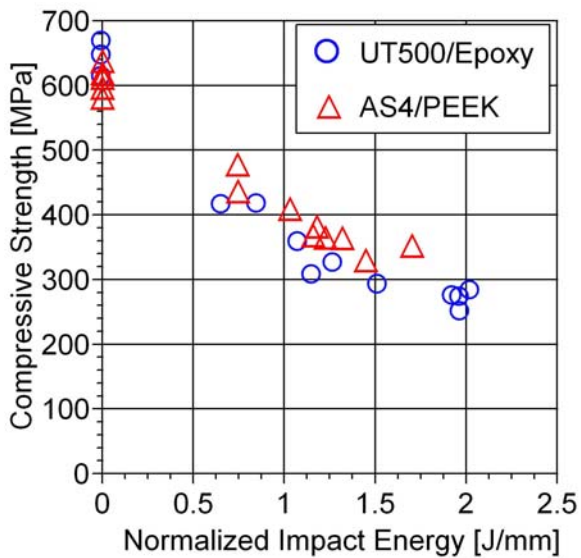
Fig. 6. CAI strength as a function of normalized impact energy

Figure 6 depicts the CAI strength of the laminates. The abscissa is the normalized impact energy. The compressive strengths of the unimpacted specimens were on average 642 MPa for the UT500/Epoxy and 606 MPa for the AS4/PEEK. Figure 7 shows the CAI strength normalized by the ultimate strength of the unimpacted specimens as a function of the normalized effective diameter of delaminations. The CAI strengths of the UT500/Epoxy and AS4/PEEK were reduced to about 40% and 55% of the unimpacted strengths,

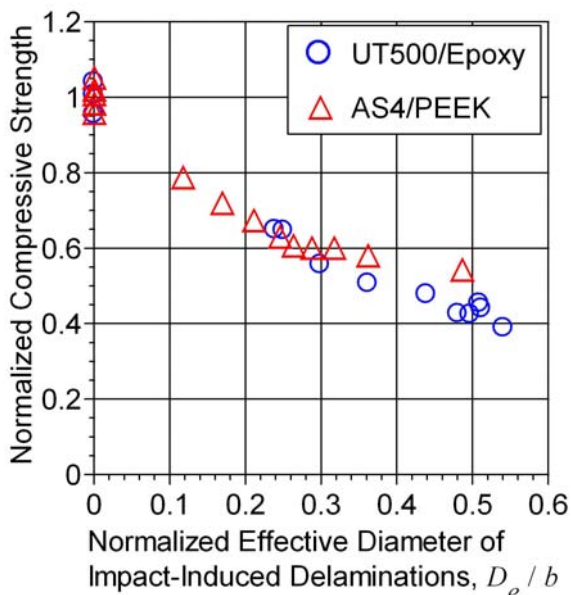
Fig. 7. Normalized CAI strength as a function of normalized effective diameter of delaminations

respectively. It was obvious that a tougher composite specimen offered better CAI strength.

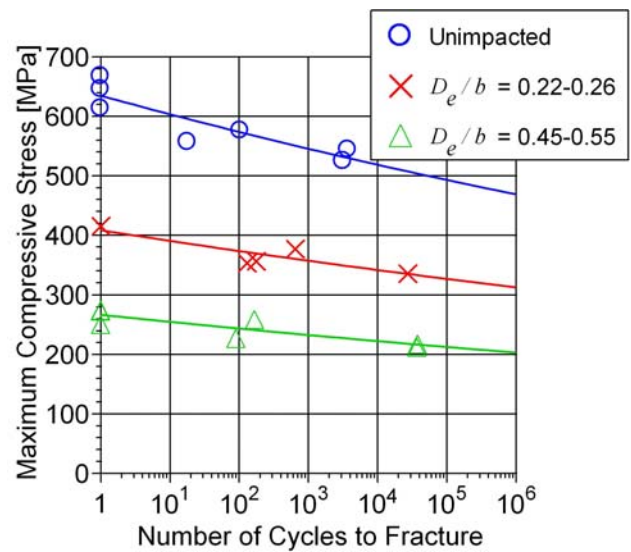
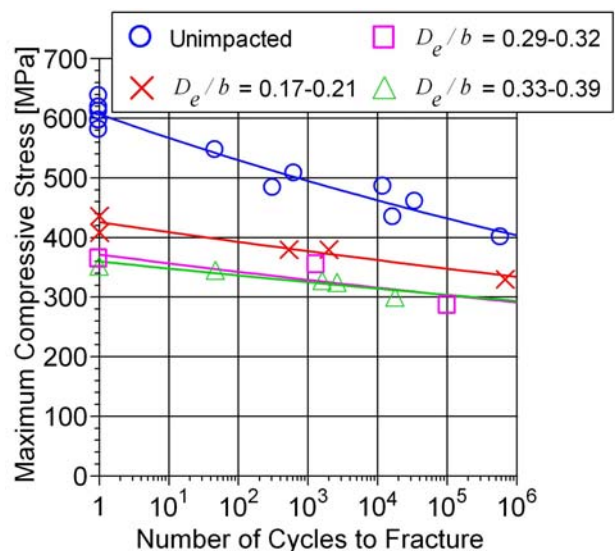
(a) UT500/Epoxy laminates

(b) AS4/PEEK laminates

Fig. 8. S-N curves sorted by the size of the effective delamination diameter

Post-impact fatigue test data were processed in the form of relationships between maximum compressive stress and number of cycles to fracture (S-N curves). Figures 8(a) and (b) are depicted using the compression fatigue test data of the specimens sorted into a few groups by the size of the effective delamination diameter. The results of the

UT500/Epoxy and AS4/PEEK are plotted in Figs. 8(a) and (b), respectively. The S-N relationships for the unimpacted specimens are shown by blue circles in Figs. 8. Figures 8(a) and (b) indicate that increasing amounts of the impact damage reduced the compression fatigue performance of the laminate.

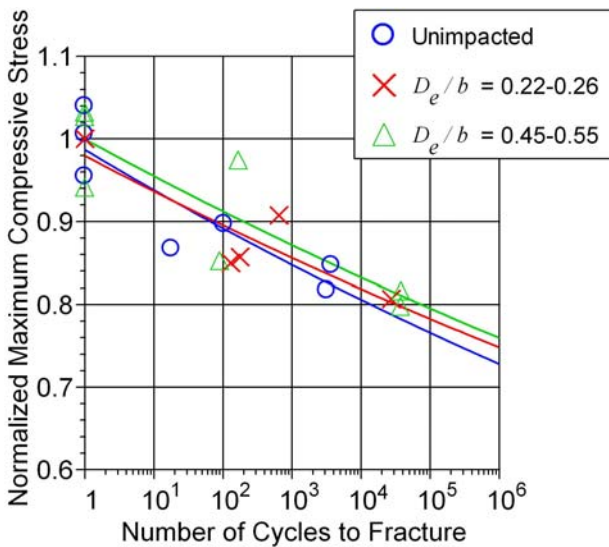
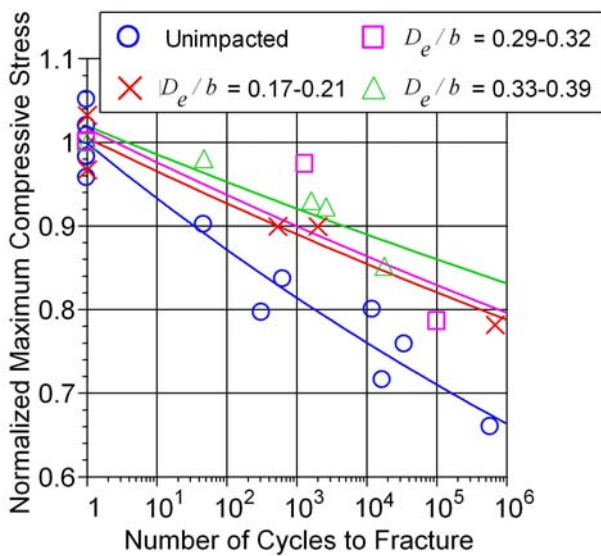
(a) UT500/Epoxy laminates

(b) AS4/PEEK laminates

Fig. 9. Normalized maximum compressive stress as a function of cycle number to fracture

In order to clarify the amount of fatigue strength degradation, the S-N curves are plotted using an ordinate normalized by the CAI strengths of the specimens with the same damage size, as shown in Figs. 9(a) and (b). In the case of the UT500/Epoxy, the specimens with impact damage showed similar decrease rate in the fatigue strength

to those without impact. On the other hand, the AS4/PEEK specimens without impact showed the steeper slope of the S-N curve in comparison with those with impact.

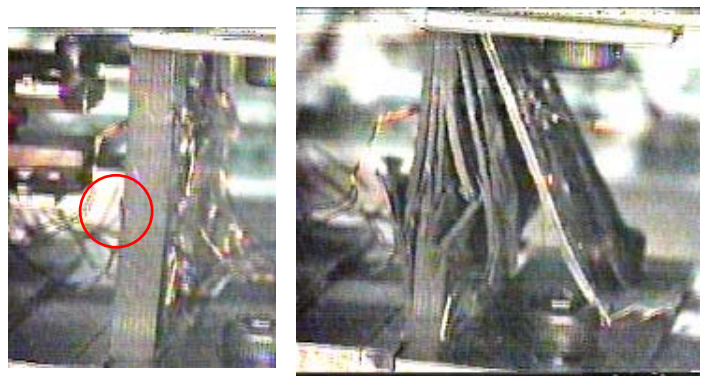
(a) N=637 (b) N=638

Fig. 10. Photographs of an unimpacted AS4/PEEK specimen in fatigue (Fatigue life of this specimen was 638.)

In the case of the unimpacted specimens, any large out-of-plane deflection was not observed during fatigue. Figure 10 shows photographs of an unimpacted AS4/PEEK specimen under fatigue loading. The specimen was cyclically subjected to a maximum compressive stress of 507 MPa. The number of cycles to fracture of this specimen was 638. A small delamination of a surface layer at the

free edge was initiated at one cycle before the fracture, as circled with a red in Fig. 10(a). The specimen was abruptly broken during the 638th loading as shown in Fig. 10(b). All of the unimpacted specimens for both the material systems were catastrophically fractured as shown in Fig. 10.

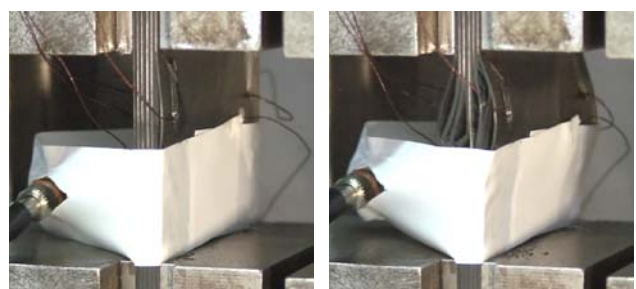
(a) Backside at N=37,700 (b) Backside at N=37,750
Fig. 11. Photographs of an impacted UT500/Epoxy specimen with $D_e/b = 0.55$ in fatigue. (Fatigue life of this specimen was 37,750.)

Figure 11 shows photographs of an impacted UT500/Epoxy specimen during fatigue loading. This specimen was subjected to 1.59 J/mm impact that caused the delaminations with $D_e/b = 0.55$, and subsequently cyclically loaded to a maximum compressive stress of 217 MPa. The number of cycles to fracture of this specimen was 37,750. Figure 11(a) represents the delamination extended to the free edge and the back-surface sublaminates were locally deformed in the out-of-plane direction at the 37,700th loading. Fig. 11(b) shows the fractured specimen at the 37,750th loading.

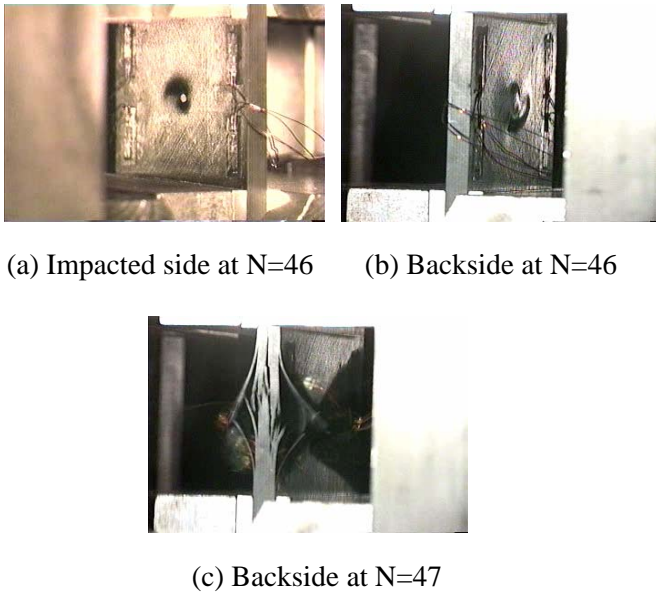
(a) Impacted side at N=46 (b) Backside at N=46
(c) Backside at N=47

Fig. 12. Photographs of an impacted AS4/PEEK specimen with $D_0/b = 0.37$ in fatigue. (Fatigue life of this specimen was 47.)

Figure 12 shows photographs of an impacted AS4/PEEK specimen in fatigue. This specimen was subjected to 1.26 J/mm impact and delaminations with $D_e/b = 0.37$ occurred. The maximum compressive stress of this specimen during the fatigue test was 345 MPa. The fatigue life of this

specimen was 47 load cycles. Figures 12(a) and (b) represent the impacted side and the rear side of the specimen loaded at the 46th cycle, respectively. The impact crater and its vicinity were sunk into the out-of-plane direction and the thin surface layer on the rear side of the specimen was locally buckled as shown in Figs. 12(a) and (b). The specimen was abruptly fractured at the 47th loading as shown in Fig. 12(c).

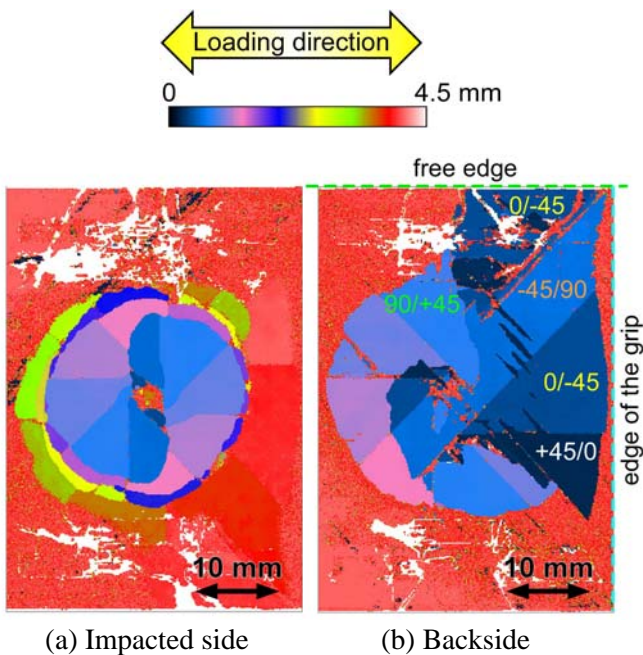
(a) Impacted side (b) Backside
Fig. 13. C-scan images of the UT500/Epoxy specimen at N=16,468, the impact-induced delaminations of which were shown in Figs. 2 and 3

Figure 13 shows delamination growth behavior of the UT500/Epoxy specimen, the impact-induced delaminations of which were shown in Figs. 2 and 3. This specimen was subjected to 1.91 J/mm impact, as mentioned before, that caused the delaminations with $D_0/b = 0.46$, and subsequently cyclically loaded to a maximum compressive stress of 244 MPa. Figure 13 indicates the C-scan images of the specimen just after the 16,468th cyclic loading, when the specimen had not yet been fractured. The loading direction is right and left in Fig. 13. Examination of the C-scan images in Fig. 2 and Fig. 13 reveals that the impact-induced damage grew widthwise to the free edge on the rear side of the specimen during the fatigue test. The delamination between the 22nd -45-degree ply and the 23rd 0-degree ply reached the free edge. And the delaminations on the rear side propagated in the loading direction to the edge of the binding grip.

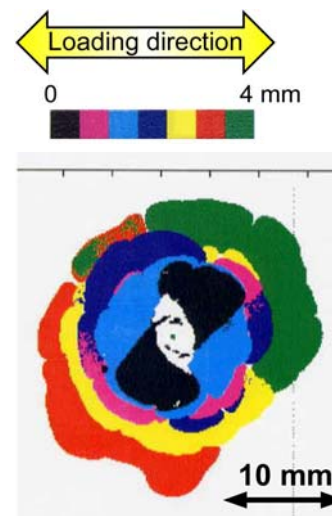
Fig. 14. C-scan image of the impacted side for the AS4/PEEK specimen at N=500, the impact-induced delaminations of which were shown in Fig. 4

Figure 14 show the C-scan images of the AS4/PEEK specimen just after the 500th loading, the impact-induced delaminations of which were shown in Fig. 4. This specimen was subjected to 1.03 J/mm impact, as mentioned before, and the delaminations with $D_0/b = 0.33$ occurred. The maximum compressive stress during fatigue was 327 MPa. Comparing Fig. 14 with Fig. 4, it is obvious that the impact-induced damage on the rear side grew widthwise a little but not lengthwise during

fatigue. C-scan image just after the 1,000th loading showed the delamination on the rear side extended widthwise in 2 mm more. However, the delaminations never reached the free edge before the fatigue fracture.

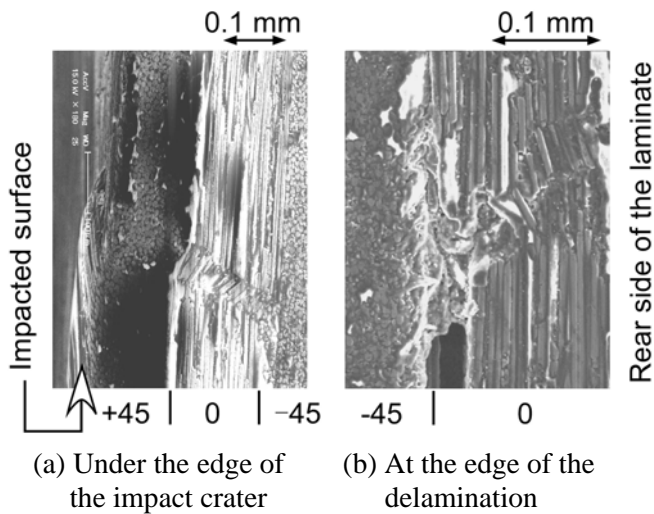
Fig. 15. SEM photographs showing kink band occurred at the 0-degree ply in the AS4/PEEK specimen laminate.

Several post-impact fatigue tests were interrupted in order to inspect an interior damage after measuring a large amount of AE (acoustic emission). The specimens were sectioned in the vicinity of the impact crater using a diamond-impregnated saw, and the cross sections were examined with a scanning electron microscope (SEM). Abrasive papers were used to polish the cross-section so that interior regions of the laminates could be inspected. Figure 15 indicates a kink band observed at the 0-degree ply in the AS4/PEEK specimen during the post-impact fatigue test. Figure 15(a) indicates a kink band observed at the 0-degree ply under the edge of the impact crater. Figure 15(b) shows a kink band caused in the 0-degree ply at the edge of the delamination between the 0-degree ply and the -45-degree ply near the rear surface. The number of loading cycles of the sectioned specimens almost reached the fatigue life on the S-N curve shown in Fig. 8(b). The fiber microbuckling and kinking seem to be intimately related to fatigue fracture.
