# MEASUREMENT OF DAMAGE PROGRESSION IN OPEN HOLE TENSION TESTS

Adrian F Gill\*, Paul Robinson\*, Dennis Hitchings\*

\*Imperial College London

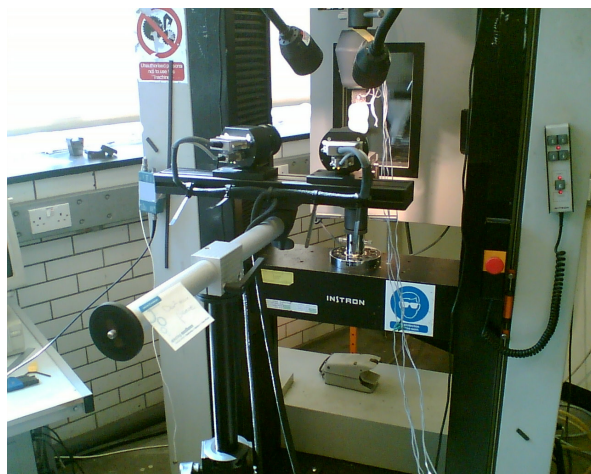
OHT tests were performed as per [1] (Fig. 2) and strain fields were recorded and computed using ARAMIS Digital Speckle Photogrammetry (DSP) equipment. DSP is an optical technique for computing strains and displacements by tracking a recognisable pattern spray-painted onto a surface. The ARAMIS software used in this investigation calculates the strain field by differentiating the displacements in two directions monitored by the camera for small facets automatically meshed onto the surface. Facet size for this investigation was approximately 0.5 mm x 0.5 mm (225 pixels per facet). Strain results for the system were verified with strain gauge data away from the hole and tabs and excellent correlation was found.

Fig. 2. Digital speckle photogrammetry (DSP) system

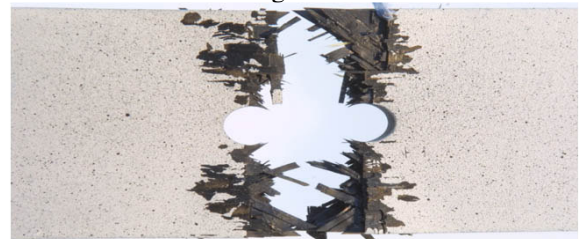
All tested OHT specimens failed though a combination of fibre fracture, matrix cracking and delamination (Fig. 3). Fig. 4 shows the longitudinal strain field of such a specimen just before final failure occurs with the location of a significant change in strain identified. Fig. 5 presents the strain at the identified point over the duration of the test. It can be seen that at 275 seconds into the test a large increase in strain occurred. This increase in strain results from changes in the compliance of the laminate and is indicative of damage. The occurrence of damage at this stage in the test was confirmed by a large acoustic emission event (Fig. 6). Additionally, the occurrence of damage at the identified point was confirmed through post-test microsections such as Fig. 9.

Fig. 3. Failure of a quasi-isotropic OHT specimen.

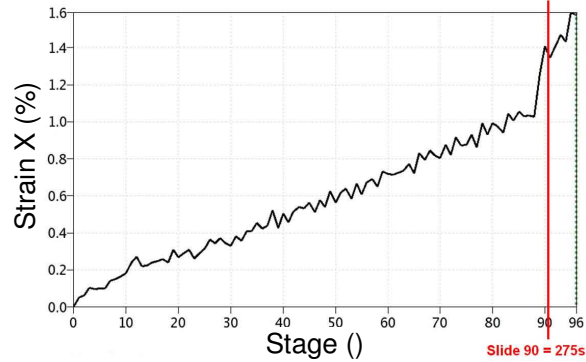
Fig. 5. Strain at highlighted damage point.

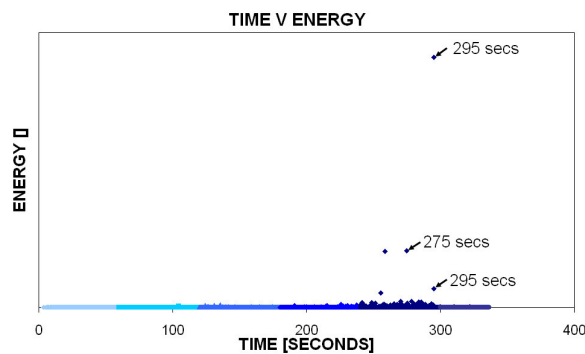
Fig. 6. AE output shows large emissions as 275 secs, corresponding to observed strain increase. Final failure occurred at 295 secs.

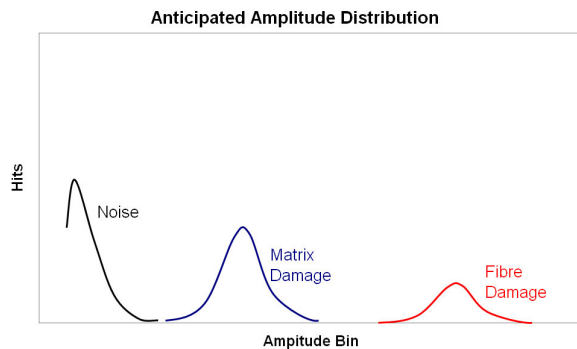
Fig. 10. Anticipated amplitude spectrum with peaks for individual damage mechanisms.

The use of acoustic emission to identify and isolate damage mechanisms was also investigated. It was reported by Bailey et al [6] that composite damage mechanism could be successfully distinguished using variations in signal amplitude between high energy fibre damage and low energy matrix damage. This variation resulted in two peaks in the signal amplitude spectra that identified individual damage mechanisms (Fig. 10). Recorded

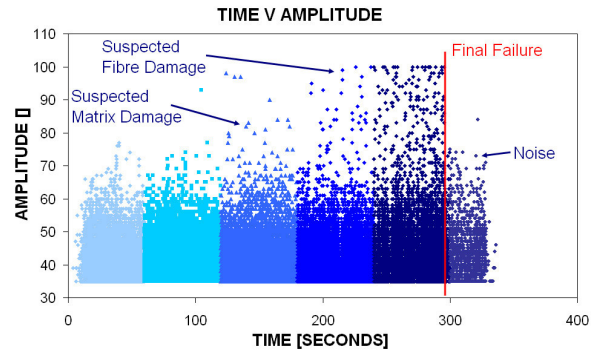
Fig. 11. Recorded signal amplitudes during test.

amplitudes and the amplitude spectrum are presented in Fig. 11 and Fig. 12 respectively. It was found that distinct damage distributions did not occur, preventing damage mechanisms from being isolated. Possible explanations for this are that the amplitude distributions resulting from individual damage modes are not statistically distinct, that the expected amplitude distributions occurred outside the limits of the acoustic emission equipment or that the amplitude distributions resulting from individual damage mechanisms were drowned out by the more frequent matrix damage and noise resulting from test machinery, traffic and other university activities. Efforts were made to isolate and filter background noise but were without success.

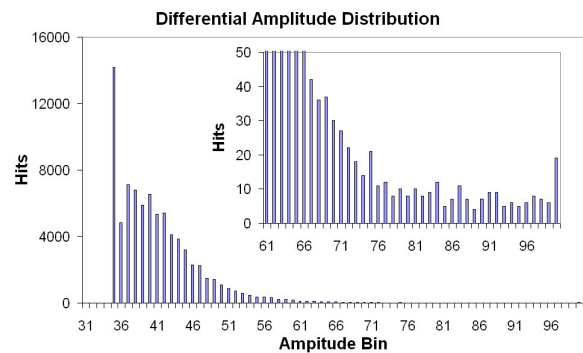
Fig. 12. Actual amplitude spectrum does not exhibit distinct peaks for individual damage mechanisms.

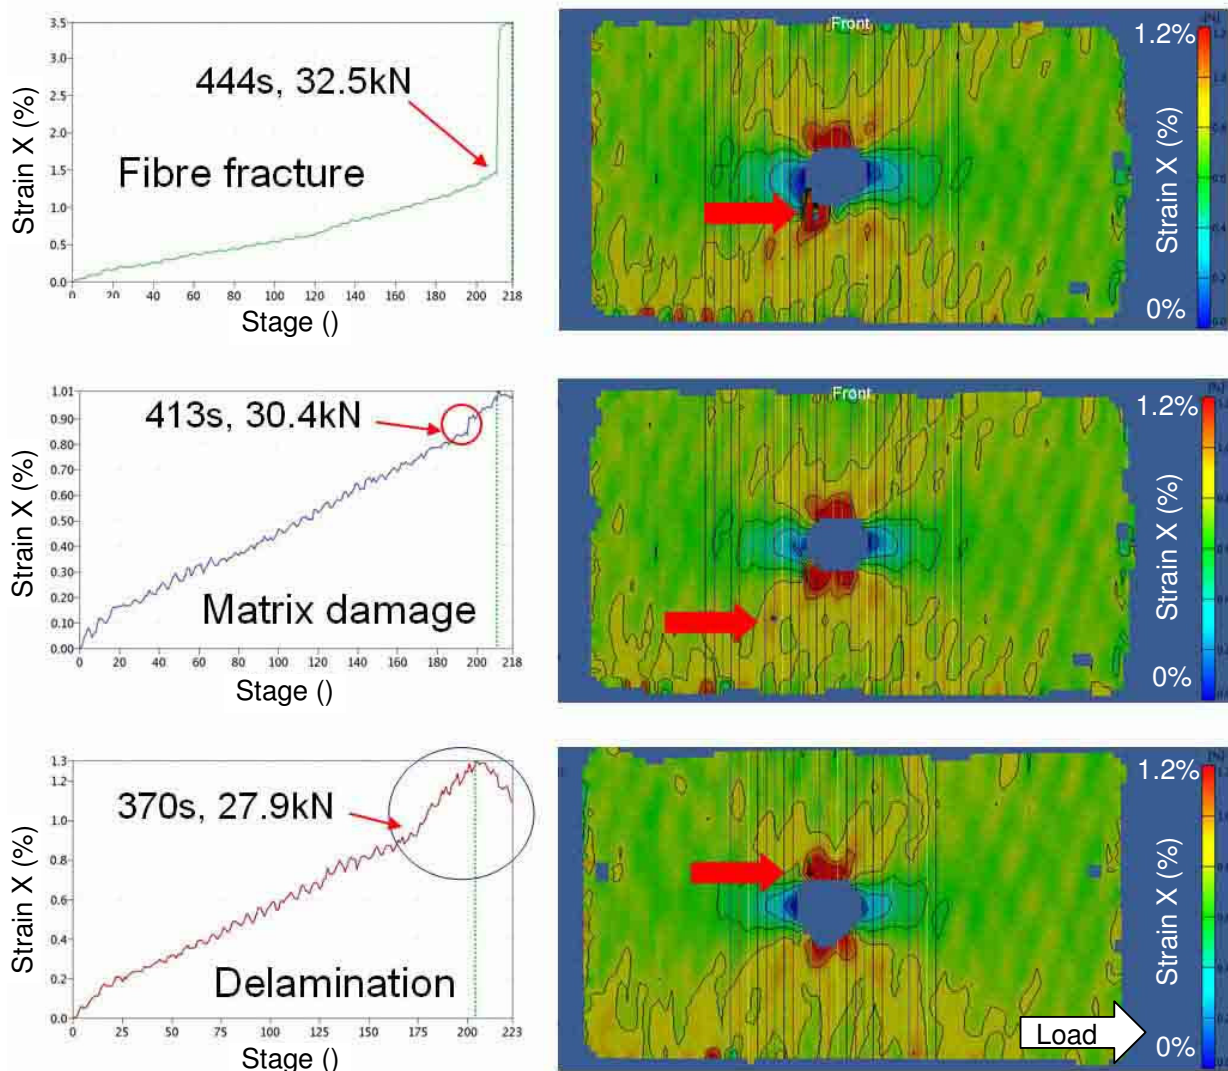
Fig. 13. Damage mechanisms identified by rate and magnitude of strain change.

To identify the damage mechanisms responsible for the observed strain increases, tests were repeated as per section 3.1 but stopped at significant acoustic emission bursts. It was found that observed strain increase could be assigned to one of three damage types (Fig. 13):

- The damage event suspected of being fibre fracture exhibited a sudden large strain increase. (Fig. 13 – Top)
- Suspected matrix cracking exhibited a sudden small strain increase. (Fig. 13 – Middle)
- Suspected stable delamination growth exhibited a long duration damage event of large magnitude. (Fig. 13 – Bottom)

The change in strain field between 413 secs and 444 secs in Fig. 13 (from two lobes to one) is the result of crack formation at about 8 o'clock to the hole (Fig. 8) that causes a redistribution of strain.
