DAMAGE TOLERANCE AND IMPACT RESISTANCE OF COMPOSITE SCARF JOINTS

Alex B. Harman* and Chun H. Wang*

*Defence Science and Technology Organisation (DSTO).

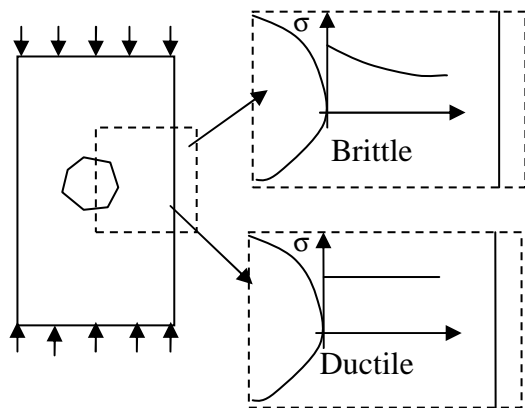
Figure 5 Schematic of residual strength analyses

zone has been experimentally measured using strain gauges. The results showed that the modulus was around 60% [2] of the parent. This will yield a stress concentration factor of $\sigma_{edge} / \sigma_{applied} = 1.4$. This concentration factor applies to all damage sizes, but the actual failure stress would also depend on the size of damage [4]. This is shown schematically in Figure 5, which showed that damage size has a relatively minor influence.

If the composite laminate is assumed to undergo non-linear deformation (e.g. progressive damage due to matrix cracking) prior to final failure, then the local non-linear deformation of the composite may cause the stress concentration to diminish, thus the stress field becomes approximately uniform across the ligament. Since the ligament width is dependent on the size of damage (d) and the overall specimen width (W), the failure stress predicted using this approach will depend on the d/W ratio for each of the damaged specimens. Therefore, if greater impact energy causes a larger area of damage, the predicted failure will be affected accordingly. The average stress in the ligament region of the specimen is given by

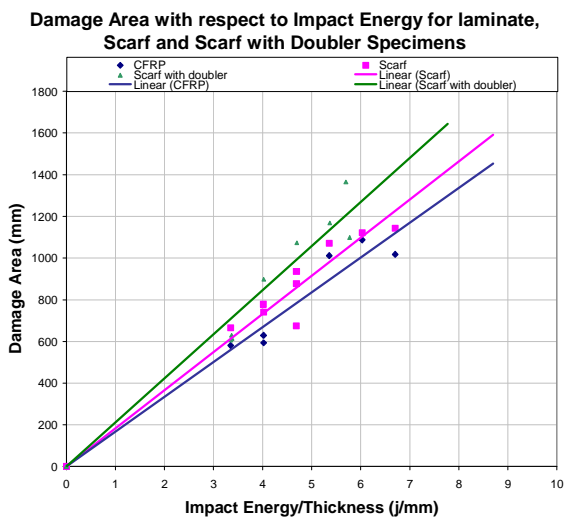
Figure 7 Damage area vs impact energy for each of the specimen types (laminate, scarf and scarf with doubler).

A number of dummy and CAI specimens were impacted at varying energy levels to establish the relationship between impact energy and the damage size for each of the specimen types. Impact damage was characterized using pulse-echo C-scanning to determine the damage area within the laminate. The final graph showing the correlations is provided in Figure 7.

These results show that an approximately linear correlation existed between damage area and impact energy.

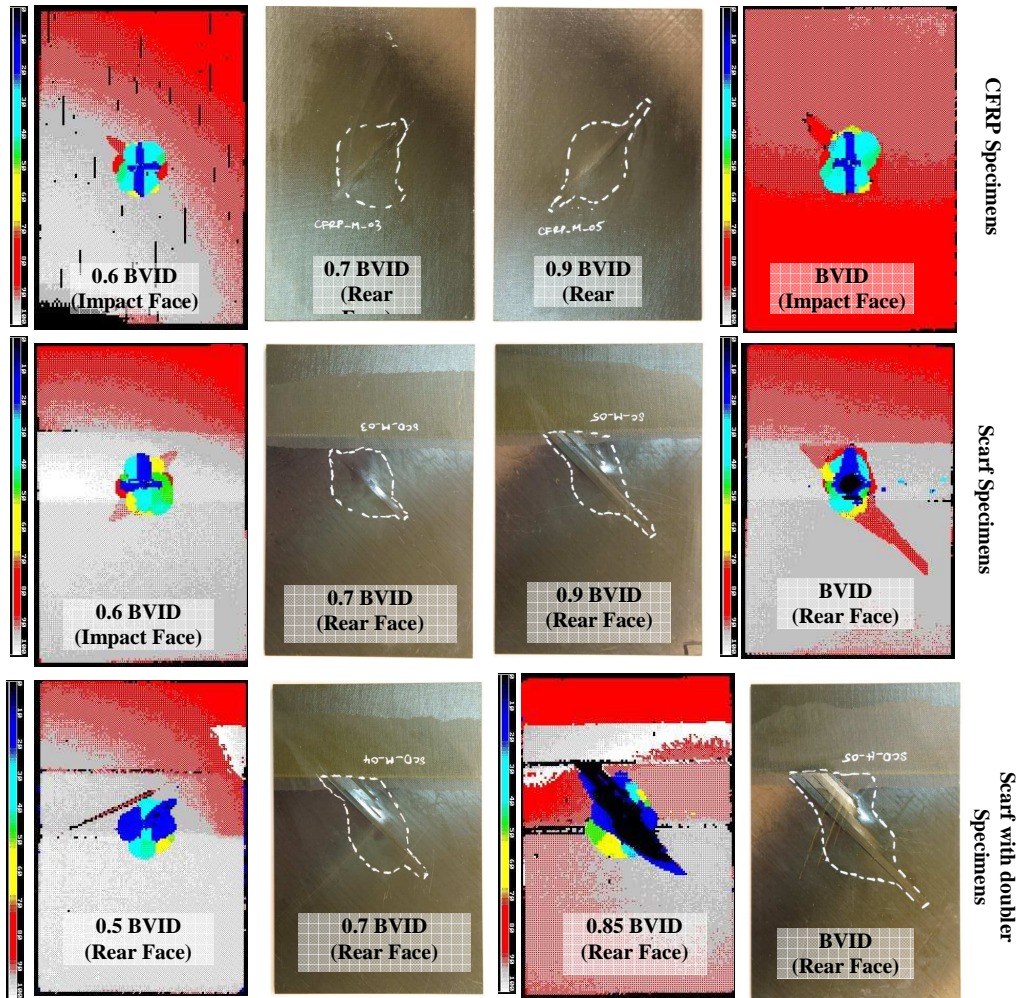
Figure 8 C-scan images for each of the specimen types at energy levels rising from 0.5BVID to BVID.

The shape of the damage caused in plan view can be seen in the C-scan images provided for each of the specimen types in Figure 8. These results show that the damage at lower energy levels is approximately circular, but as the energy level increases, the damage

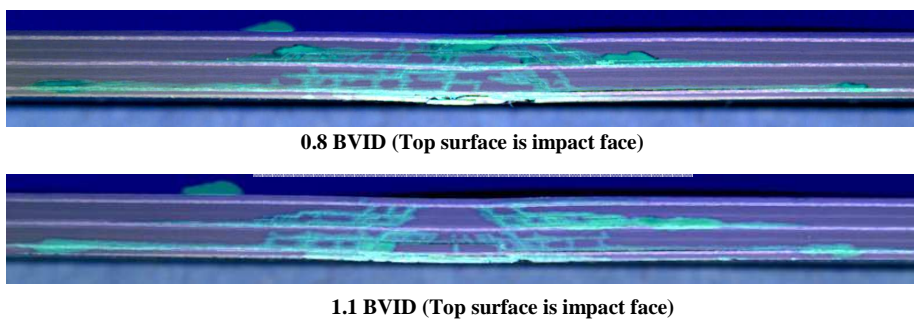
Figure 9 Transverse cut through two laminate specimens impacted with 0.8BVID (top) and 1.1BVID (bottom).

The damage introduced within the internal structure of the laminates could only be determined by destructively sectioning damaged dummy specimens following the impact event. A transverse cut is shown of the laminate specimen in Figure 9. These results show significant delamination progression caused in the central and back surface 45° and 90° plies.

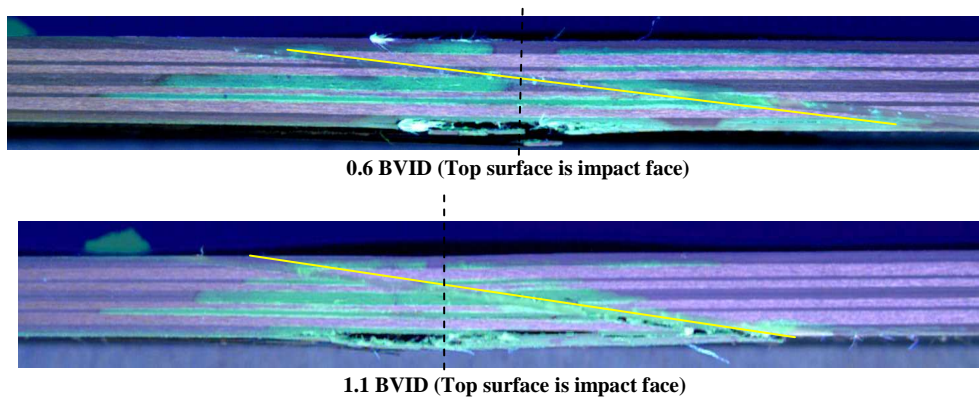
Figure 10 Longitudinal cut through two scarf specimens impacted with 0.8BVID (top) and 1.1BVID (bottom).

A longitudinal cut through the scarf specimen is shown in Figure 10. These results also show significant delamination caused in each of the 45° and 90° plies. Of particular note is that both tips of the scarf joint are damaged significantly.

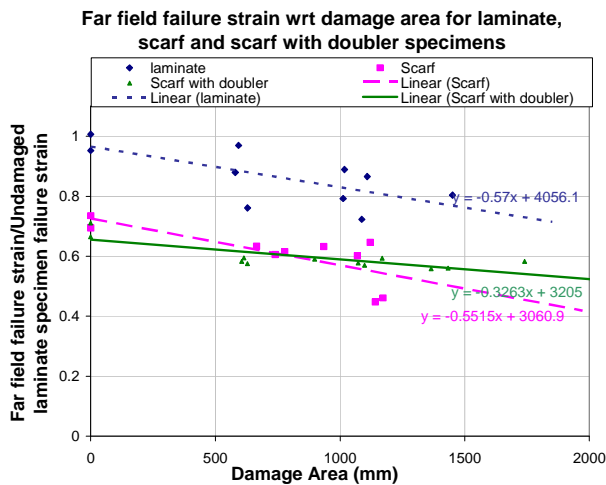
Figure 12 Far field failure strain with respect to impact damage area

The results from the residual strength testing have been presented in two ways. The first is far field strain at the time of failure with respect to impact damage area (Figure 12), and the second is the calculated average ligament strain (Figure 13) assuming the adherend material to behave in ductile manner with respect to damage area. All results are normalized with the un-notched compression failure strain of the parent laminate which

equated to $4300\mu\epsilon$. This value is expected to be the lower bound for the compression strength of this laminate, as some evidence of buckling was observed in the gap region of the test fixture despite edge and end clamping of the specimen that exceeded the requirements of the test method. These results show a clear reduction in strength with increasing damage area for all specimen types. The results also show that the average ligament strain at failure in the scarf joint specimens is almost consistently 20% lower than the parent

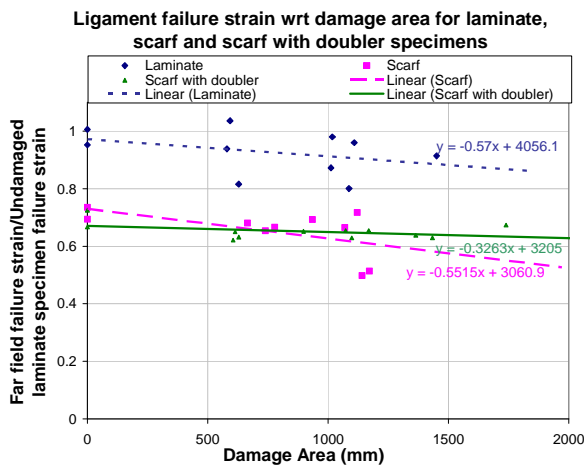
Figure 13 Average ligament strain at failure with respect to impact damage area

laminated ligament strain for a given damage area. This suggests that the strength differential between the parent laminate and the scarf joint is maintained with increasing damage up until the point where significant scarf damage occurs at the higher than BVID impact energies. This may provide a simplified tool for determining the strength of the damaged scarf joint based on a known undamaged strength and the area of damage that occurs within the scarf joint. These results show that at the lower energy levels the doubler has no effect on the failure strain of the scarfed adherend, but at the high energy levels, the doubler prevents the dramatic reduction in strength observed in the scarf specimens.

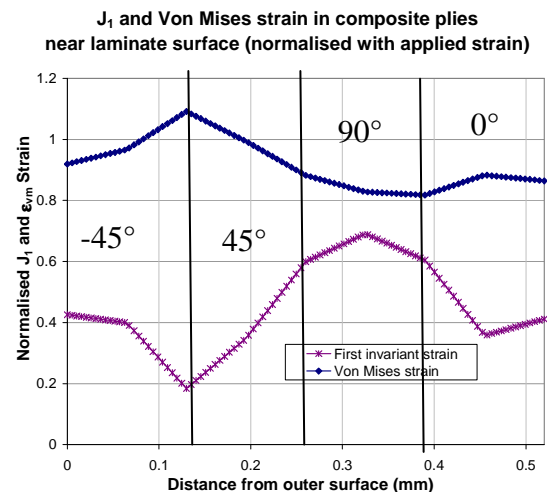
Figure 17 Strain in outer four ($-45/45/90/0$) plies near the parent laminate surface

A plot of the strain through the thickness of the laminate showed that the peaks occurred in the outer three 45° and 90° plies. As such, only the strain distribution in the outer four plies is shown in Figure 17. These results show that the Von Mises strain peaks at the interface between the 45° plies and the J_1 peaks within the 90° ply. This is consistent with observations by Gosse [5] using the Strain Invariant Failure Theory (SIFT).

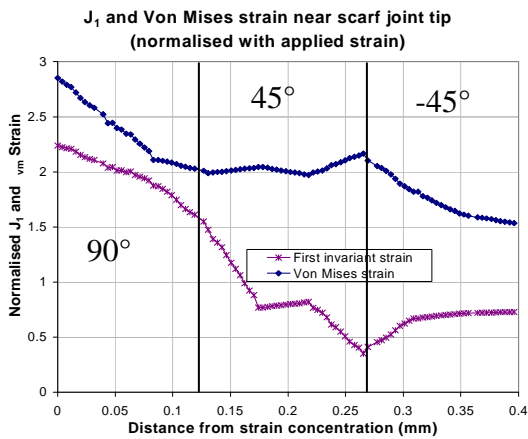
Figure 18 Strain distribution from the peak strain location to the outer surface of the tip.

FEA of the scarf joint showed that a significant strain peak was observed at the interface between the 90° and 0° ply closest to the scarf joint tip. Observations of the scarf joint failure modes confirmed that this may be a site of failure initiation. A plot of the Von Mises and J_1 strain from the 0° to 90° interface (peak) along the path of highest strain is shown in Figure 18. These results show that the strain concentration in the scarf joint adherend far exceeds that in the parent laminate, which would explain premature failure of the specimen, despite it being an adherend failure rather than a cohesive failure through the scarf joint adhesive. As discussed the strain concentration causes the ligament strain to be 40% greater than the applied strain at failure. This equates to an applied ligament strain of $6000\mu\epsilon$. A plot of the shear strain in the scarf joint adhesive subjected to an applied strain of $6000\mu\epsilon$ is provided in Figure 19. These results show that at this load, the peaks in the adhesive shear strain do not exceed the elastic limit of the adhesive. Therefore, it is unlikely that the adhesive failed prior to overall specimen failure.

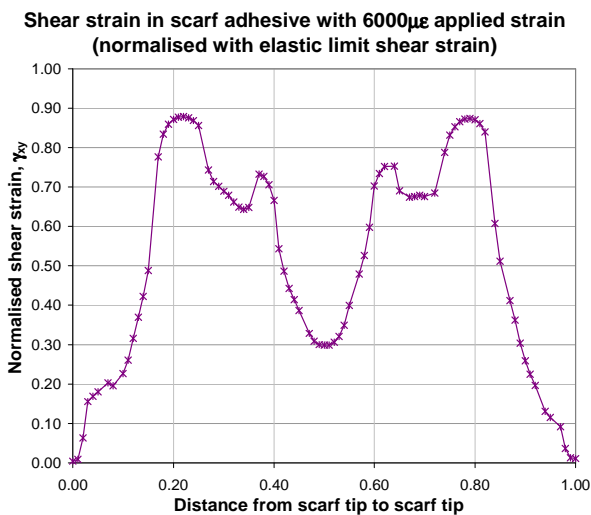
Figure 19 Shear strain distribution at the extreme ligament strain for the scarf joint specimens.
