AE CHARACTERIZATION OF BENDING FRACTURE PROCESS IN SiC/SiC COMPOSITES WITH TRANSPIRATION COOLING STRUCTURE

Toshimitsu HAYASHI, Shuichi WAKAYAMA
Tokyo Metropolitan University

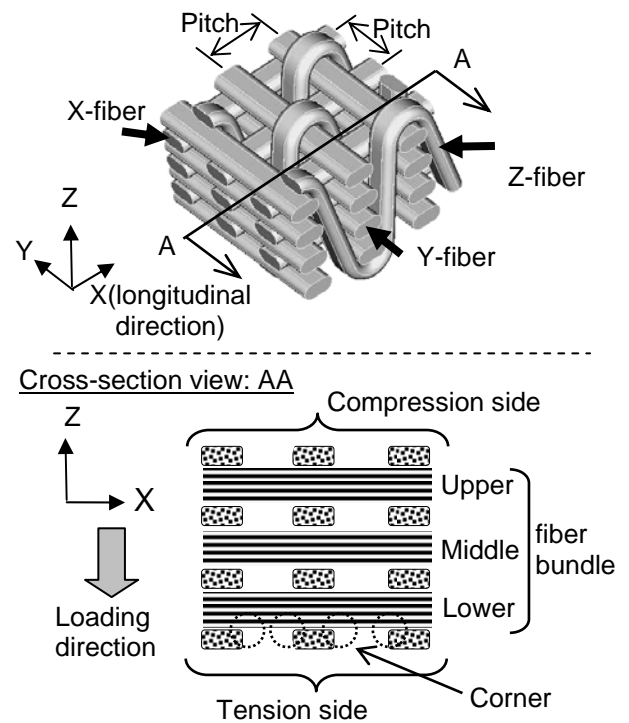
Fig. 1. Schematic diagram of weaving architecture (Fiber volume ratio; X:Y:Z=1:1:0.2, Pitch; 2mm).

The SiC/SiC composites used in this study were made of Tyranno™ ZMI SiC fiber (Ube Co.) and SiC matrices. The composites have the 3D-orthogonal weaving structure as shown in Fig.1 schematically. The 3D-woven architecture consists of three layers of X bundles, four layers of Y bundles and Z bundles. In a cross sectioned view of “AA” in Fig.1, three longitudinal X-fiber bundles are shown. The X-fiber bundles are called, upper, middle and lower hereafter. Tensile side is not flat because of the weaving structure, which will result the notch-like geometry deriving stress concentration. The location of the notch-like geometry indicated by dotted circles is called a “corner”.

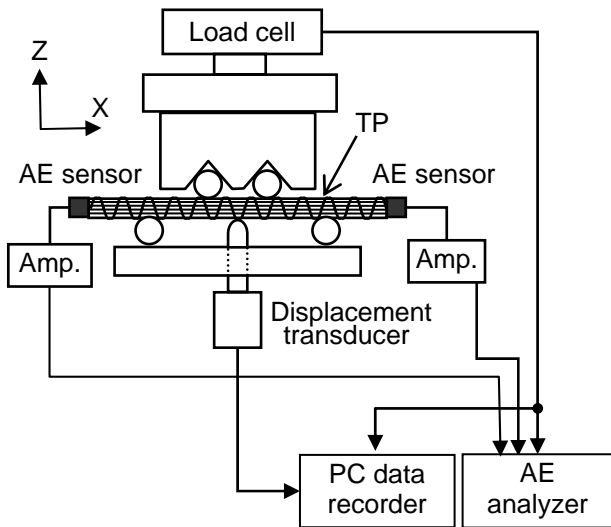
Fig.2. Schematic diagram of bending test apparatus.

Figure 2 shows the schematic diagram of the testing system. Four-point bending tests were conducted with inner span of 10 mm and outer span of 30 mm at room temperature in air. Loading was applied along Z-direction under a constant cross-head speed of 0.5 mm/min so that the tensile stress was applied along X-direction. Loading patterns are, 1) loading to fracture, 2) loading up to about 50 or 100 MPa and unloading.

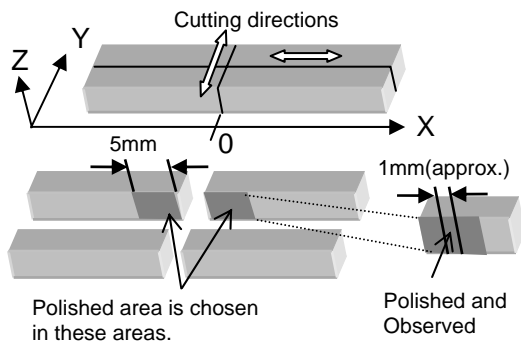
Fig.3. Cutting directions and polished area by the argon ion beam.

After the bending test, the specimens were soaked in an epoxy resin and kept at 90°C in vacuum for hardening. After the epoxy resin was hardened, the specimens were cut into four pieces with a diamond cutter as shown in Fig.3. The cut surface in the XZ-plane was polished by a 16 μm diamond sheet and then polished by the argon ion-beam(JEOL,SM-09010). The depth of the polished area by the argon ion beam was about 50 μm so that the section mechanically damaged before the ion-beam polishing can be removed.

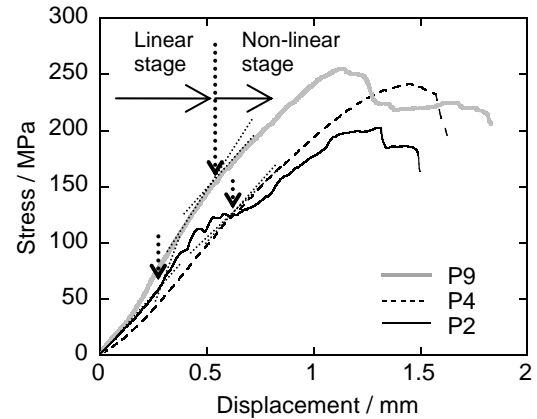
Fig. 4. Stress-displacement curves of the 3D-woven SiC/SiC composites, showing the unsteady behavior in P2.

The measured stress-displacement curves for the specimen of P2, P4 and P9, subjected to the bending fracture, are shown in Fig.4. Both a linear section and a subsequent non-linear section were recognized in each stress-displacement curve. The linear section extends to a stress level of about 130MPa and 150MPa for the specimens P4 and P9, respectively and 60MPa for the specimen P2 as indicated by the dotted arrows in the figure. The slope of non-linear sections of P4 and P9 gradually decreased with increasing the displacement. The non-linear part of P2 is fractured, which suggests unsteady deformation behavior.

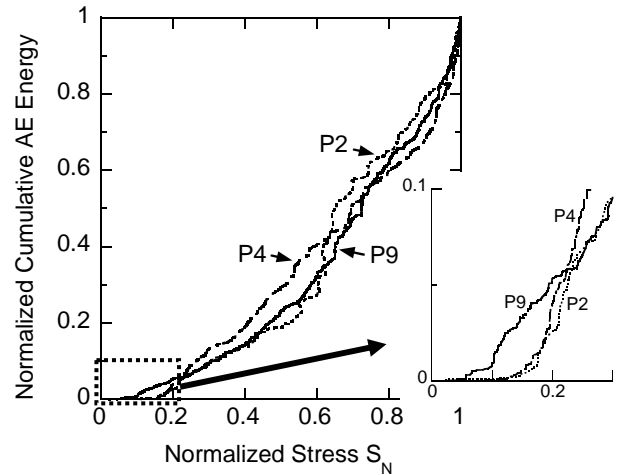
Fig.5. Normalized Cumulative AE Energy vs. Normalized Stress, showing that the AE activity of P9 initiated in the earliest.

by the each fracture stress is presented in Fig. 5. The AE energy accumulated even in the linear stage macroscopically defined by the stress-displacement curves. It suggests that micro-damage is accumulated in the macroscopically linear stress-range. It is worth noting that the accumulation of the AE energy of P9 initiates in the earliest. It indicates that the matrix rich specimen P9 most quickly accumulates the micro-damage in the early stage of loading.

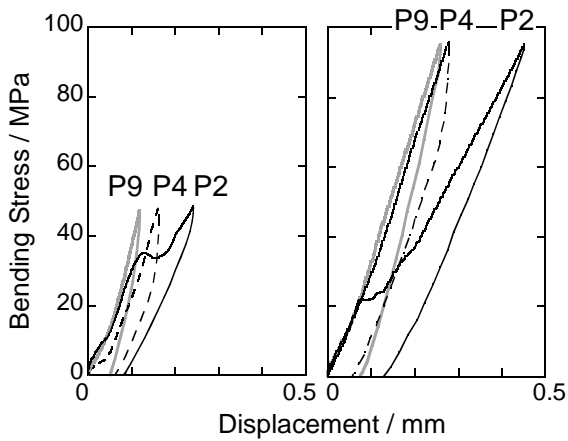
Fig.6. Stress-displacement curves during loading and unloading.

Figure 6 shows the measured stress-displacement curves for the specimen, P2, P4 and P9, during loading up to 50MPa(left) and 100MPa(right) and then unloading. The onset of the non-linear

stage was observed only in P2. The onset stress was largely scattered, which suggests the poor matrix composites shows largely unsteady mechanical behavior.

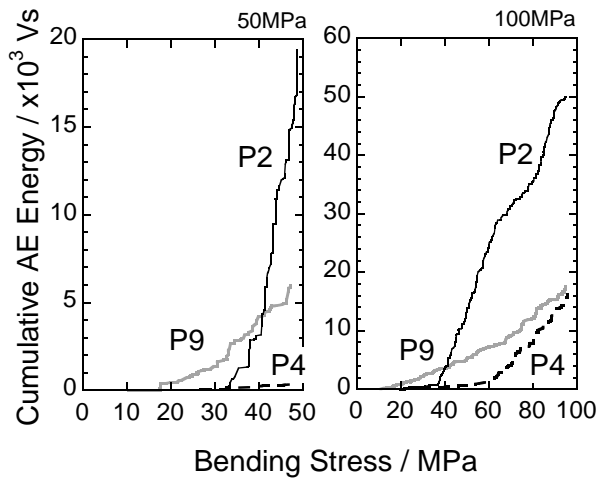
Fig.7. Cumulative AE Energy vs. bending stress during loading to 50MPa(left) and 100MPa (right), showing that the AE activity of P4 was moderate.

Figure 7 shows the AE energy accumulation behavior during loading and unloading. During loading up to 100MPa, the specimen P2 showed a significant AE activity, indicating a large micro-damage accumulation. The standard matrix specimen P4 showed moderate accumulation of the AE energy. It indicates that specimen P4 shows moderate damage accumulation behavior in the early stage of loading.

The comparison between the micrographs in Fig.11 and 12 indicates that almost no significant micro-damage was progressed while loading from 50MPa to 100MPa. However, since the AE activity of P2 was observed in a stress range between 50 and 100 MPa as previously shown in Fig.7(right), micro-

The micro-damage in P4 after loading up to 50MPa ($S_N \approx 0.2$) and unloading has not been found in the polished cross section. This result shows a good agreement with the moderate AE activity as shown in Fig.7 (left).

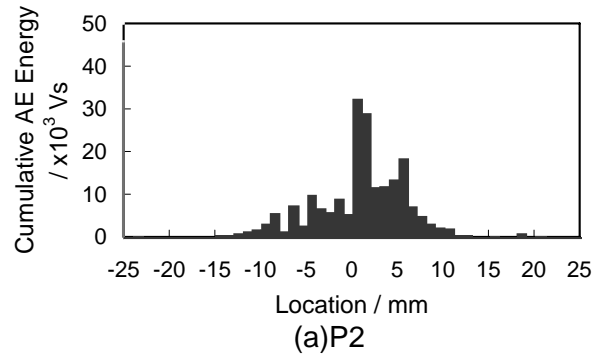
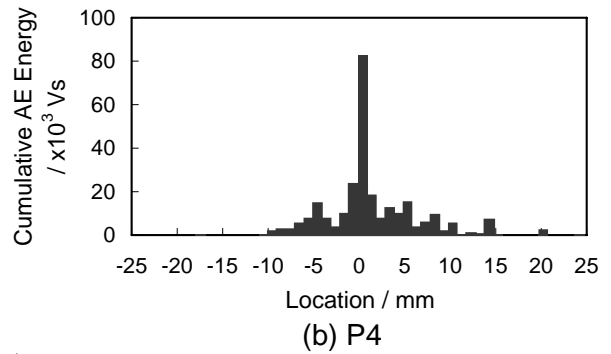
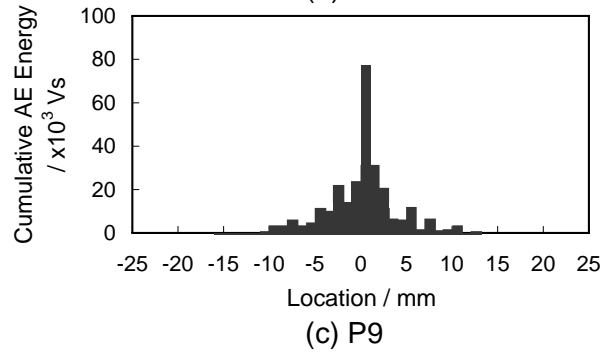
Fig.8. Location of AE events showed by the cumulative AE energy detected during loading up to fracture.

The histogram of Fig. 8 shows the estimated AE locations in the longitudinal (X) direction versus the accumulated AE energy at the AE location during loading up to fracture in P2, P4 and P9. It is seen that most of the AE events are distributed at the center in the gage section regardless of the PIP cycles.

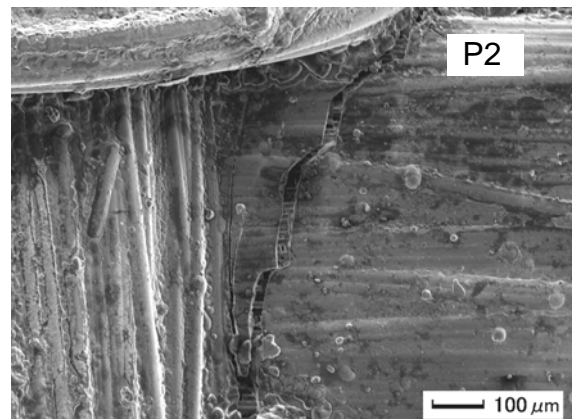
Fig.9. Typical appearance in tension side at the corner which indicates the location defined in Fig.1. The location of the crack shows good agreement with the estimation by the AE measurements.

Figure 9 shows the typical severe macro-damages observed on the tension side. It is seen in the figure that the crack perpendicular to the longitudinal fiber bundle is observed. The severe failure location observed in each specimen nearly coincided to the AE event location at which most of the AE energy was detected.

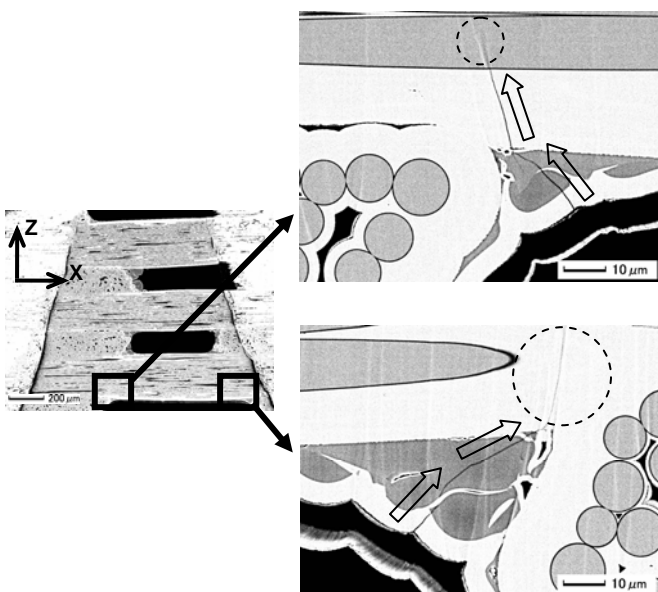
Fig.11. Micrographs of the specimen P2 after unloading from 50MPa showing the corner cracks (Note that the line highlighted by the dotted circle is a trace polished by the argon ion beam).

The observed micro-damages in P2 after loading up to 50MPa ($S_N \approx 0.25$) and unloading are shown in the SEM micrographs in Fig.11. The corner cracks were observed.

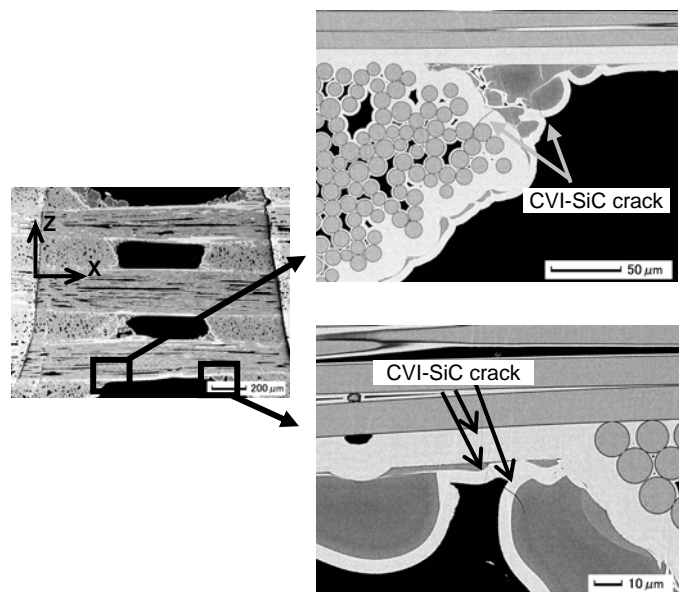
Fig.12. Micrographs of the specimen P2 after unloading from 100MPa showing the corner cracks.

Figure 12 shows the micro-damages in P2 after loading up to 100MPa ($S_N \approx 0.50$) and unloading. The corner cracks were observed in the figure.

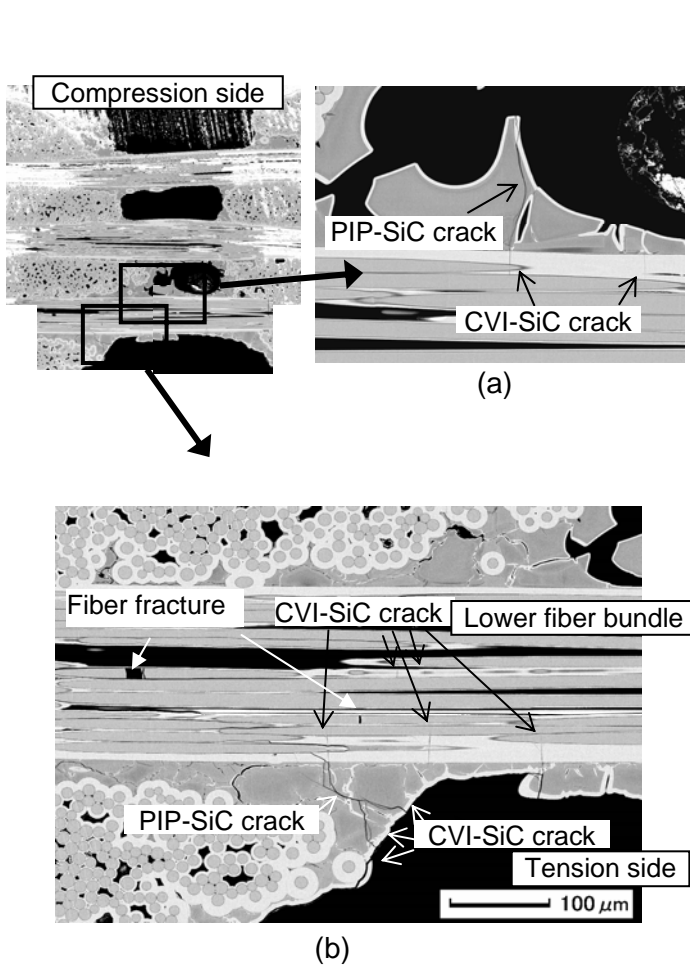
Fig.13. Micrographs of the specimen P4 after the bending fracture showing moderate fracture behavior.

Figure 13 shows the micrographs of the polished cross section of P4. The CVI-SiC cracks in the lower fiber bundle are also observed in Fig.13(a) and (b), however it is apparent that the crack density in the CVI-SiC is smaller than that of P2 shown in Fig.10(c). The corner crack is also observed in Fig.13(b), however the crack opening displacement is small. These observations indicated that the accumulation of the micro-damage in P4 was the most moderate among all specimens.

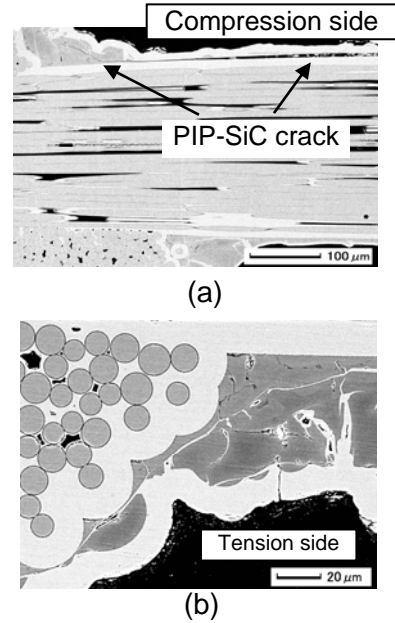
Fig.16. Micrographs of the specimen P9 after unloading from a stress of 50MPa.

The micro-damage after unloading from a stress of 50MPa ($S_N \approx 0.2$) is shown in Fig.16. A crack propagating in the PIP-SiC matrix on the compression side was observed in Fig.16 (a). In the Fig.16(b), the corner crack was observed.

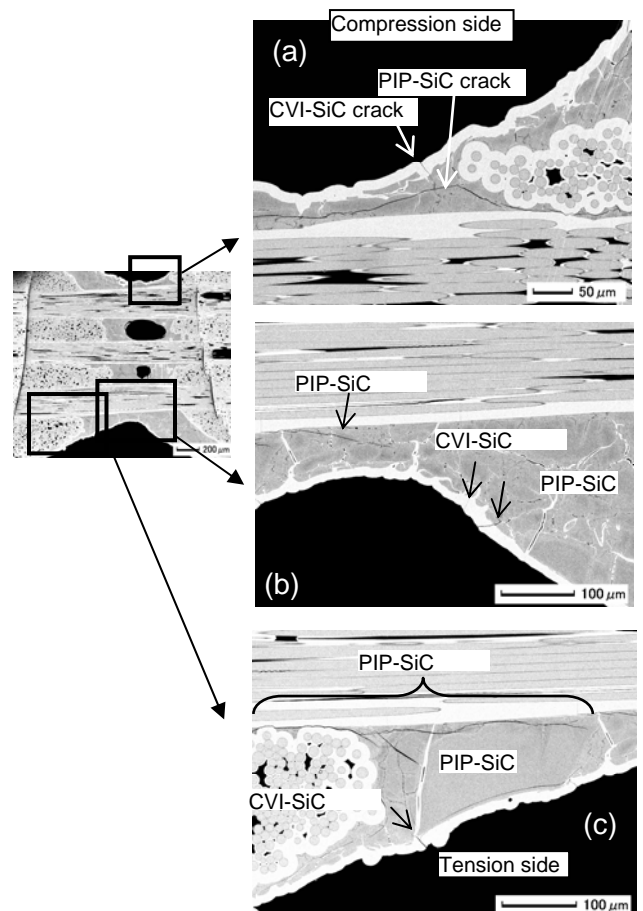
Fig.17. Micrographs of the specimen P9 after unloading from 100MPa

Figure 17 shows the micro-damages observed in P9 after unloading from 100MPa. In the Fig.17(a), the cracks in the PIP- and CVI-SiC matrices were found on the compression side. The corner cracks are observed in Fig.17(b) and (c).
