# REPAIR EFFICIENCY OF RESIN INFUSED SCARF REPAIR TO MARINE SANDWICH STRUCTURES

## SUMMARY

A vacuum-assisted resin infusion technique is used to repair the damaged skin and core of a GRP/Balsa sandwich. Flexural effectiveness of the repair both in tension and compression are evaluated for two repair configurations and repair systems. Prediction analyses were undertaken to study the failure mode and good experimental agreement was found.

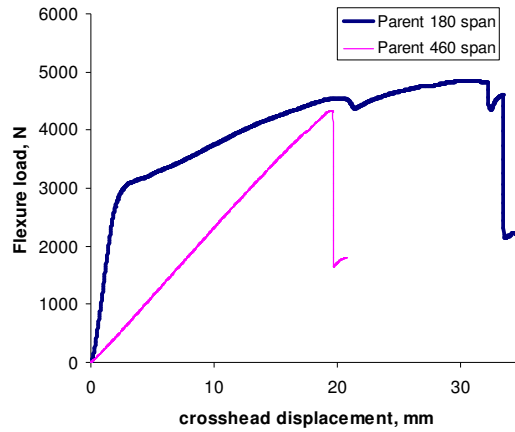
Figure 6: The flexure load vs. cross-head displacement of the undamaged specimen under different span lengths

The flexure behaviour of the undamaged VARI GRP/Balsa sandwich structure was experimentally studied by subjecting the coupons under two different span lengths (180 mm and 460 mm). Four specimens were tested for each span length. The flexure load vs. cross-head displacement of the undamaged specimens for two different span lengths, one each, is shown in figure 6. The coefficient of variation in the slope of load vs. deflection curve for all 180 mm span coupons are 7.01% and for all 460 mm span coupons are 1.1%. The failure load and the failure mode observed in the undamaged coupons are tabulated in Table 1.

It was noted that the failure load of short span coupons is higher than the 460 mm span coupons. There is a large variation in the stiffness of the coupons. The possible reasons for the increase in failure load in short span is to be explored in prediction. All the specimens failed by means of core shear, between inner and outer supports. In short span (180 mm), core shear is slowly followed by upper skin-core debond extending towards either sides, see figure 7 a. In case of larger span (460 mm), it was immediately followed by skin-core debond, figure 7 b.

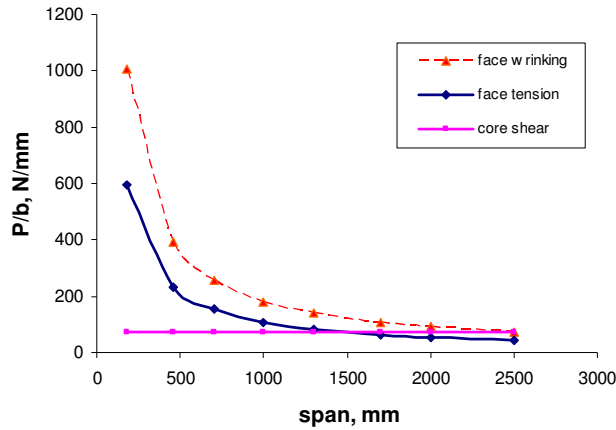
Figure 8: Failure mode for GRP/balsa sandwich under quarter point flexure loading.

The material properties considered for the predictions are provided in table 3 and 4. The failure load/unit width for different failure modes are calculated for GRP/balsa core sandwich using the above equation (2)-(4) and are plotted as a function of span length  $L$ , see figure 8. In GRP/Balsa sandwich structure, face wrinkling occurs at very high load or large span. Before face wrinkling, face yielding occurs. Hence face yielding and core shear are the predominate failure modes for the present geometry balsa sandwich structure. For this system, the sandwich would fail under core shear till it reaches about 1500mm span length. Face yielding then becomes the failure mode after about 1500 mm span length. To calculate critical span, equ (5) was derived from equ (2) and (4)

The calculated critical span for the system used is 1440 mm. This makes our experimental work clear on the core shear failure mode for 180 mm span and 460 mm span in undamaged coupons. For the Balsa core sandwich structure, core thickness has no influence on failure mode and only by changing the face-sheet material system and face thickness, the failure mode can be changed. When the experimental failure load was compared with the theoretical predicted load, it was noticed that the predicted core shear failure load for 460 mm span was 3700 N (calculated from  $P/b = 74$  N/mm in figure 8) and it agrees well with the experimental load of  $3857.33 \pm 414.79$  N. For 180 mm span, predicted failure load was 3700 N, but the experimental failure load was
