# HAIL IMPACT ON COMPOSITE STRUCTURES OF CIVIL AIRCRAFTS

Ye Zhang<sup>1</sup>, Yue Shi<sup>2</sup> and Jifeng Xu<sup>3</sup>

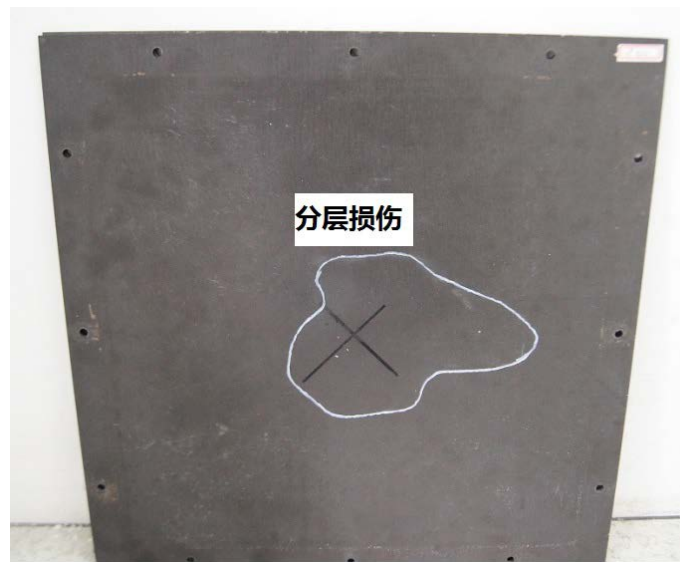
Figure 3: Impact damage in the CFRP laminate caused by high velocity hail impact

In total, six hail impact tests were performed for the composite laminates with different impacting velocities. The collapse failure process of hailstones was captured by the high speed camera as shown in Fig. 2. Based on the NDI results, the experimentally obtained damage patterns and locations are shown in Table 2. The main damage pattern was observed as the composite delamination without any sign of impact dent, which is merely different to the metal structures. The impact damage location was found to be significantly dependent on the impact velocity. For medium velocity hail impact, no obvious delamination of CFRP laminates was noticed in the impacting region. The damage was only found in the clapping areas due to the stress concentration from the bolts fixing the laminate to the support frame. However in high velocity hail impact tests, merely serious delamination occurred in the impacting area and the fiber rupture was found on the back-side surface of laminates. A typical delamination damage in the CFRP laminate resultant from the high velocity hail impact is presented in Fig. 3.

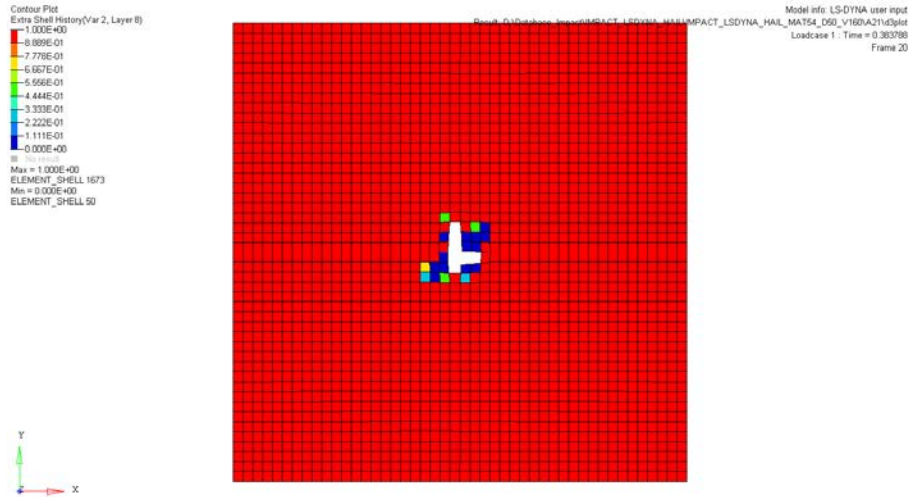
Figure 6: Damage pattern and location of composite laminate in high velocity hail impact

In FE models, the hailstone was modeled using the elastic null material MAT\_009 in LS-DYNA and meshed with SPH particles. The Gruneisen equation was taken as the equation of state (EOS), which defines the phase changes of hailstones from solid into liquid. The composite damage MAT\_054 was used for composite laminate, which was meshed into two-dimensional shell-like elements. An explicit FE analysis has been performed to model the failure process of hailstones and impact damage of composite laminates. The failure process of hailstones obtained from FEA was shown in Fig.5 which was validated by the video captured by high speed camera in experiments. Moreover Fig.6 shows the typical damage pattern and location produced by the high velocity hail impact, and it was noticed being comparable to the damage region obtained from NDI.
