# EVALUATION OF LASER SURFACE IRRADIATION ON THE MODE I FRACTURE TOUGHNESS OF COMPOSITE JOINTS WITH CFRP ADHERENDS

Ran Tao<sup>1</sup>, Marco Alfano<sup>2</sup> and Gilles Lubineau<sup>1</sup>

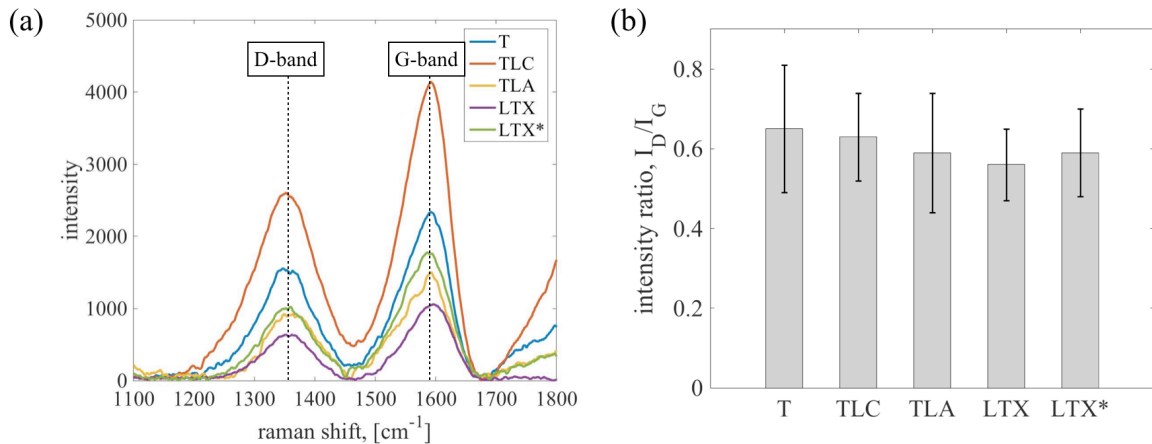
Figure 1: (a) Raman spectra of various surface treatments; (b) intensity ratio between D-band and G-band of carbon materials.

As previously described, Raman spectra were determined and are reported in Figure 1(a). However, direct comparison of intensity values can be affected by Raman measurement errors, *e.g.* laser beam focus, intensity fluctuations, the orientation of the sample relative to the laser beam. Therefore, intensity ratios  $I_D/I_G$  were calculated to identify the crystalline order of carbon materials and are reported in Figure 1(b).

Since no significant differences were observed in the intensity ratio  $I_D/I_G$ , it is inferred that all treated surfaces feature the same chemical structure of carbon materials, indicating the absence of significant variation in the amount of structural defects in carbon fibers.

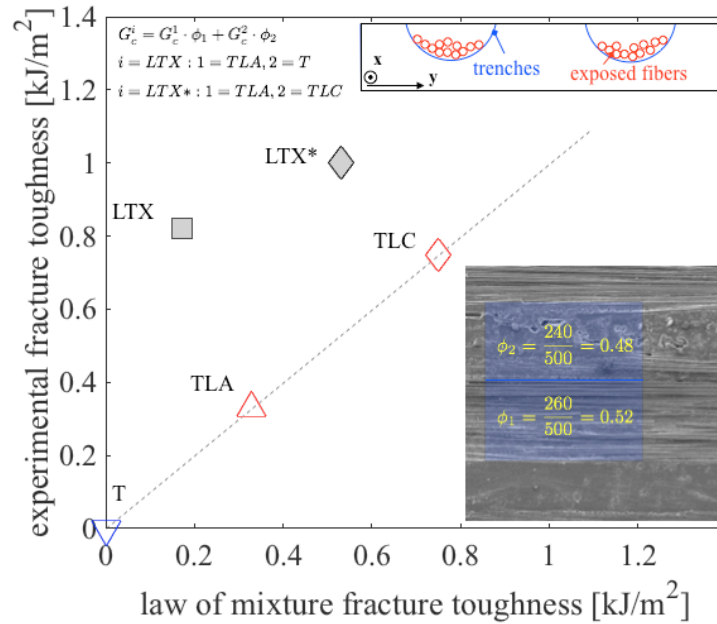
Figure 6: Fracture toughness of patterned treatments compared with the toughness calculated from the law of mixture.

Finally, Figure 6 reports the obtained values of fracture toughness as a function of fracture toughness  $G_{Ic}$  calculated using the law of mixture,

where  $G_{Ic}^1$  and  $G_{Ic}^2$  are the fracture toughness of two treatments, respectively,  $\varphi_1$  and  $\varphi_2$  are corresponding area fraction. A representative square is extracted and shown as the blue region in Figure 6. Since trenches develop along the x-direction, the width ratio of different treatment regions gives the area fraction. Considering that the pattern spacing is 500  $\mu\text{m}$ , 260  $\mu\text{m}$  width of trenches indicates an area fraction 52%.

Both patterned and uniform treatments are plotted in Figure 6. Uniform treatments T, TLC and TLA all locate on the dashed line, representing same experimental toughness as calculated toughness using the law of mixture. However, patterned treatments LTX and LTX\* deviate from the prediction of the law of mixture. The enhancement of fracture toughness on LTX and LTX\* surfaces should mainly come from the increased bonded area compared to the “flat” case, as the schematic shown in Figure 6. Furthermore, energy dissipation during fracture can be also elevated by promoted mechanical interlocking due to curved surface profile and the induced bridging effects associated to exposed carbon fibers.
