STUDY OF DAMAGE CHARACTERISTICS IN COMPOSITE STRUCTURES FROM SIMULATED LIGHTNING STRIKES

Keywords: Lightning strike, Composite structure, Direct effect, Joule heating, Shock waves.

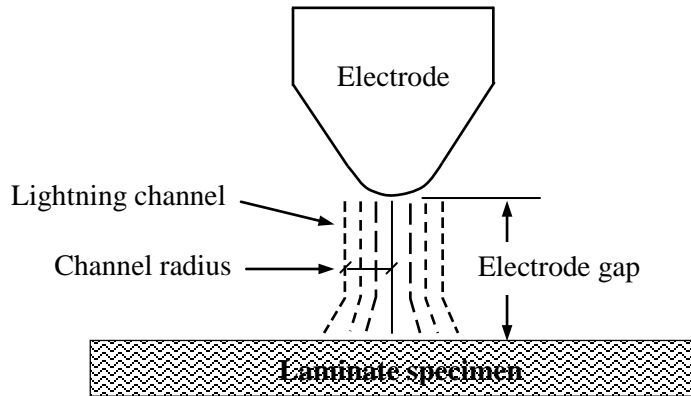
Fig. 1 Illustration of a lightning channel for direct effects on composite structure

In the simulated lightning strike for direct effects, electric current from a pulse generator was injected onto the surface of the composite specimen with an electric charge being transferred to its surface. A solid electrode was preferred (rather than a solid ball or a flexible wire) and hence could not only be positioned vertically to the specimen surface but also be controlled from a selected electrode gap between the tip of the electrode and the specimen surface. This was particularly desirable in considering that a wide range of the damage sizes was expected in a group of specimens so that the effects of the damage on their residual compressive performance could subsequently be evaluated. In this way, a lightning channel formed during a travelling of the electric charge to the specimen surface could be of cylindrical shape with a slight radially outward widening towards the surface of the specimen, as illustrated in Fig. 1. Consequently, the area of the lightning channel on the specimen surface covered by the electric arc could be approximated by the arc root radius of the lightning channel, though the arc root radius could expand outwardly during the lightning strike due not only to the mechanics of the lightning strike but also to carbon fibres being conductive. Unlike a ball tip, the solid conical rod also induced shock waves and ensured that the short discharged arc did not split or disperse at the root of attachment location so that the maximum deposition of the electric energy or current density on the specimen was achieved.

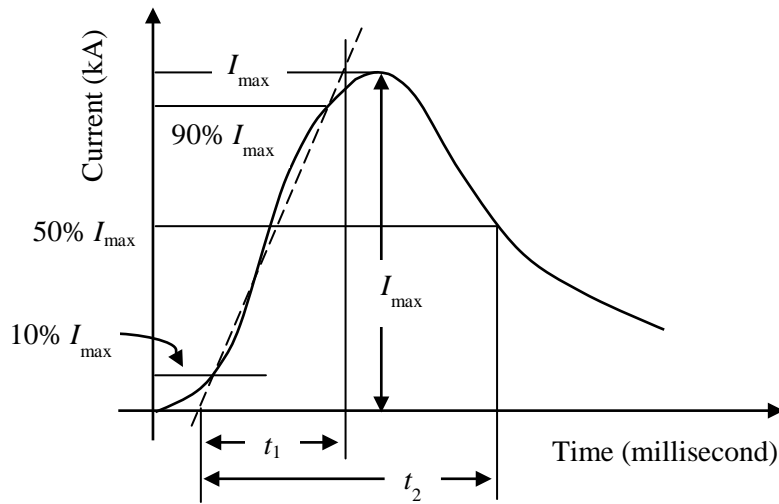
Fig. 2 Typical waveform of high current lightning strike with characteristic times

where I_0 , a and b are constants and t the lightning strike duration. These constants can be determined with the availability of a measured waveform with front time t_1 , half value tail time t_2 and peak current I_{\max} , as illustrated in Fig. 2. Once available, current at any time of the lightning strike can be obtained. In particular, action integral (AI), the most important parameter of representing the strength of the lightning strike input for direct effects can be calculated by

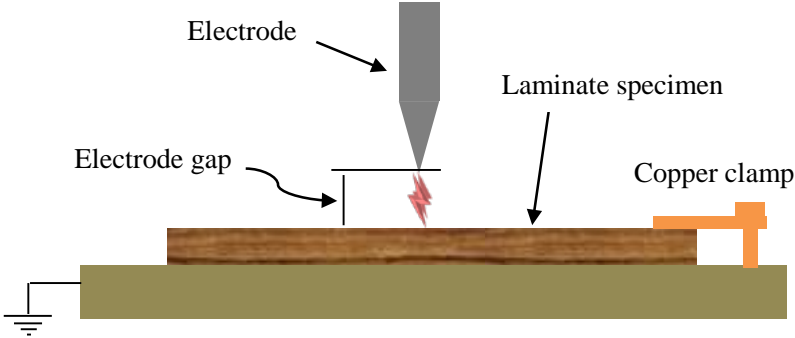
Fig. 3 A simulated lightning strike test set-up

procedures. Both were of 150 mm by 100 mm. An experimental lightning strike set-up shown in Fig. 3 was intended to deliver electrical currents of short duration and relatively high magnitudes. In a test, a 10 mm diameter copper rod with a conical tip of 30° apex angle and with about 2 mm tip diameter was pointed vertically to the centre of a specimen with an electrode gap of no more than 24 mm. A lightning strike was a single current discharge accompanied always by an audible sound of explosion. For the carbon/epoxy specimens, burning flames of carbon fibres were always visible along with a smell of burned resin. Electrical currents of 3 to 91 kA were generated using an impulse generator configured with 8/20 waveform, with the lightning strike durations of no more than 30 milliseconds (ms). A varying degree of damage was induced in each of two groups of the unpainted unprotected composite specimens. A copper earth braid strip drew electrical current from the attachment location to ground, if the current did not attach to the laminate. All the lightning strike test results are summarised in Table 1.

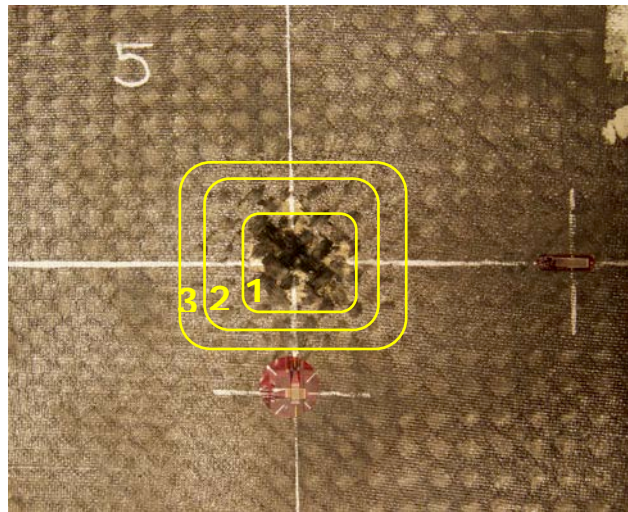
Fig. 4 Carbon/epoxy specimen struck by lightning current of 61kA

Carbon fibres in the carbon/epoxy specimens are conductive, whereas E-glass/epoxy specimens are completely insulative. Thus, their damage characteristics under the lightning strikes are very different. The intense visual inspections of the struck carbon/epoxy specimens reveal that fibre tufting, resin sublimation and resin discolouring are three major damage mechanisms, irrespective of magnitude of lightning current. These damage characteristics appear in three concentric approximately rectangular regions, as an example shows in Fig. 4. The central region 1 is dominated by fibre tufting, as can be

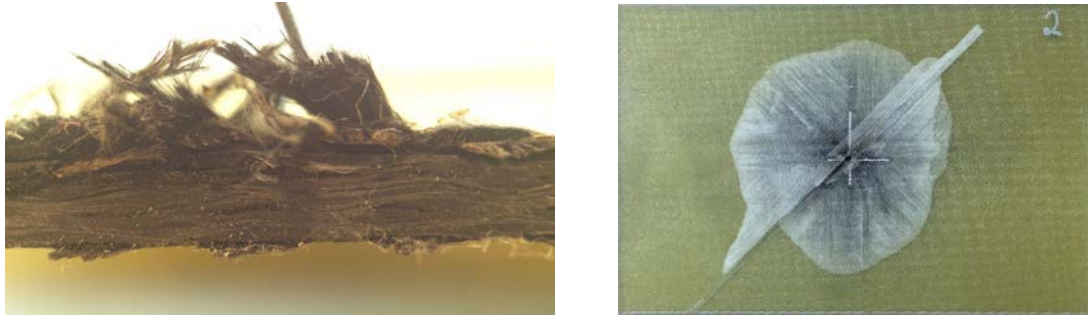
Fig. 5 (a) Carbon/epoxy struck by a 90kA current and (b) E-glass/epoxy struck by a 10kA current

seen from a separate cut-up specimen in Fig. 5(a), except for the specimens being struck with the lower end of the lightning currents (C3-1 and C3-2). The fibre tows of the top ply in those two specimens were exposed due to resin sublimation but were bridging over a shallow cavity without tufting or breaking. The middle annular region is represented by the isolated exposed cross-over segments of fibre tows due to resin sublimation, as a spreading lightning arc swept through the immediate vicinity of the lightning channel at the very high temperature. The outer annular region includes just the area of discoloured resin, which could be scorched by the front of the out-sweeping lightning arc at the much lower temperature. The reason that these annular regions appear in the shape of squares is because the conductive carbon fibre tows in the top surface ply are in 45° angle directions so that they carried the thermal energy in those directions. A cut-up of a separate specimen (C3-3) shows a limited delamination and the penetration of the lightning strike reached only the third ply out of the total of eight, as resin is non-conductive. This seems plausible, as all the specimens were placed on a rigid table without a chance of bending during the lightning strikes and the limited delamination may very well be associated with fibre tufting. Therefore, the estimations of the damage areas in each of these specimens cover the entire area within the region 3. The surface damage obtained via visual inspections could be either close to or greater than C-scanned projected interior area [6]. Moreover, experiences in [1] suggested that the surface damage agreed well with AIs, as C-scanning is not able to pick up resin pyrolysis. Thus, the areas in the carbon/epoxy specimens as given Table 1 are based on the largest damaged surface areas.

For the insulative E-glass/epoxy specimens, preliminary trials with the lightning current up to 70 kA did not inflict any damage, as that was because the levels of the transferred charges may not have been higher enough to overcome the dielectric breakdown strength of this material [1,7]. Thus a tiny pilot through hole of 0.5 mm diameter was drilled at the centre of all the specimens to overcome the dielectric barrier of the material. The major damage mechanism was found to be extensive delamination as an example in Fig. 5(b) shows. At the lower end of the lightning current range at 2.54 kA, there was almost no damage visible in specimen G2-3, whereas at the upper end of the lightning current range at 29.82 kA, there was some fibre tufting at the centre of the specimen. Soot is clearly visible through the delaminated interfaces but there was neither sign of resin discolouring nor smell of burned resin, interestingly. Although temperature in the lightning channel could rise up to 1000°C , as reported [1], there is little visual evidence of Joule heating or resin pyrolysis in this E-glass/epoxy material. Since the E-glass/epoxy specimens were translucent, as could be seen in Fig. 5(b), this nature facilitates significantly not only the examination of damage mechanisms but also the estimations of the delamination areas.

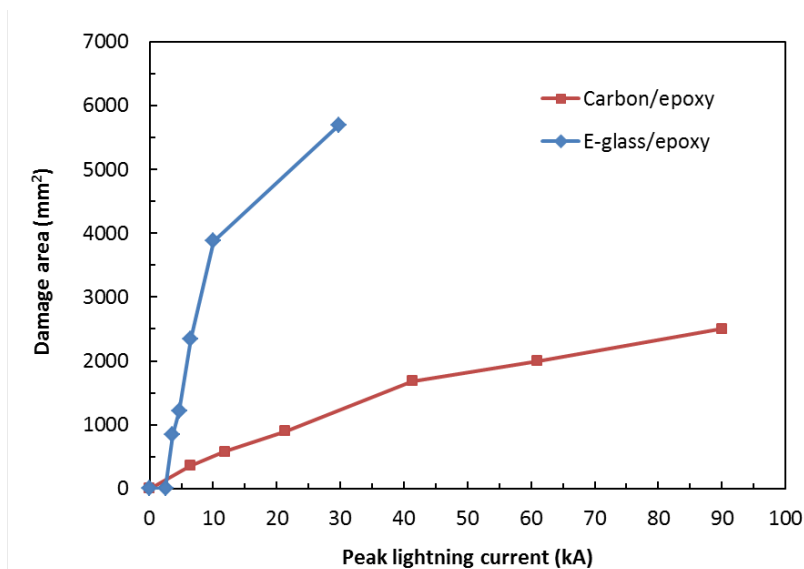
Fig. 6 Relationship between lightning current and damage area for laminates

When an electric energy of the lightning current was deposited on the surface of each carbon/epoxy specimen, local temperature within the lightning channel must have arisen to an extremely high level due to its finite conductivities in the in-plane directions. Since the direction of the lightning strike was in the insulative thickness direction, the attached lightning arc hence sublimated the surface resin in its path. Then the heat flow was obstructed by the exposed but firmly in-position carbon fibre tows. By this time, part of the heat flow or the thermal energy was diverted to the electrically-connected in-plane fibre directions where the resistance of the dissipations was significantly less, the remaining of the diffused heat flow for the given thermal energy had the significantly limited capacity to further sublimate the next resin layer between the top ply and the next ply down. Within a duration of less than 30 ms, a significantly higher level of lightning current or AI was needed for resin of the second ply to be sublimated. This understanding is in agreement not only with the qualitative surface inspection results in Table 1 but also with the trend of the damage area results in Fig. 6. The trends of the damage areas with the increase in AI were similar, as shown in [3].

Fig. 6 shows the parabolic variations of damage areas with the increase in peak current, which seems to decay towards the upper end of the lightning current range. Nevertheless, the very different trends from the different composite laminates had the different damage mechanisms. For the carbon/epoxy specimens, this trend seems to suggest that the thermal energies converted from the electrical energies had not been consumed just within the lightning channel. Instead, the areas covered by all three regions in Fig. 4 seem to be about three times of the lightning channel. Although the local temperatures in the lightning channel may well have been around 1000°C , the duration of such high temperatures could be extremely short so that resin sublimation was largely confined within the lightning channel. For the E-glass/epoxy specimens, the decaying parabolic trend indicates that the most of the electrical energies had gone into a generation of delaminations and their enlargements.

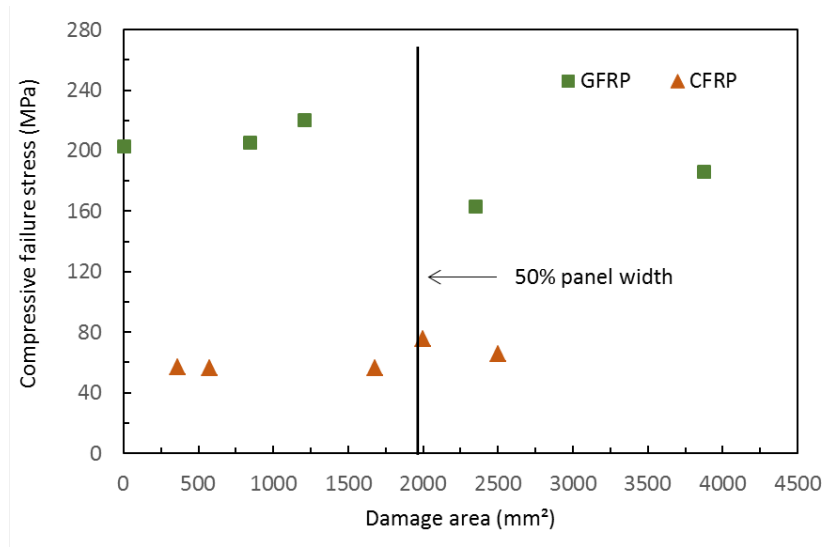
Fig. 7 In-plane compression test results of lightning struck carbon/epoxy and E-glass/epoxy panels

To ultimately develop an in-depth understanding for the nature of the damage in the lightning struck composite specimens, the lightning strike damaged panels were further tested for their residual in-plane compressive strengths. The methodology follows that used for the residual in-plane compressive strengths of impact-damaged composite panels. The overall test results for compressive failure stresses are presented in Fig. 7 against damage areas. In the diagram, the term of compressive stress was used, rather than residual compressive strength, is because all the panels but one (G2-1) failed prematurely close to one of the loaded ends, as shown in Fig. 8. For the carbon/epoxy panels, this finding strongly suggests that the lightning damage was relatively shallow close to the surface of these panels and the respective extents of fibre tufting and delamination are relatively small. This is in agreement with the earlier examinations. If the depth of the damage were deeper than two plies, the panels could have failed in the mid-section region, when the extent of those two panels in the width direction is greater than 50%. This is because such damage with a presumed severity ought to be sufficient to instigate a further propagation in the width direction under in-plane compressive loads, thereby triggering a catastrophic failure of the panels. For the E-glass/epoxy panels, the panels with the delamination extent of 40 mm or greater were again expected to fail around the mid-section region, whereas the two least damaged panels were expected to fail close to the panel ends. However, the only one (G2-1) out

of the three most damaged panels failed in the mid-section region and the other two (G2-4 and G2-5) did not, which is surprising.

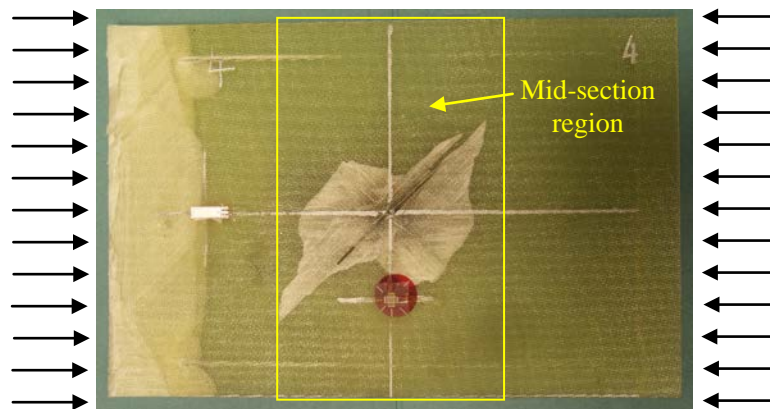
Fig. 8 An end failure of lightning struck E-glass/epoxy specimen G2-4 after in-plane compression test
