CHARACTERIZATION OF THE DAMAGE BEHAVIOR OF RECYCLED CARBON FIBER WITH X-RAY AND ACOUSTIC EMISSION TECHNIQUES

Christian Becker^{1*}, Nicole Motsch-Eichmann¹, Joachim Hausmann¹

¹: Leibniz-Institut für Verbundwerkstoffe GmbH, Kaiserslautern, Germany

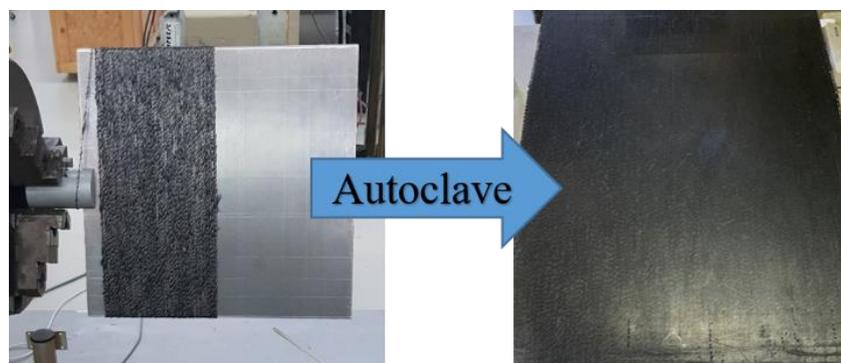
Figure 1: Plate winding process and final unidirectional rCF plates after autoclave cycle

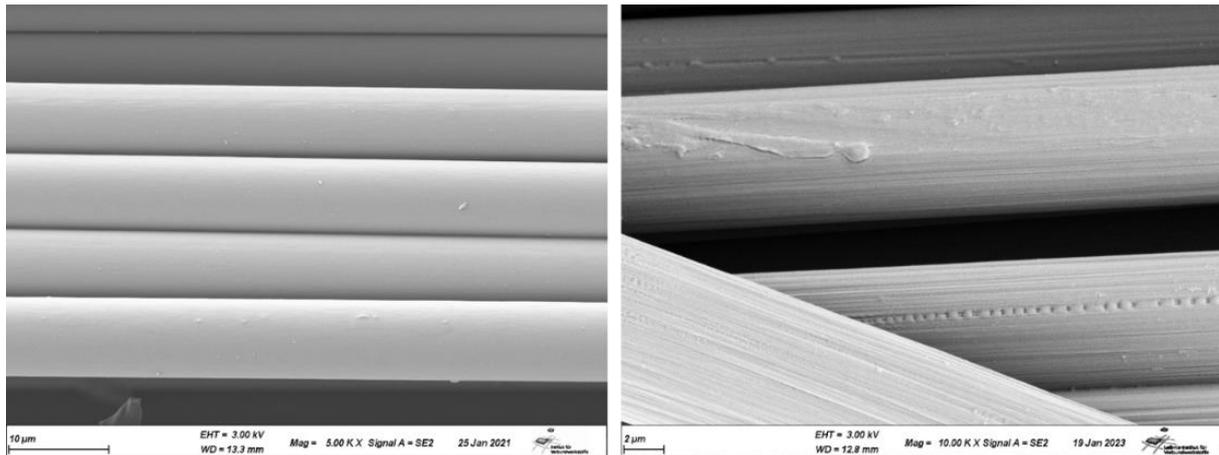
Figure 2: SEM images of the dry rCF fibers of the same charge with no visible adhesions (left) and visible unknown grooves plus film (right)

Before the plates were wound, first scanning electromicroscopic images of the untreated rCF staple fibres were taken (Figure 2). Here it can be seen that there is no pure smooth carbon fiber but a light film on the fibre. This could be remnants from the original fibre sizing that were not completely dissolved in the pyrolysis process. In some cases, coarser particle adhesions can also be seen, which can also lead to a reduced adhesion of the new matrix to the fibres.

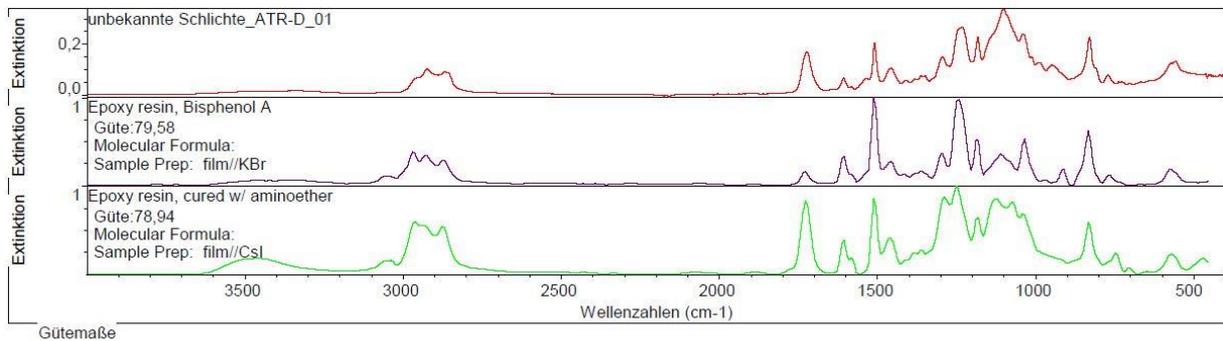
Figure 3: FTIR analysis of sizing on rCF fibers.

FTIR (Fourier Transform Infrared Spectroscopy) measurements are carried out to gain a more precise insight into which adhesions or sizing residues are present on the fiber. For this purpose, the rCF fibers were soaked in acetone for 24 hours to dissolve the sizing. By filtering and evaporating the solution, it could be separated and subsequently characterized. The results can be seen in Figure 3. The upper curve shows the analysis (interferogram) of the unknown sizing. The lower two curves show the two highest matches to the database (Table Figure 3).

The analysis gives an 80 percent match with a bisphenol A-based epoxy system. The exact sizing cannot be determined by the analysis, but a better suitability for epoxy resin systems can be assumed. In addition, it can be surmised that the rCF fibers used are from production residues and not from pyrolysis.

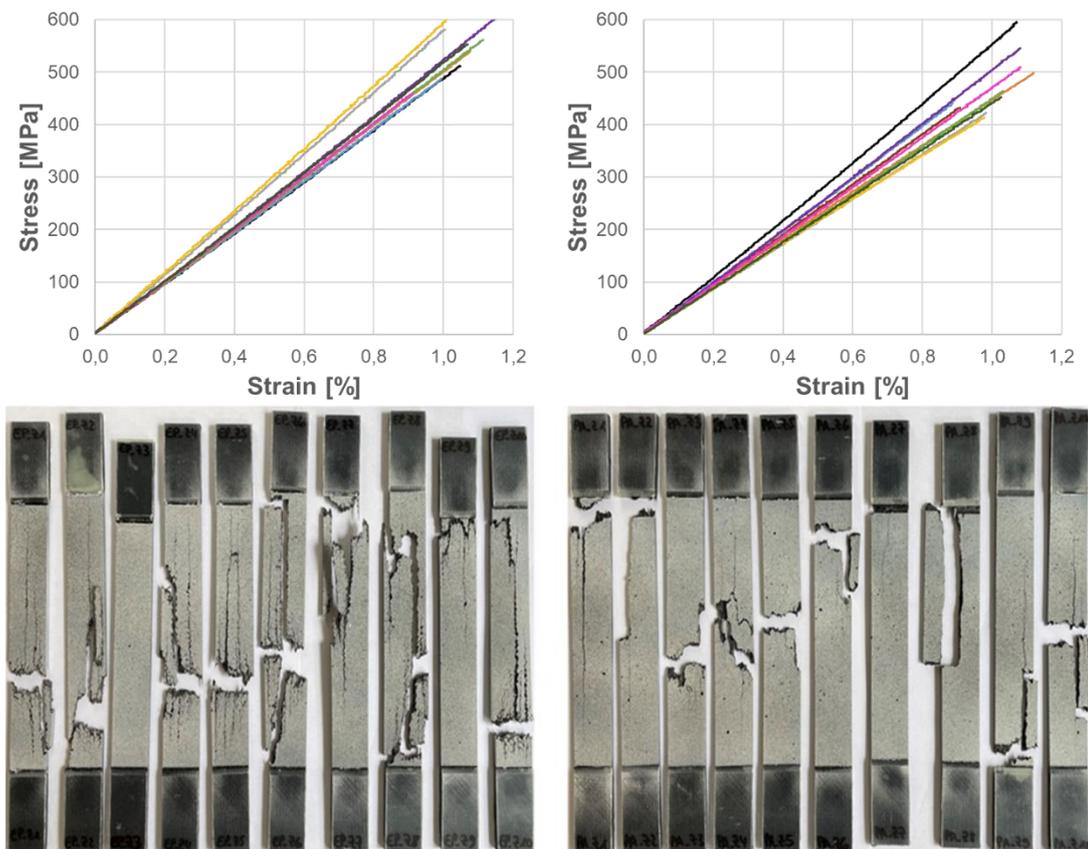
Figure 4: Stress-strain diagrams and correspondent failed samples of EP-rCF (left) and PA6-rCF (right)

The results of the tensile tests are shown in the Figure 4 and Table 1. It can be seen that at the same elongation at break, the EP specimens with a modulus of elasticity of approx. 50,000 MPa and a strength of 550 MPa have about 10 % higher characteristic values than the PA6 specimens. The fracture patterns of the specimens are also similar, whereby the PA6 specimens break completely less frequently and the fracture surfaces are bridged by fiber strands (see Figure 4).

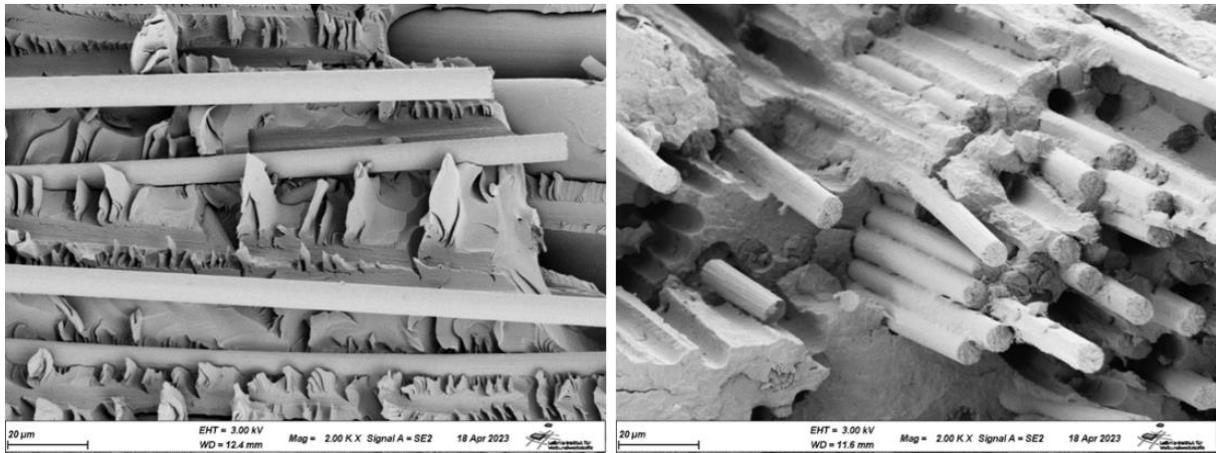
Figure 5: SEM images of fracture surface of EP-rCF (left) and PA6-rCF (right)

However, looking at the SEM images of the fracture surfaces, it can be seen that the fiber-matrix adhesion between rCF fiber and the PA6 matrix has better properties than to the EP matrix. In Figure 5, it can be seen that fiber pull-out forms channels in both matrix systems. This indicates a less than optimal adhesion for both. However, in comparison, it can be seen in the left picture that clearly larger fiber pieces are free, on which no matrix residues can be seen. This speaks for a pure fiber pull-out behavior. In the right picture, on the other hand, clearly shorter fiber ends protrude from the material, which still show matrix residues in some places. The visible fiber channels could be signs of fiber breaks where the end was pulled out of the matrix. However, as with the EP samples, this could also indicate pure fiber extraction. This must be proven by further investigations.

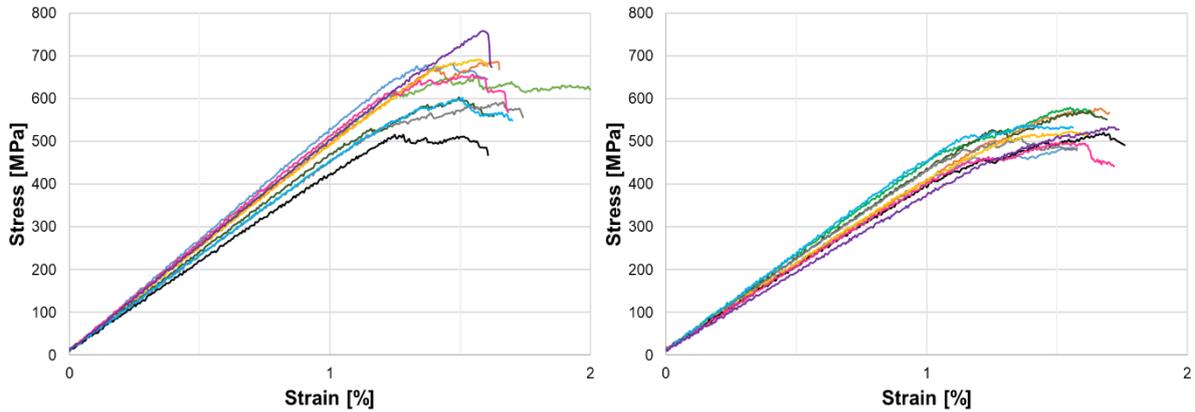
Figure 6: Stress-strain diagrams of the bending tests for EP-rCF (left) and PA6-rCF (right)

The results of the bending test are shown in Figure 6 and Table 2

Here, too, the picture is similar to that of the tensile tests. The EP specimens have a higher strength and a higher bending stiffness at a similar elongation. The fracture pattern looks similar for both variants. No delaminations are visible, but mainly failure in compression (top side) and tension (bottom side) and the associated crack growth under 45° through the specimen.

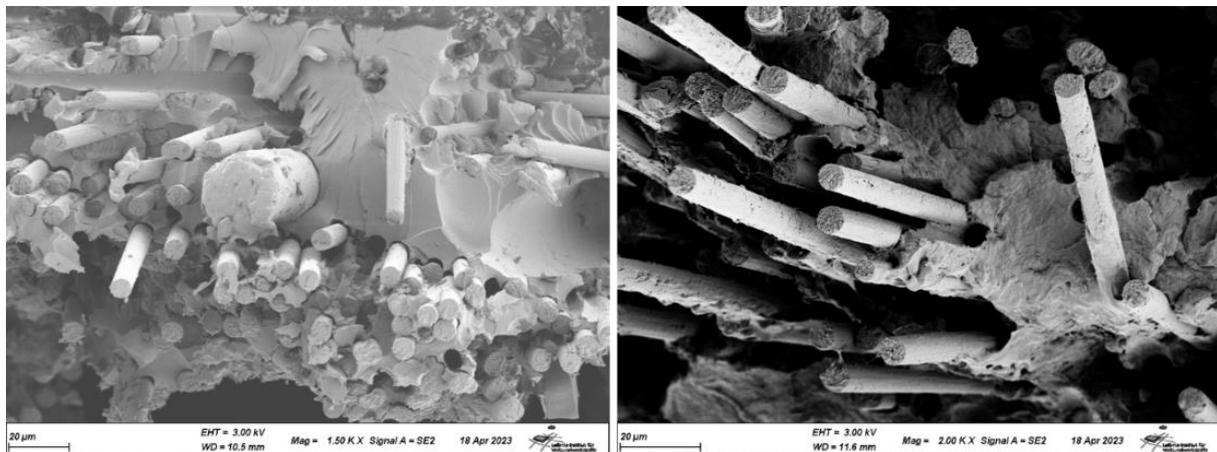
Figure 7: SEM images of the fracture surface of the EP (left) and PA6 (right) bending samples

If we now look at the SEM images of the fracture surfaces in Figure 7, we see nearly the same picture as for the tensile tests. Pull-out channels are visible in both. The EP sample on the left shows clear detachments between fiber and matrix, but hardly any matrix adhesion to the exposed fibers. In the PA6 samples on the right, however, clear matrix adhesions can be seen despite the presence of pull-out channels, which indicates better bonding behavior. Once again,

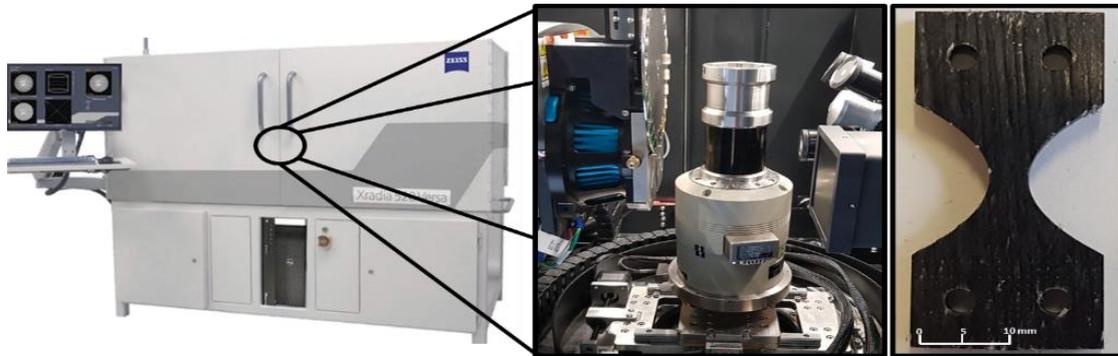
Figure 8 X-Ray Microscope Zeiss Xradia 520 Versa with in-situ module Deben CT 5000 and used sample geometry (right)

The test set-up for the in-situ transverse tensile tests is shown in Figure 8 together with the specimen geometry used. The test series were carried out as a load increase test. After reaching a defined load level, the tensile test was stopped, the specimen was relaxed (to avoid undesired movement artefacts in the CT scan) and then a 360° scan was performed. This was carried out until the specimen failed.

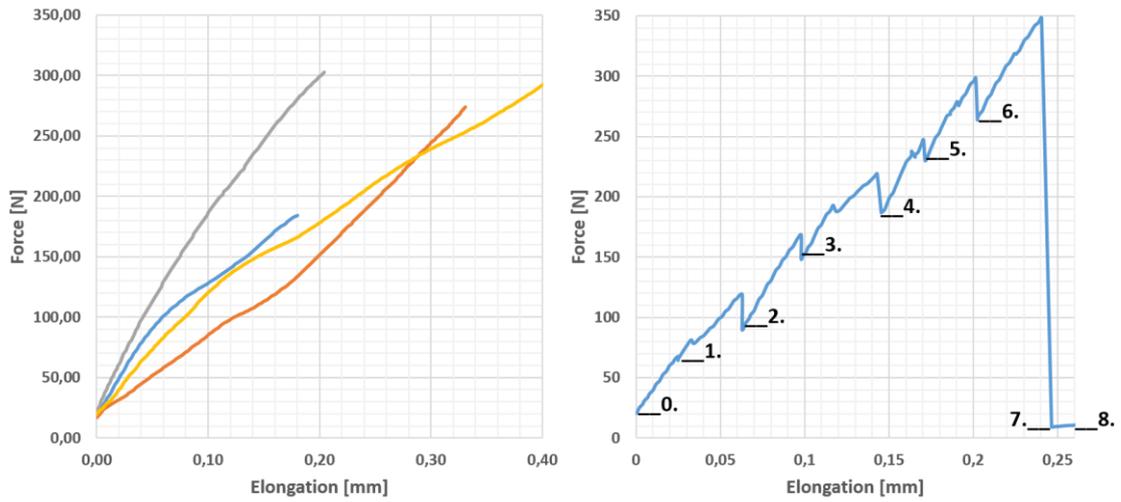
Figure 9: Force-elongation diagram from the pre-tests of the rCF-in situ samples EP-rCF normal to the fiber orientation. (left) and diagram during in-situ experiment with load levels; relaxation of sample visible (right)

In order to get a first impression of the failure behavior of the specimens, preliminary tests were carried out to determine the load levels for the test. These are shown in Figure 9 on the left. Figure 9 on the right shows the force-displacement curve of the load increase test. It can be seen that the breaking force of 350 N is approx. 40 % higher than the mean value (around 250 N) of the preliminary tests (16 % higher than the maximum value (300 N)). This is due to relaxation effects in the material. Keeping the sample at a constant strain level for a long time causes the sample to relieve internal stresses. This leads to an increase in the maximum load that can be sustained. These effects lead to stronger alignment of fibers in the direction of the load, resulting in stiffening of the material. This is confirmed by the decrease in elongation at break from 0.3 mm on average to 0.25 mm.

1. 20 N pre-load
2. 70 N, relaxation to 65 N
3. 120 N; relaxation to 90 N
4. 170 N; relaxation to 145 N
5. 220 N; relaxation to 180 N
6. 250 N; relaxation to 230 N
7. 300 N; relaxation to 270 N
8. 350 N; failure
9. 20 N; crack opening

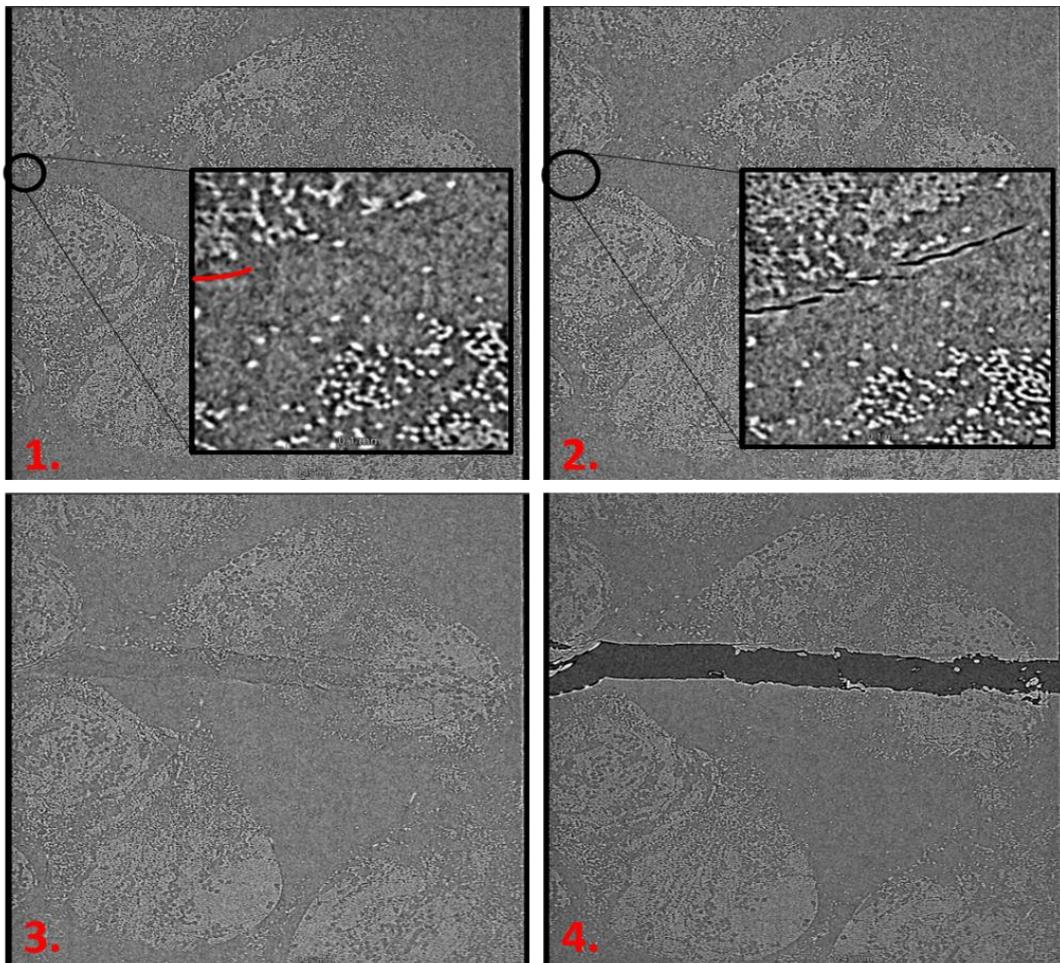
Figure 10: Volume rendering images of in situ tensile test of EP-rCF: 1) 250 N; small crack (red line) at the edge of sample. 2) 300 N: crack propagation between the fibers. 3) 350 N: failure of the sample. 4) Crack opening of 0.1 mm

Figure 10 shows exemplary sectional views of load levels 5 to 8, illustrating crack initiation, crack growth and post-failure.

In Figure 10. 1, a slight crack is visible (marked in red for better visualization). The crack initiation starts within a roving that is slightly above the narrowest part of the specimen (normally the maximum stress under tensile load is in the narrowest part of the tailored specimen). When the load is increased to 300 N, the crack continues to expand through the roving (Figure 10 2). In Figure 10 3 at 350 N, the complete failure of the specimen takes place. It can be seen that the crack that penetrates the entire specimen is not identical to the crack seen in the previous load levels. This suggests that micro-cracks are already present in the previous load levels, which were not visible in the CT scan, but lead to failure due to the stress maximum at the narrowest point. Figure 10 4 shows the post-failure, where the crack has widened by 0.1 mm. It can be seen that individual fiber strands bridge the crack and thus maintain the structural cohesion of the specimen ("fiber bridging"). No more load is applied to the specimen (constant load at 20 N) and only fiber pull-out from the interconnected fracture surfaces takes place. This behavior can also be verified by SEM images of the failed specimens from the quasi-static mechanical tests, where fiber bridging also occurred (cf. fiber channels visible).

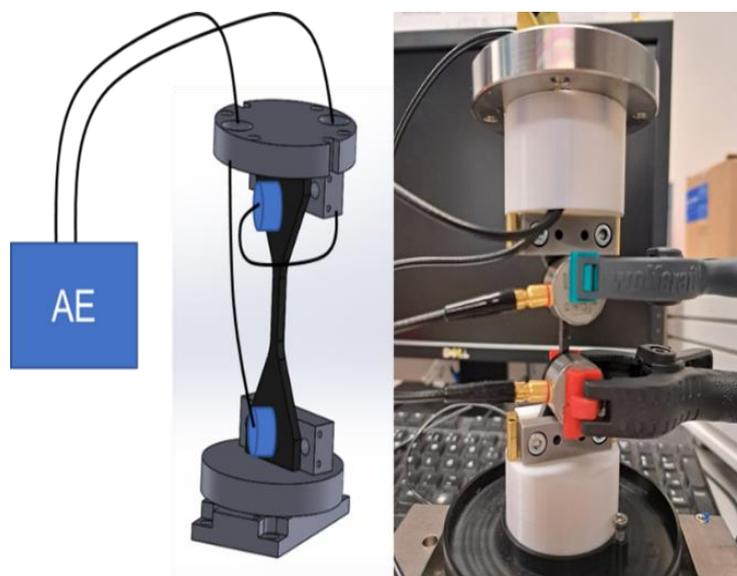
Figure 11: Integration of AE sensors into In-situ Deben CT 5000: Construction drawing (left) and final setup (right)

In order to integrate the sensors of the AE apparatus into the Deben CT 5000 in-situ module, new clamps must first be developed that allow the sensors to be guided through the closed construction into the interior. The clamps were designed in such a way that a new sample geometry developed in [7] can be used. The structure including the specimen can be seen in Figure 11.

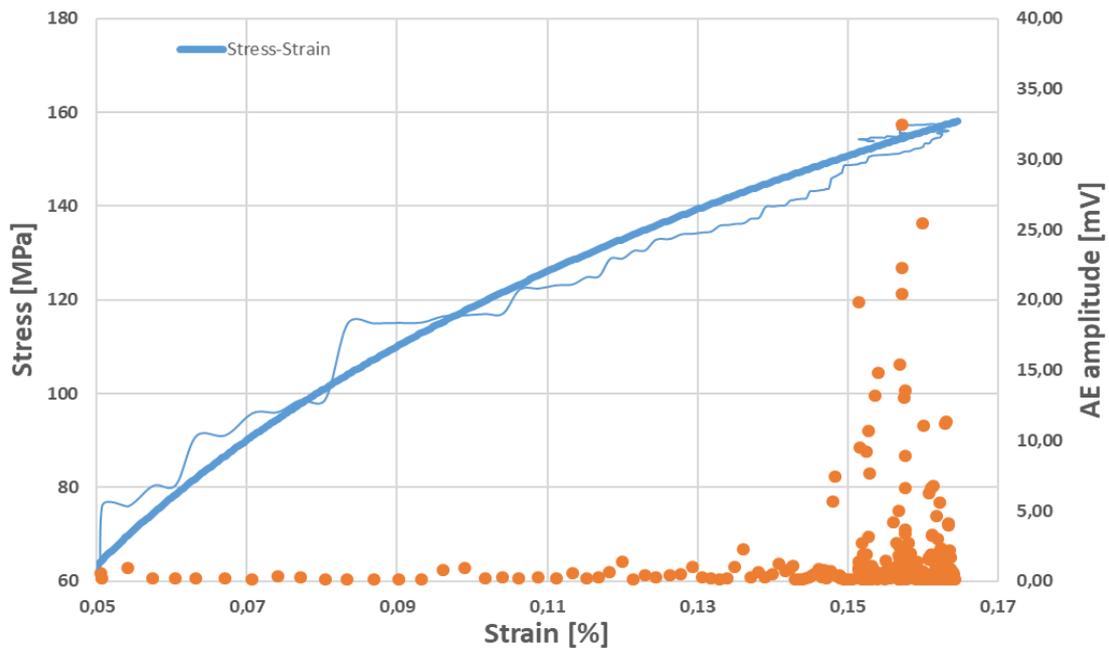
Figure 12: Example of stress-strain diagram of Bio- rCF sample with AE signal distribution

First AE tests (no in-situ tests) on the rCF test specimens showed that the general setup works. The sensor positioning is sufficient to get a large scan field of the sample. Also the sensor position delivers conclusive signals. The results of one Bio-rCF sample with the new test setup and sample geometry is shown in Figure 12.

The typical stress-strain curve for the rCF material (blue line) is shown. The orange dots represent the recorded AE events, which provide clues to events in the material. Here it can be seen that up to an elongation of 0.13 % no conspicuous signals were recorded. From there on, not only does the number of recorded events increase (increase in point density), but there is also a clear increase in the amplitude of the signals, especially from 0.15 % strain. This increase correlates with the onset of damage and ultimately the failure of the specimen at 0.17 % strain in the tensile test. This in turn means that the acoustic signals have detected initial damage in the material.
