## INTRODUCTION

The F50 catamaran is a two-hulled sailing yacht used for the Sail GP international sailing competition. These high-performance yachts use hydrofoils to lift the main hulls out of the water to reduce drag. Two types of hydrofoils are used, C/L shaped forward retractable dagger foils and inverted T shaped rear rudders. The C/L-shaped foils have a vertical hydrofoil section to generate horizontal forces and a single horizontal hydrofoil on the bottom to generate vertical lift. The dagger foils provide the majority of the hydrodynamic lift and hence are a critical load bearing structure. These are manufactured from autoclave cured prepregged carbon fibre reinforced epoxy composite laminates and are typically many tens of mm thick.

The aims of the project were to understand the structural behaviour and failure mechanics of thick, curved composite structures under an 'opening' load scenario and evaluate the capabilities of non-destructive inspection techniques and diagnostic methods such as Acoustic Emission (AE) monitoring to identify manufacturing defects and characterise in-service damage initiation and propagation.

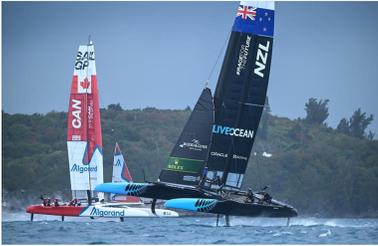
FIGURE 1. SAIL GP F50 SAILING CATAMARAN
