# EFFECT OF CHEMICAL TREATMENT AND STORAGE ON GLASS FIBER QUALITY

Asifa Awan¤, Rudi P. Nielsen, Morten E. Simonsen Aalborg University, Department of Chemistry and Bioscience, Esbjerg, Denmark. aaw@bio.aau.dk

#### International Conference on Composite Materials 2023 (ICCM23), Belfast

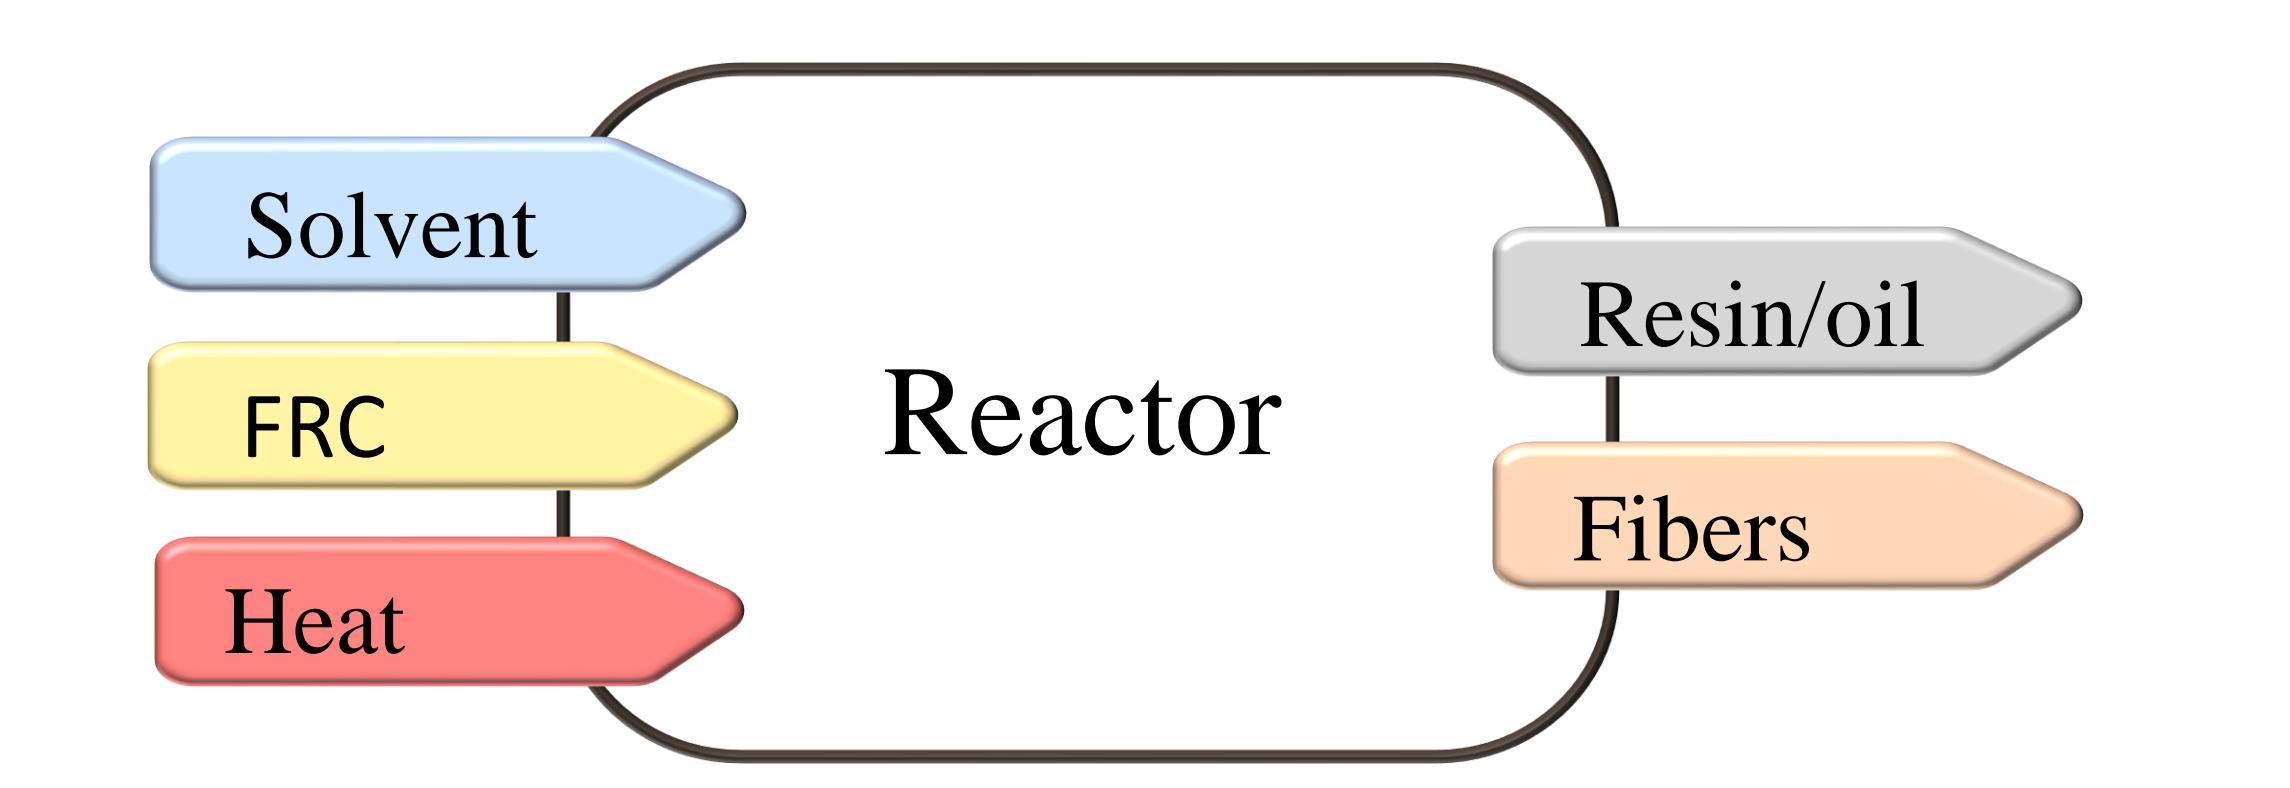
#### Flow diagram of solvolysis

- Wind energy, one of the biggest sources of renewable energy production, can have environmental impact following End-of-Life issues of glass fibre composite waste of wind turbine blades.
- **Recovering glass fibres** from blades through **solvolysis** with **organic solvents** (e.g. alcohols and acetones)
- Solvolysis of the samples were performed in sealed **high-pressure vessels**.

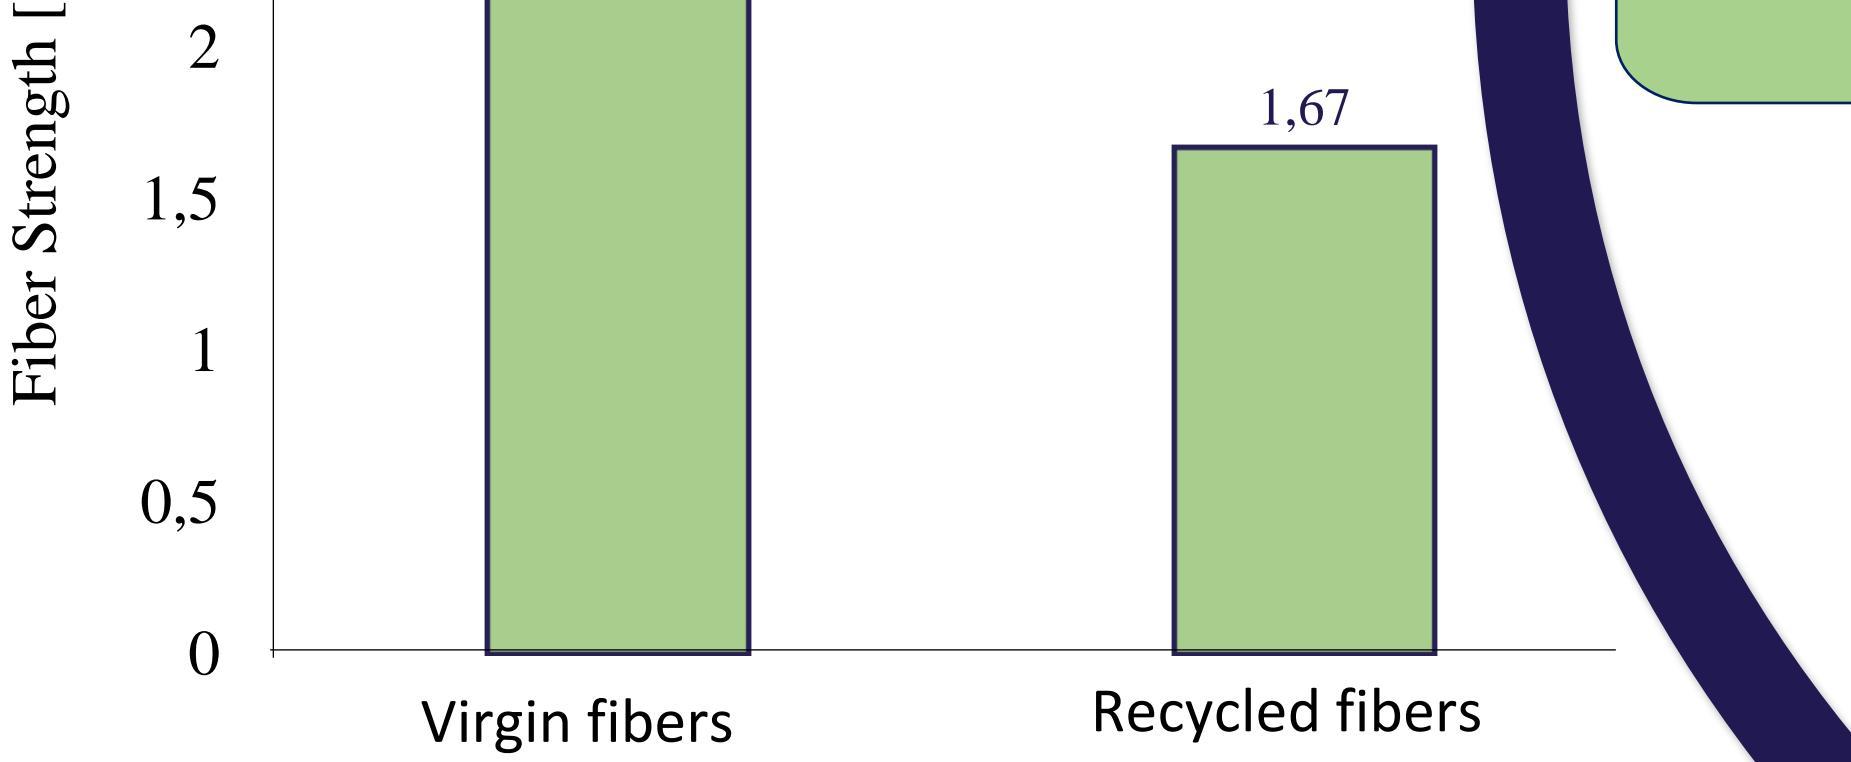
Mechanical properties of virgin glass fibers and recycled glass fibers.

Single fiber testing was performed to study the mechanical properties of glass fibers. Comparison was made between virgin and recycled fibers to check the strength loss of recycled fibers.

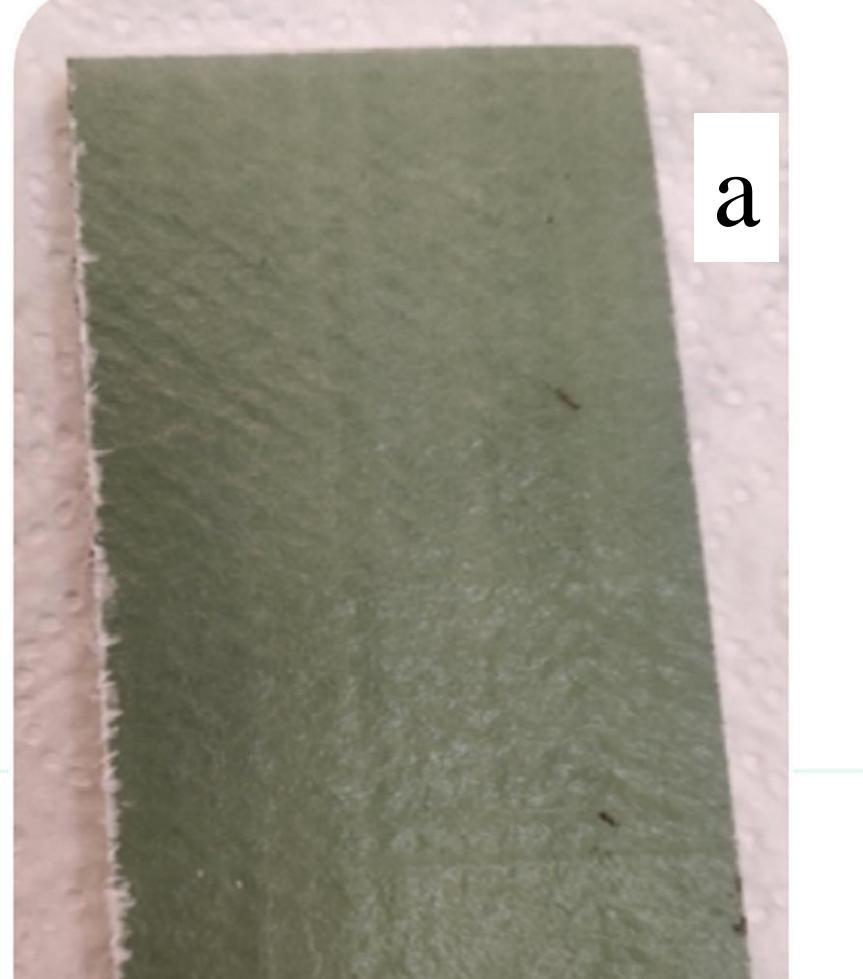
Fiber reinforced composites sample (a), depolymerized glass fibers (b), and oil product (c).

Fiber reinforced composite sample (a) was used in solvolysis. The depolymerized fibers (b) were removed from the reactor and subsequently cleaned using acetone. The oil product (c) obtained from the solvolysis process was also collected.
